# BUILDING ANALYSIS REPORT

**Property Location:** *53-55 Cataract Ave.  
Dover, NH 03820*

**Date of Inspection:** *1/30/2026*

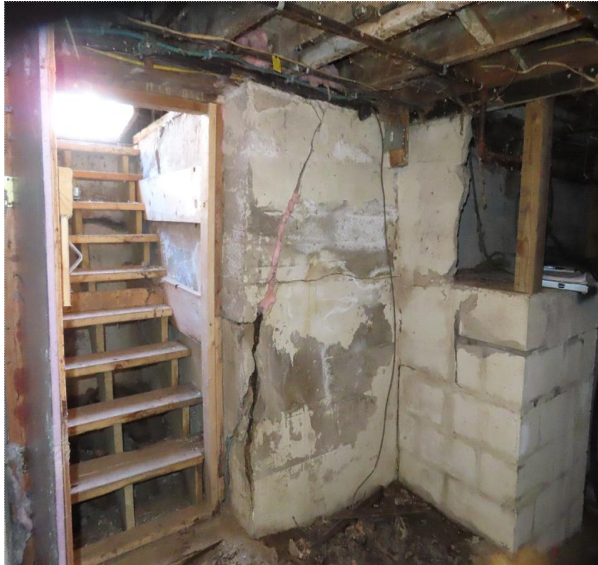
IMG\_2372.JPG

55 basement bulkhead and rear wall foundation have major structural damage and there is horizontal cracking on the left side and left front foundation walls.

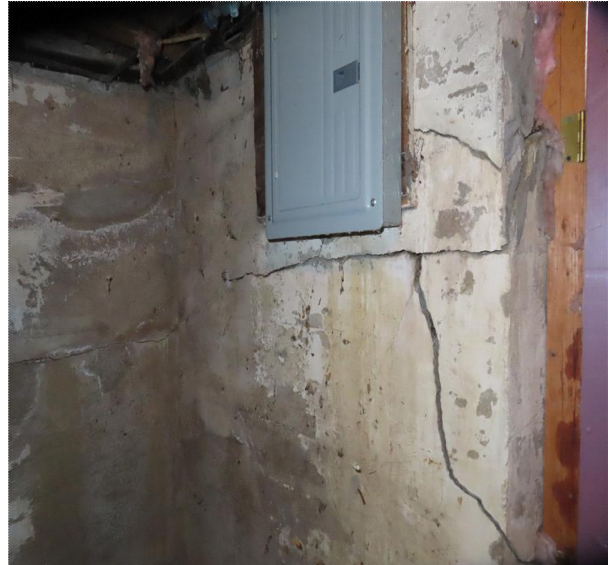
IMG\_2383.JPG

55 basement bulkhead and rear wall foundation have major structural damage and there is horizontal cracking on the left side and left front foundation walls.

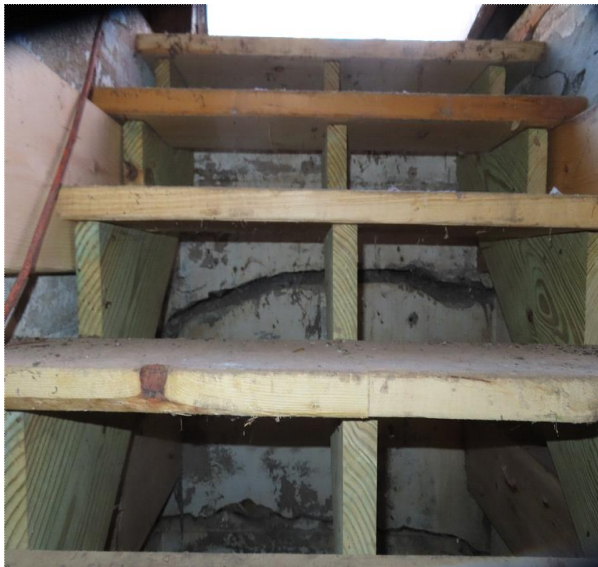
IMG\_2373.JPG

55 basement bulkhead and rear wall foundation have major structural damage and there is horizontal cracking on the left side and left front foundation walls.

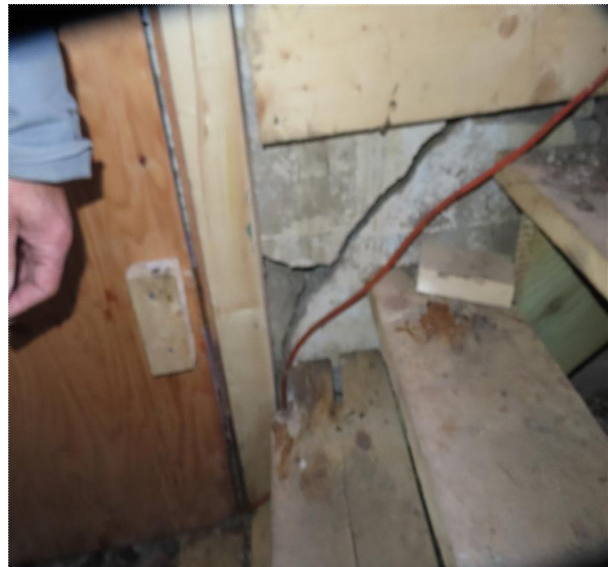
IMG\_2376.JPG

55 basement bulkhead and rear wall foundation have major structural damage and there is horizontal cracking on the left side and left front foundation walls.

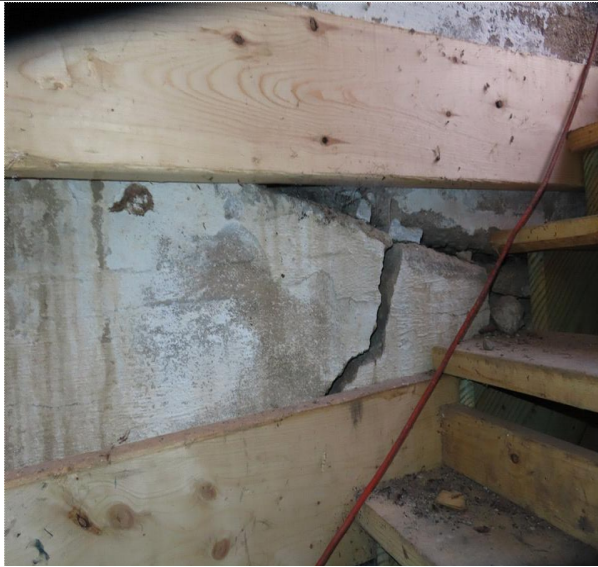
IMG\_2377.JPG

55 basement bulkhead and rear wall foundation have major structural damage and there is horizontal cracking on the left side and left front foundation walls.

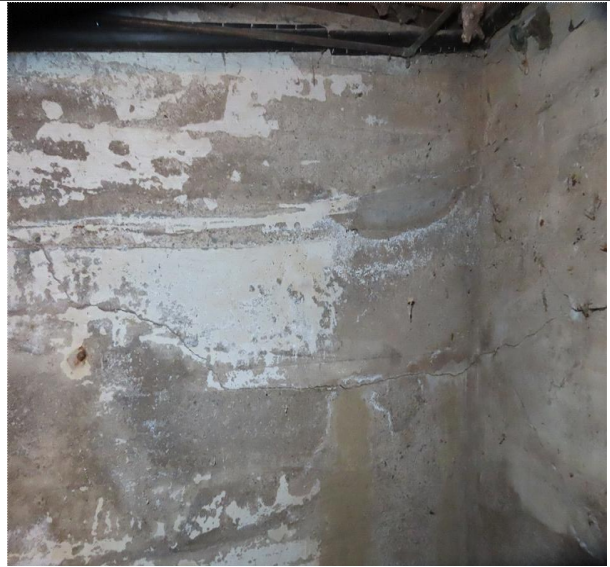
IMG\_2384.JPG

55 basement bulkhead and rear wall foundation have major structural damage and there is horizontal cracking on the left side and left front foundation walls.

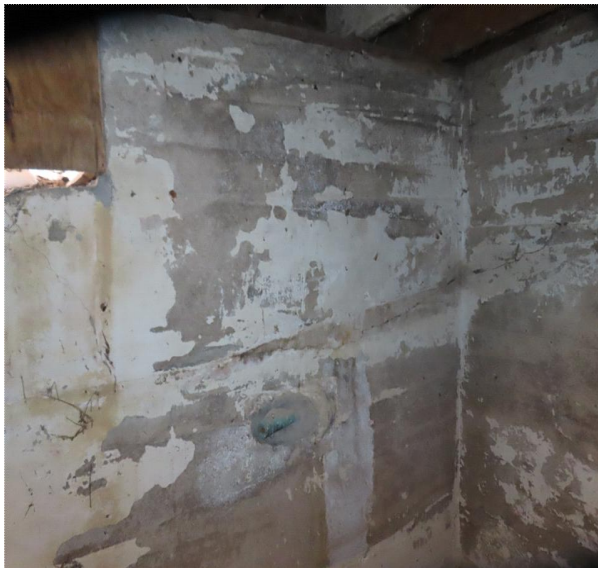
IMG\_2386.JPG

55 basement bulkhead and rear wall foundation have major structural damage and there is horizontal cracking on the left side and left front foundation walls.

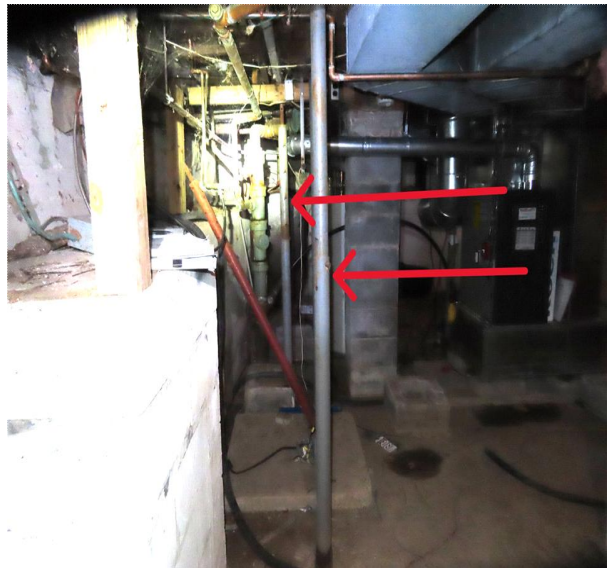
IMG\_2387.JPG

55 basement has numerous temporary jacking posts that should be replaced with structural support posts.

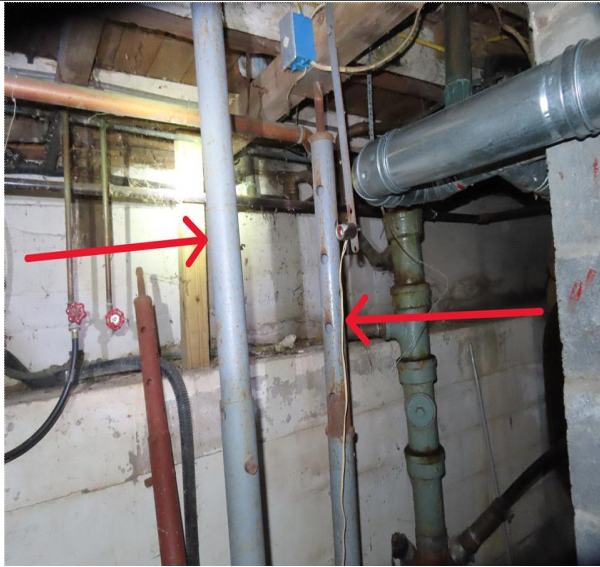
IMG\_2388.JPG

55 basement has numerous temporary jacking posts that should be replaced with structural support posts.

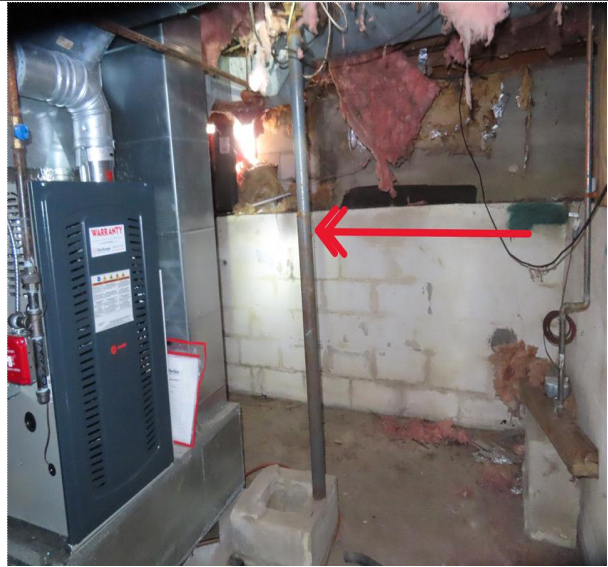
IMG\_2391x.JPG

55 basement has numerous temporary jacking posts that should be replaced with structural support posts.

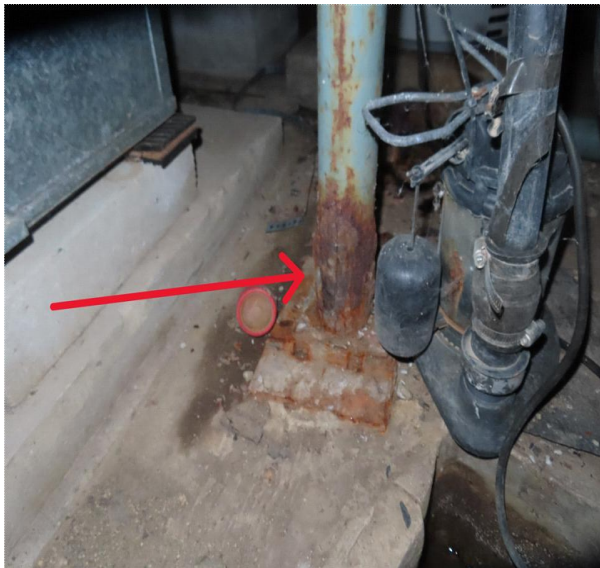
IMG\_2407.JPG

55 basement has numerous temporary jacking posts that should be replaced with structural support posts.

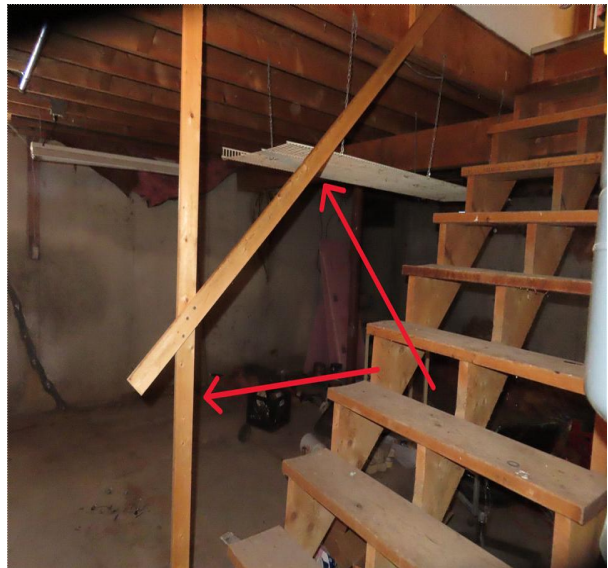
IMG\_2342.JPG

53 basement stairs need a stronger railing installed for safety.

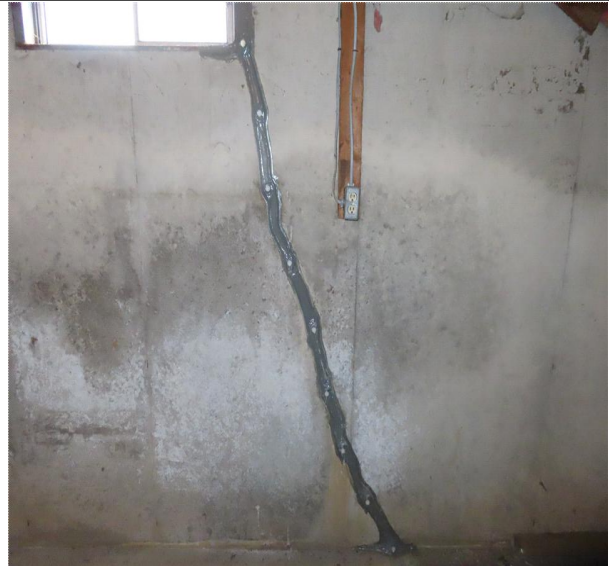
IMG\_2334.JPG

53 concrete foundation had a crack sealed in the left front corner, this repair appears to be professionally done.

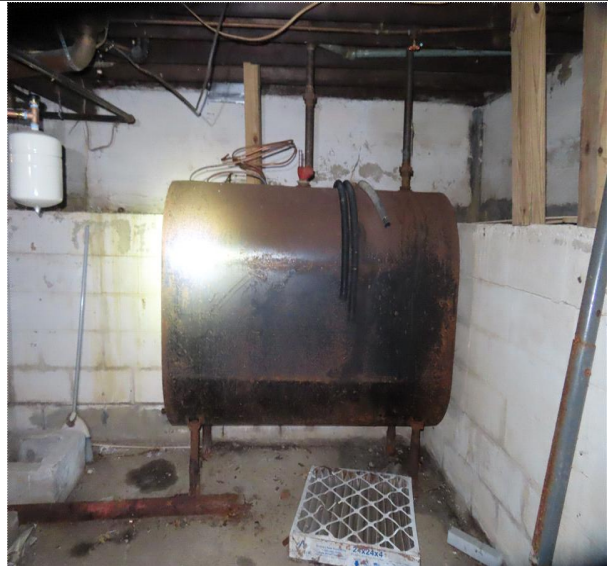
IMG\_2400.JPG

55 has an abandoned oil tank and filler pipes that need to be removed to prevent accidental oil fill.

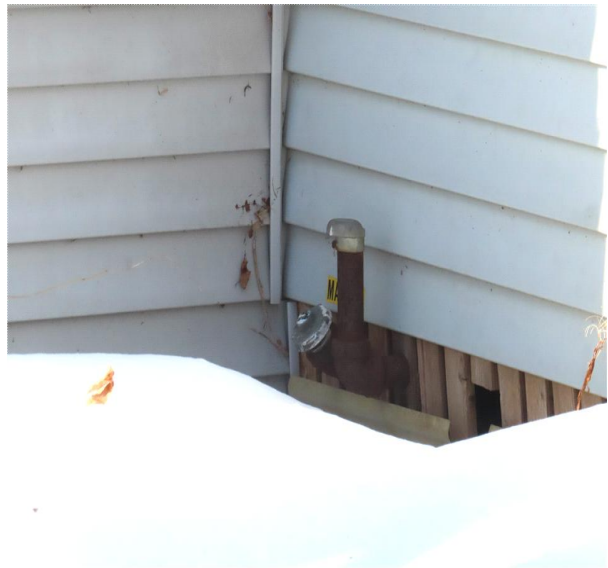
IMG\_2417.JPG

55 has an abandoned oil tank and filler pipes that need to be removed to prevent accidental oil fill.

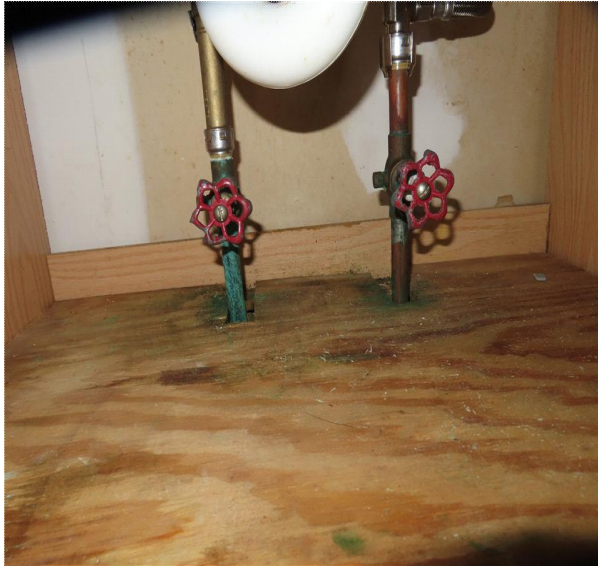
IMG\_2348.JPG

There is evidence of a prior water leak from the water shutoff area underneath 53 first floor bathroom sink, no leaks were observed today.

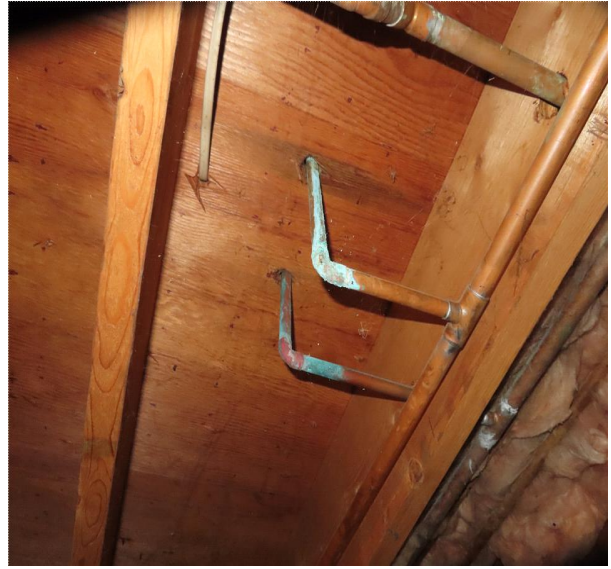
IMG\_2314.JPG

There is evidence of a prior water leak from the water shutoff area underneath 53 first floor bathroom sink, no leaks were observed today.

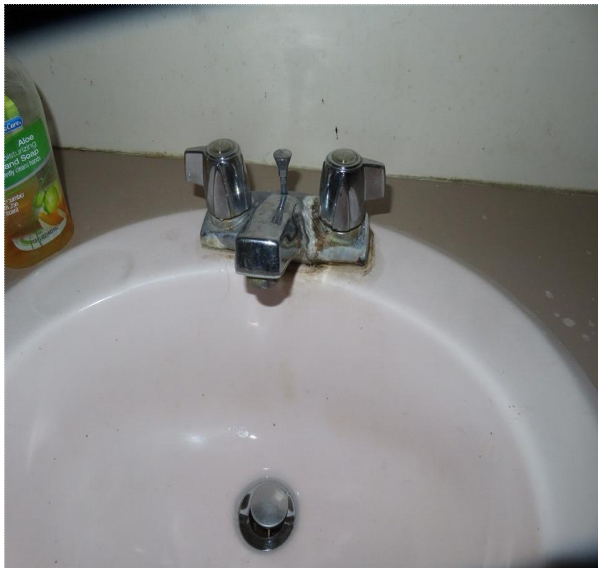
IMG\_2367.JPG

53 2nd floor bath sink faucet leaks when on and needs to be replaced.

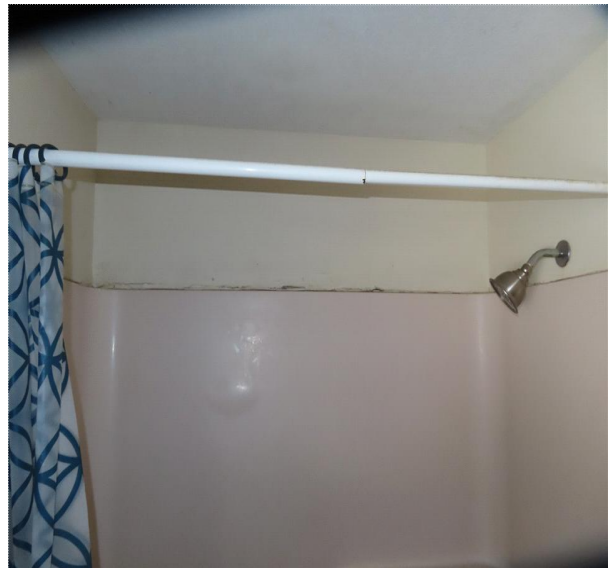
IMG\_2365.JPG

53 2nd floor bath has wall damage around the tub that needs to be repaired.

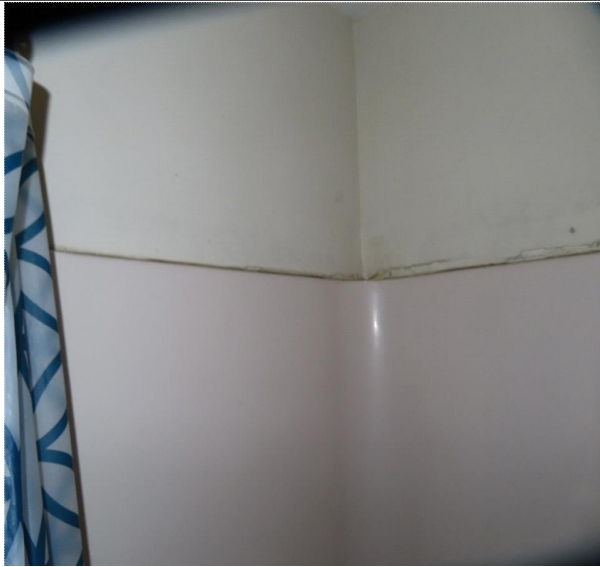
IMG\_2364.JPG

53 2nd floor bath has wall damage around the tub that needs to be repaired.

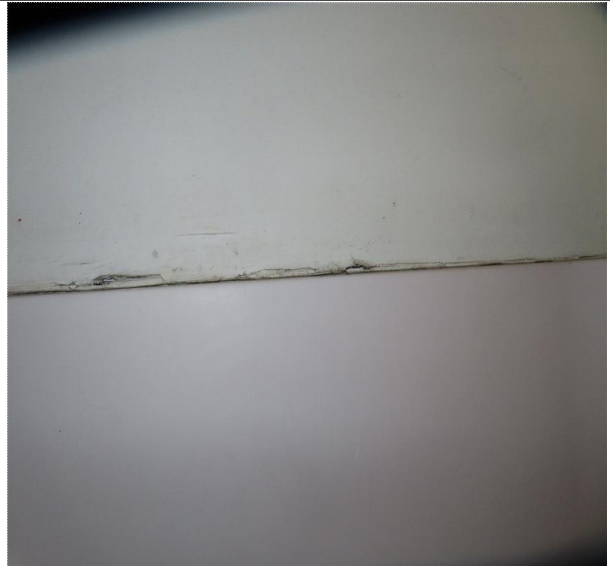
IMG\_2362.JPG

53 2nd floor bath has wall damage around the tub that needs to be repaired.

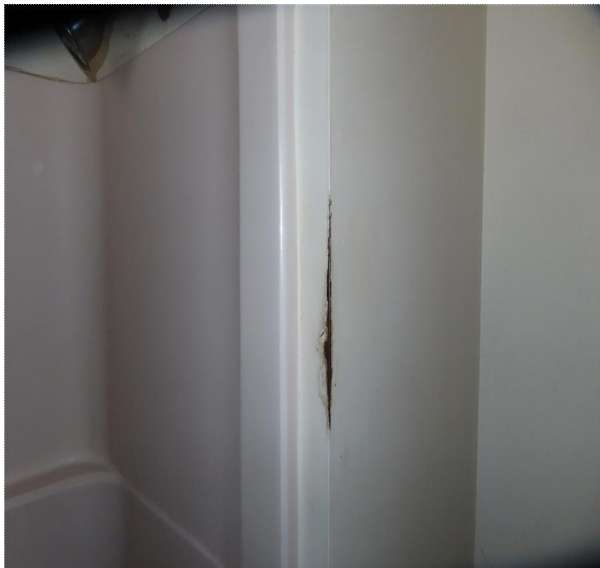
IMG\_2361.JPG

53 2nd floor bath has wall damage around the tub that needs to be repaired.

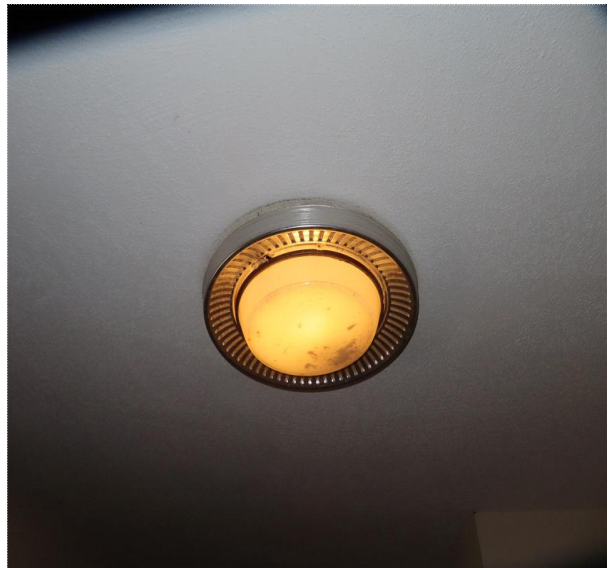
IMG\_2366.JPG

53 2nd floor bath exhaust fan does not work.

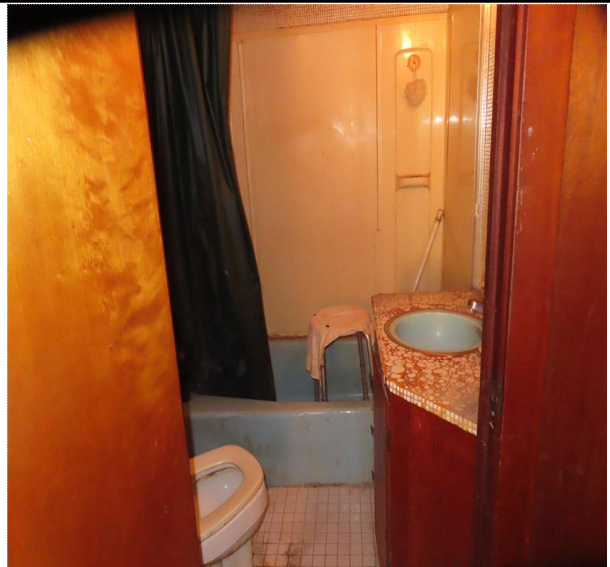
IMG\_2443.JPG

55 bath needs a total renovation.

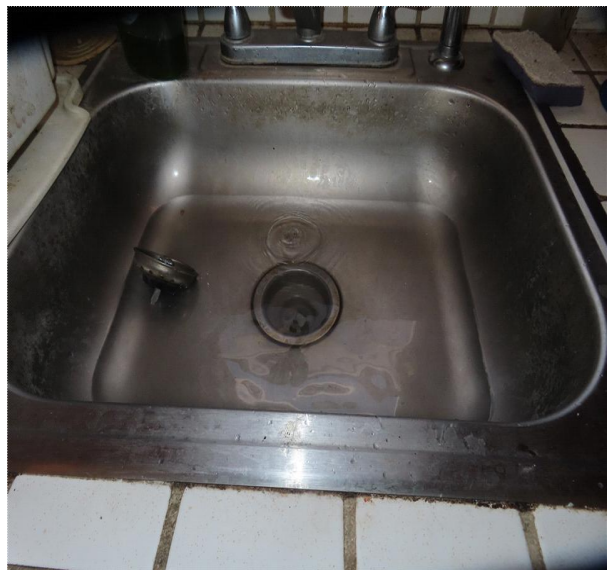
IMG\_2447.JPG

55 kitchen sink drains slowly should be diagnosed in repaired by a licensed plumber.

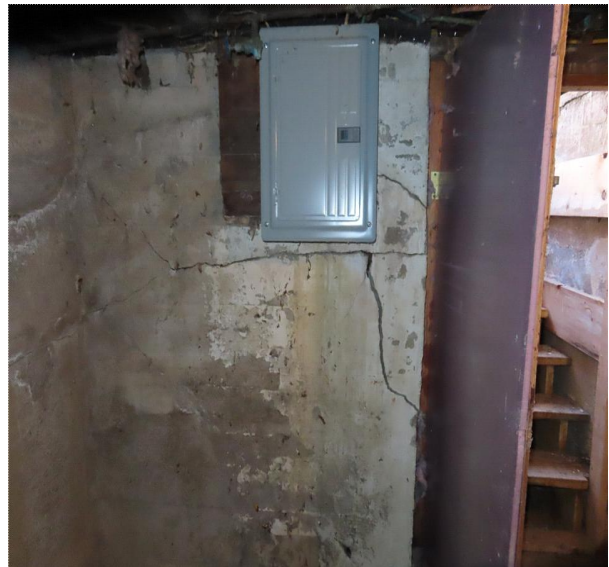
IMG\_2371.JPG

55 sub panel is located on the rear wall of 55 basement, no issues were observed inside the panel but there are water pipes above it which is a safety issue.

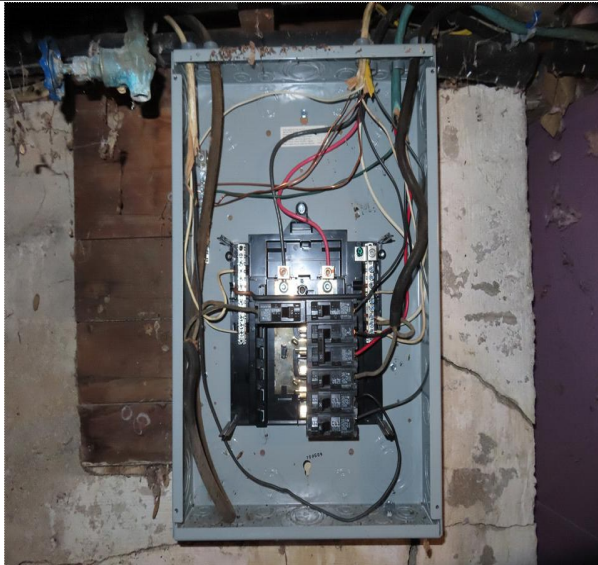
IMG\_2415.JPG

55 sub panel is located on the rear wall of 55 basement, no issues were observed inside the panel but there are water pipes above it which is a safety issue.

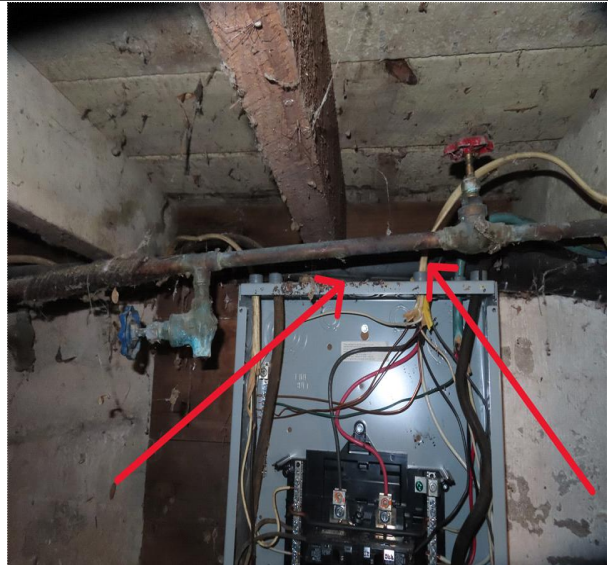
IMG\_2416.JPG

55 sub panel is located on the rear wall of 55 basement, no issues were observed inside the panel but there are water pipes above it which is a safety issue.

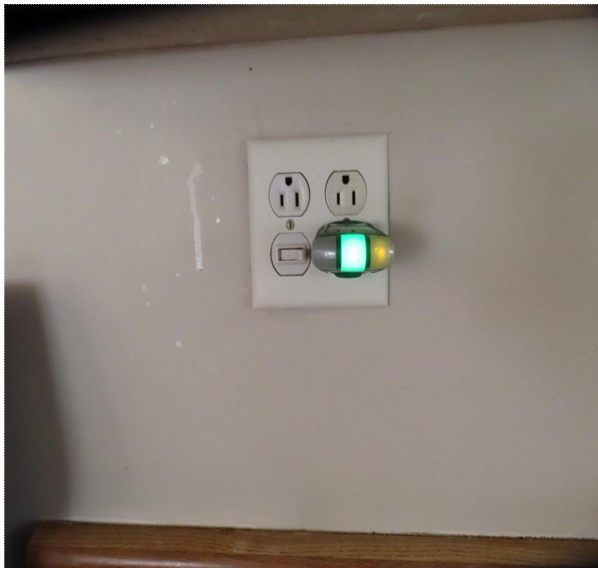
IMG\_2346.JPG

53 kitchen electrical outlets to the right of the stove and in the left corner beside the stove have open neutral feeds to them.

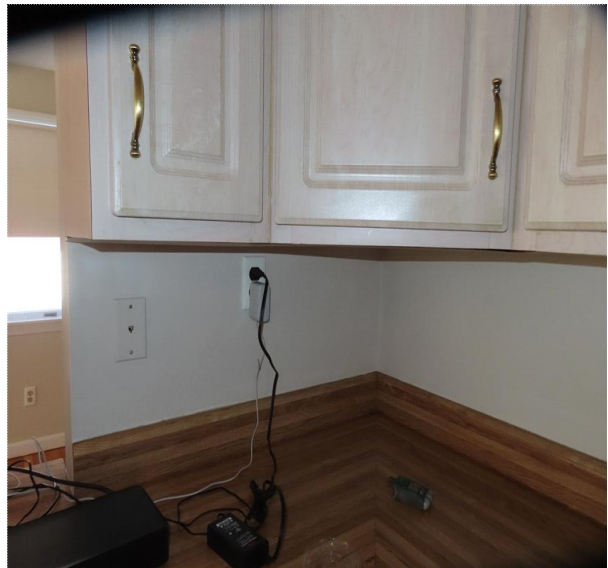
IMG\_2347.JPG

53 kitchen electrical outlets to the right of the stove and in the left corner beside the stove have open neutral feeds to them.

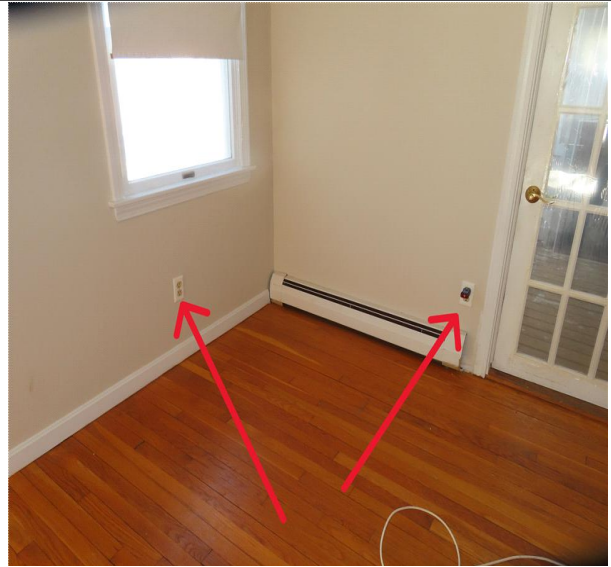
IMG\_2354.JPG

53 family room rear wall electrical outlets and both outlets in the left rear corner of the dining room have the hot and neutral wires reversed.

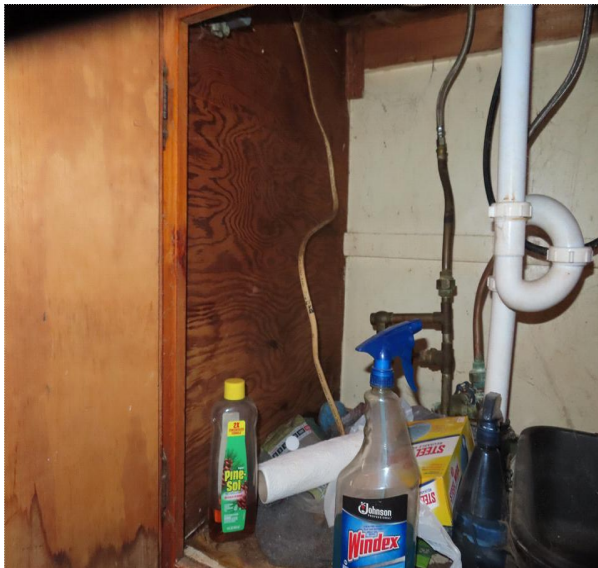
IMG\_2448.JPG

55 has a wire under the kitchen sink that should be in conduit to protect it from damage.

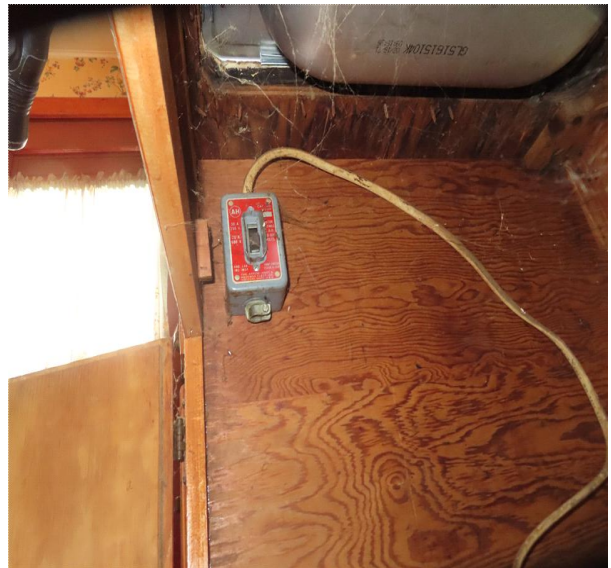
IMG\_2449.JPG

55 has a wire under the kitchen sink that should be in conduit to protect it from damage.

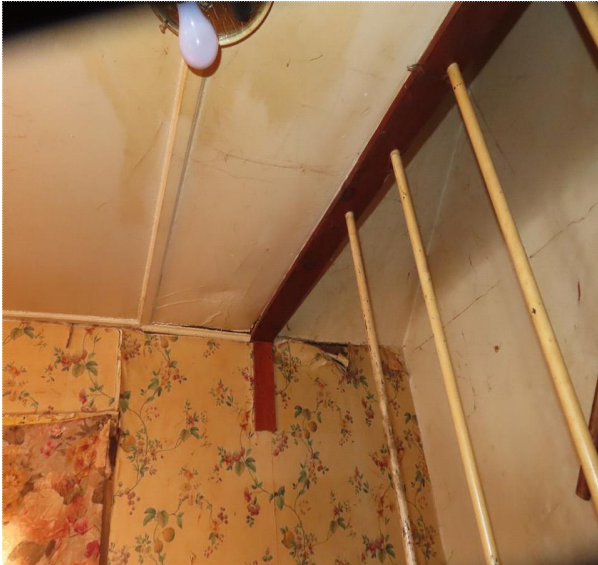
IMG\_2444.JPG

55 2nd floor stairs need a stronger railing installed for safety. 55 has ceiling and wall damage from roof leaks that need repair.

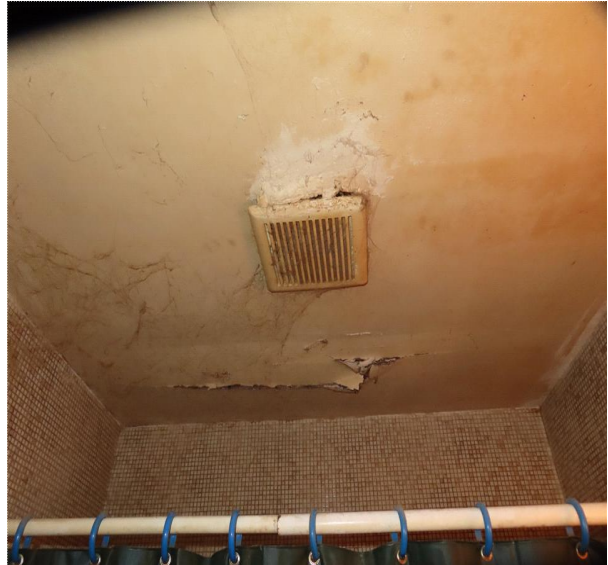
IMG\_2439.JPG

55 has ceiling and wall damage from roof leaks that need repair.

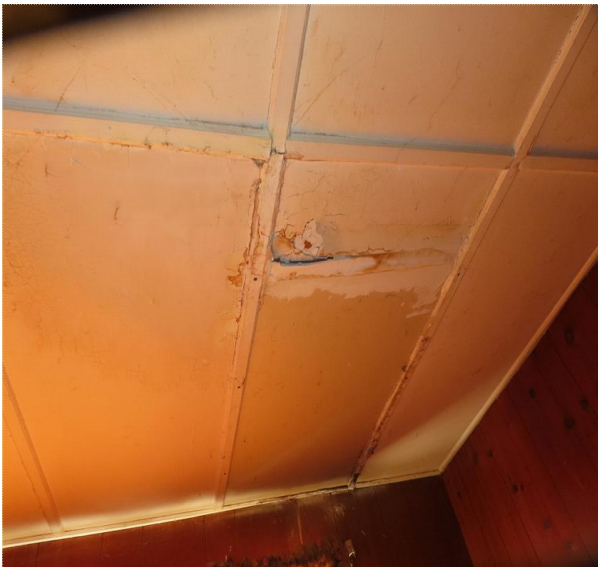
IMG\_2423.JPG

55 has ceiling and wall damage from roof leaks that need repair.

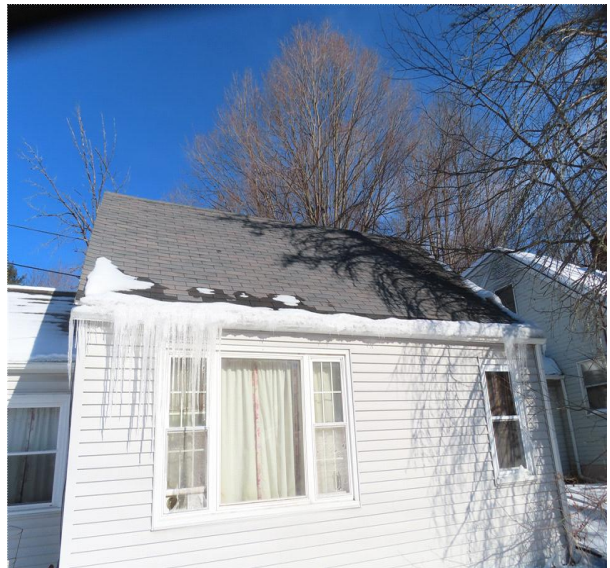
IMG\_2278.JPG

The only roof that was not snow covered was 55 front but there is evidence of roof leaks inside 55.

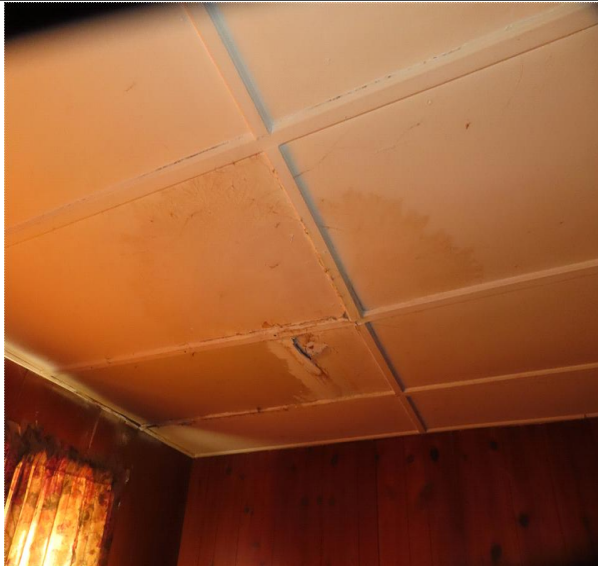
IMG\_2422.JPG

The only roof that was not snow covered was 55 front but there is evidence of roof leaks inside 55.

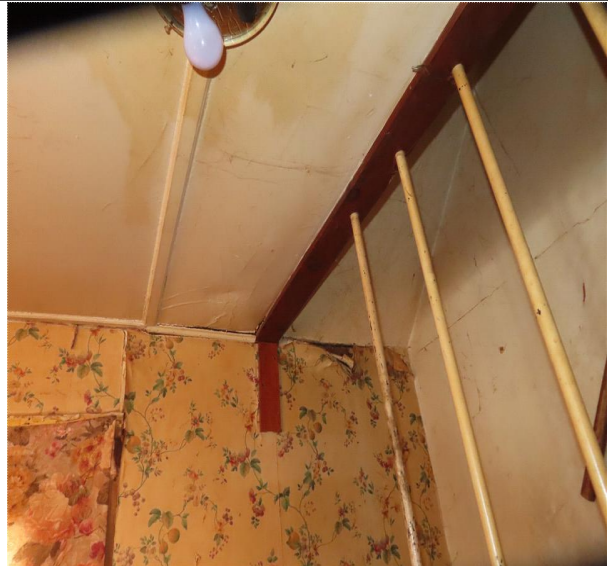
IMG\_2444.JPG

The only roof that was not snow covered was 55 front but there is evidence of roof leaks inside 55.

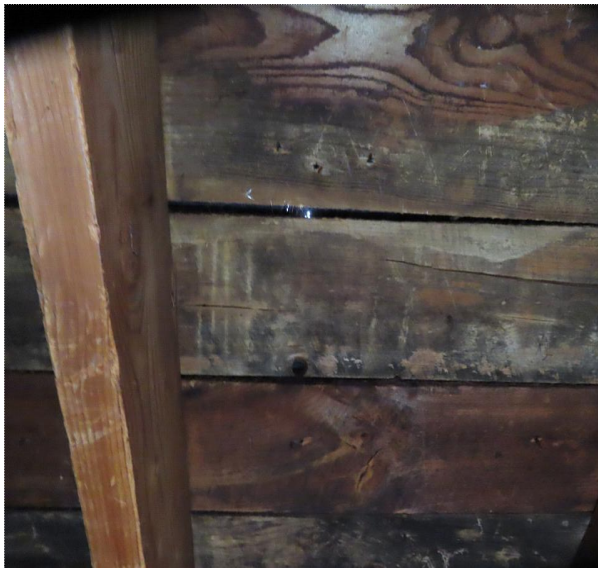
IMG\_2431.JPG

There are a couple of spots in 55 front kneewall attic area where you could see light from the outside through the roof.

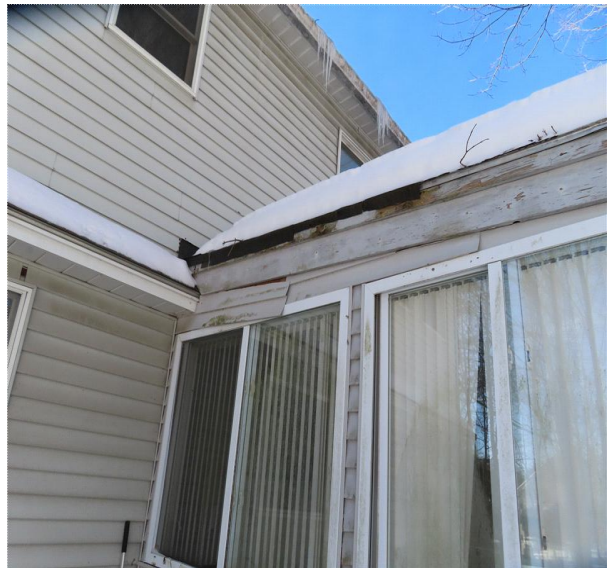
IMG\_2299.JPG

53 rear porch addition has rotted roof fascia trim that also has wood destroying insect damage, this trim needs to be replaced.

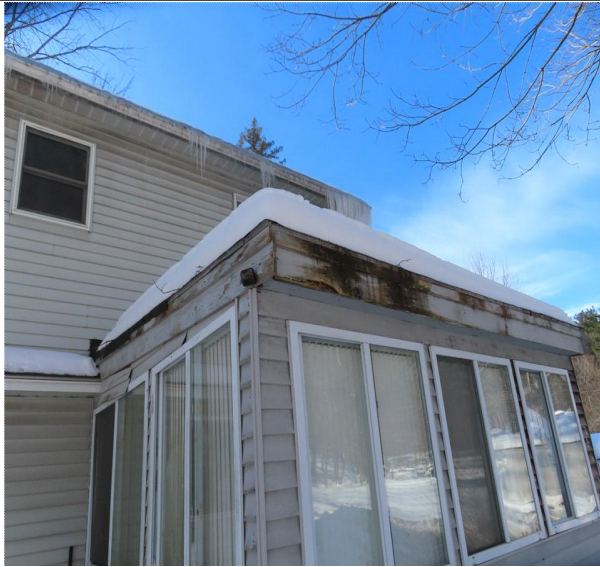
IMG\_2297.JPG

53 rear porch addition has rotted roof fascia trim that also has wood destroying insect damage, this trim needs to be replaced.

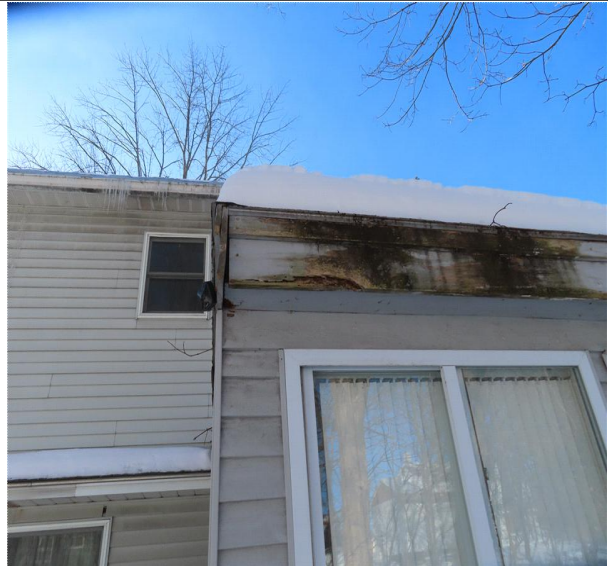
IMG\_2298.JPG

53 rear porch addition has rotted roof fascia trim that also has wood destroying insect damage, this trim needs to be replaced.

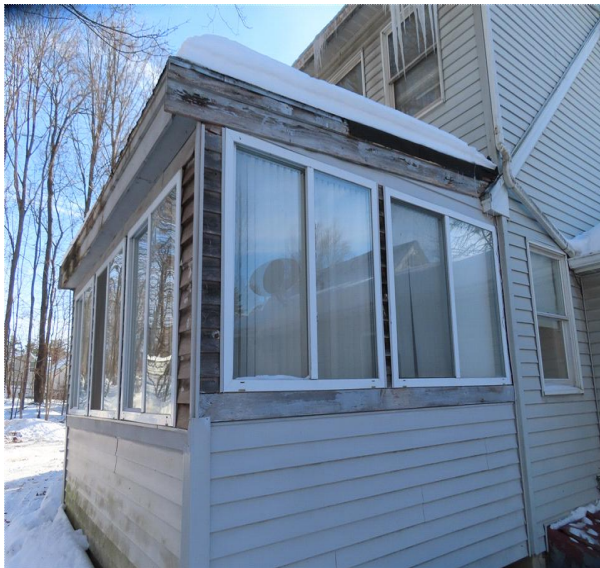
IMG\_2301.JPG

53 rear porch addition has rotted roof fascia trim that also has wood destroying insect damage, this trim needs to be replaced.

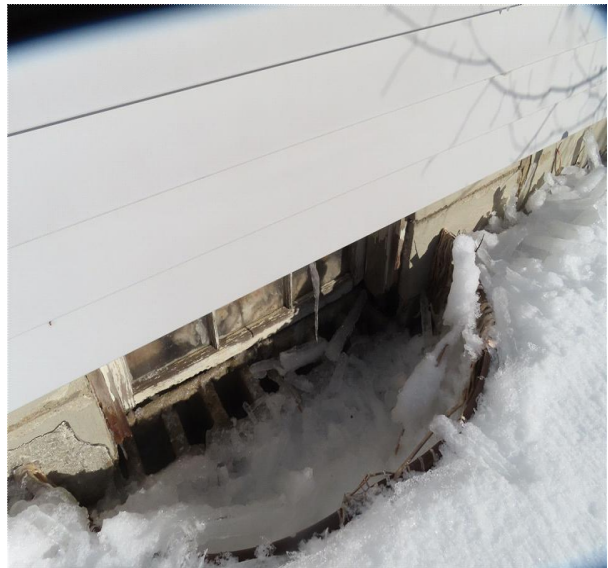
IMG\_2283.JPG

Both 55 front basement windows are rotted and are open to the basement, the windows, trim and sills need to be replaced.

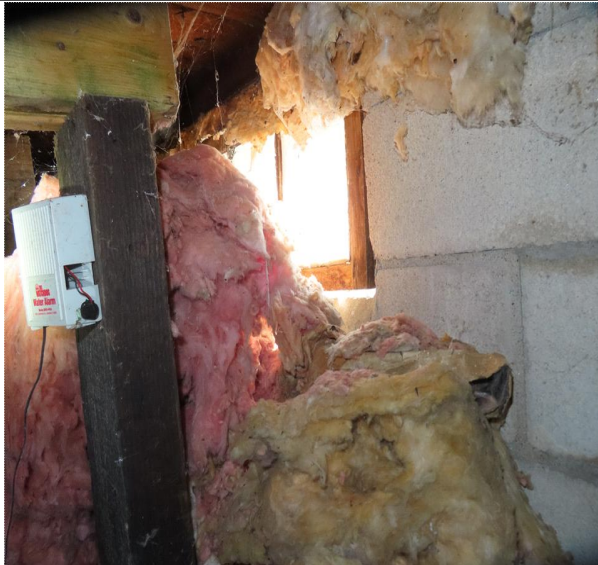
IMG\_2394.JPG

Both 55 front basement windows are rotted and are open to the basement, the windows, trim and sills need to be replaced.

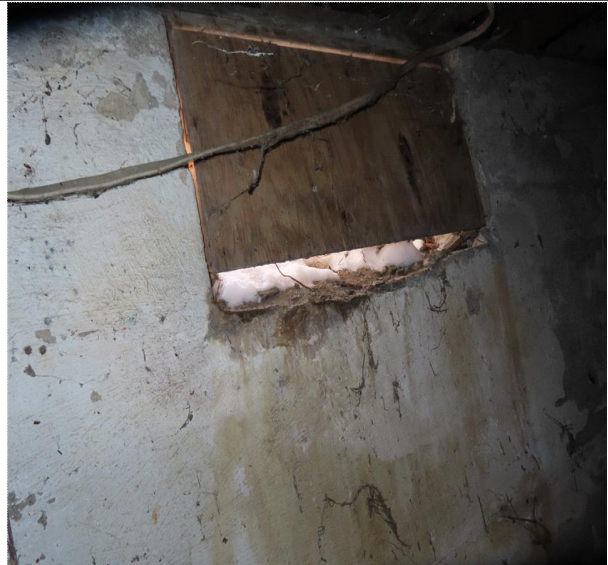
IMG\_2397.JPG

Both 55 front basement windows are rotted and are open to the basement, the windows, trim and sills need to be replaced.

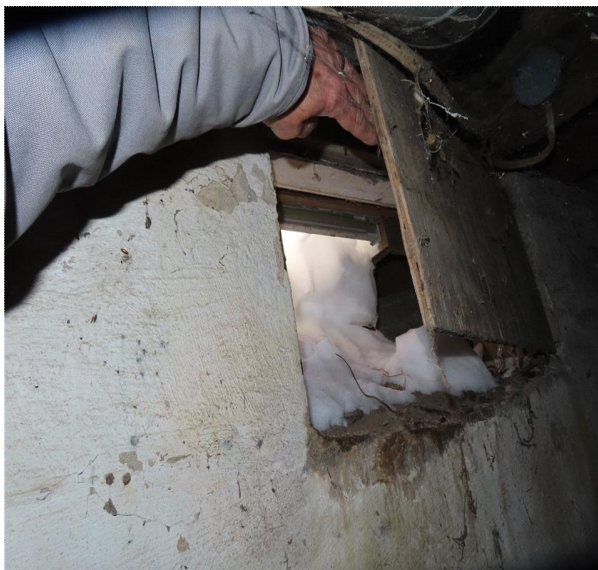
IMG\_2398.JPG

Both 55 front basement windows are rotted and are open to the basement, the windows, trim and sills need to be replaced.

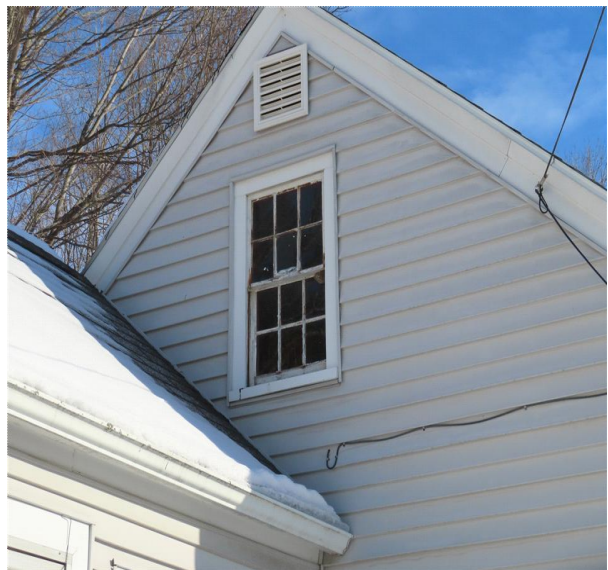
IMG\_2277.JPG

55 gable attic windows need to be scraped and painted.

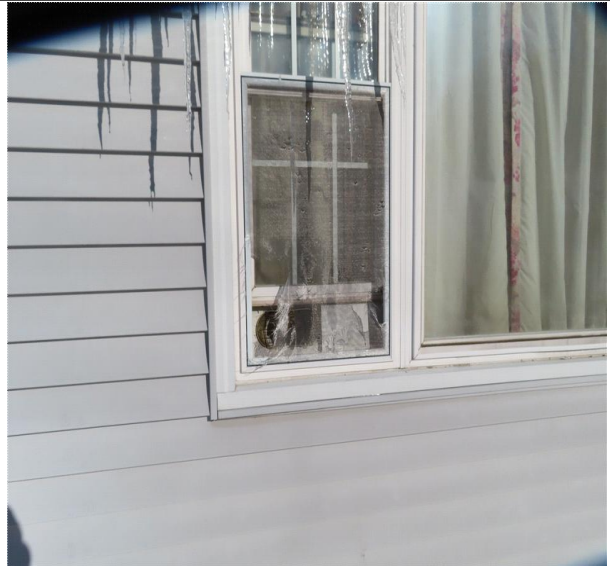
IMG\_2280.JPG

55 front windows have torn screens that need to be replaced.

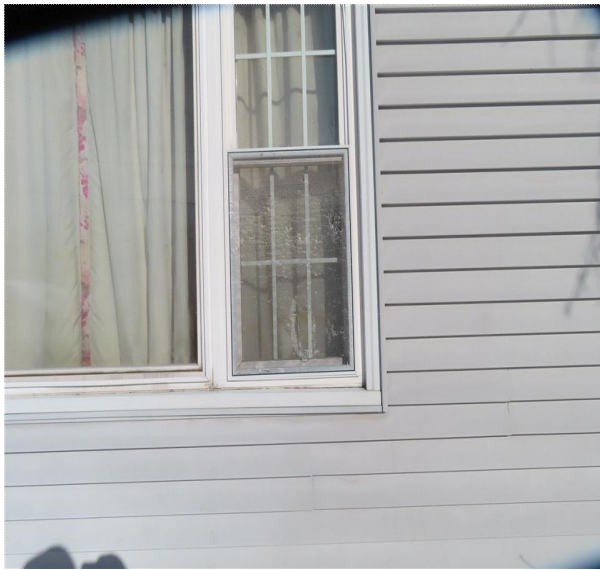
IMG\_2281.JPG

55 front windows have torn screens that need to be replaced.

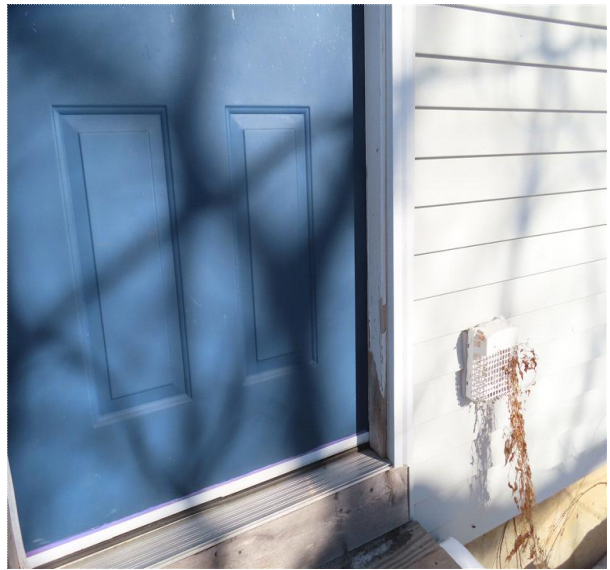
IMG\_2289.JPG

53 front door trim has peeling paint that needs to be scraped and painted.

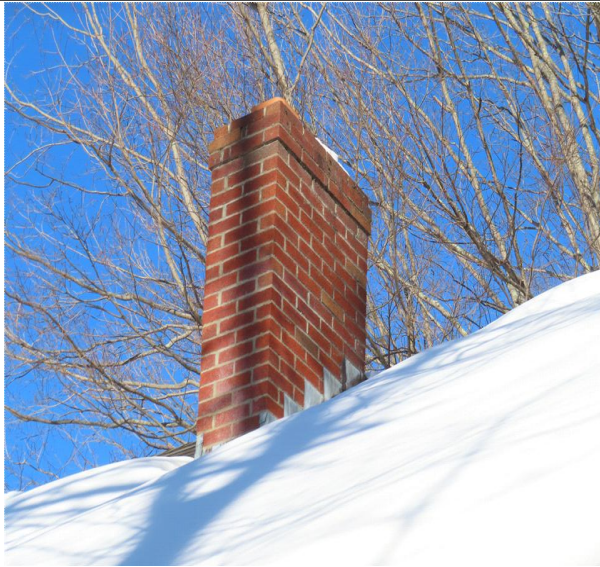
IMG\_2291.JPG

The chimneys were only observed from the ground, it is recommended to have a Level II chimney inspection.  
(Internal camera inspection)

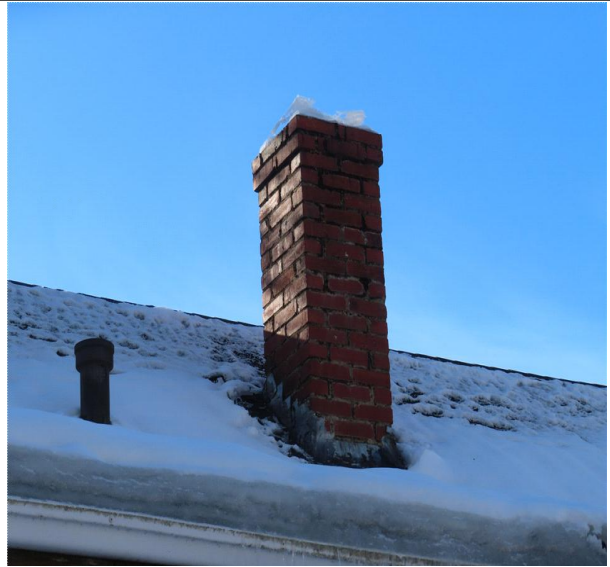
IMG\_2305.JPG

The chimneys were only observed from the ground, it is recommended to have a Level II chimney inspection.  
(Internal camera inspection)

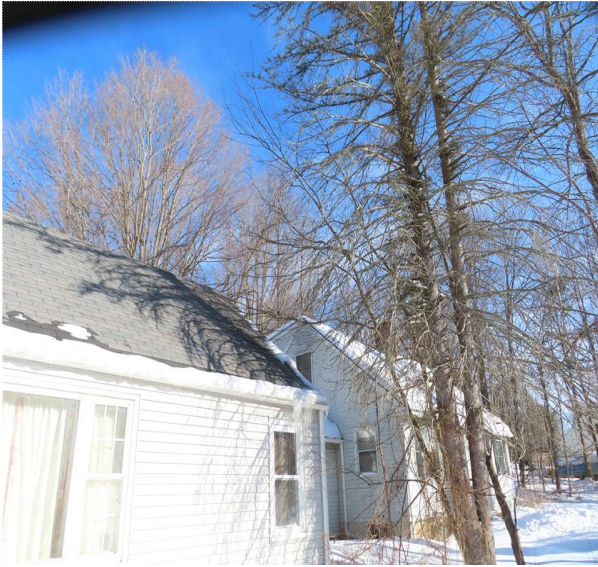
IMG\_2279.JPG

The trees over 55 roof need to be trimmed away from the home to prevent physical damage to the roof.
