## **DOVER HIGH SCHOOL AND CAREER TECHNICAL CENTER** Site & Building Assessment Report

Dover, New Hampshire

January 2015

**Volume I of II**

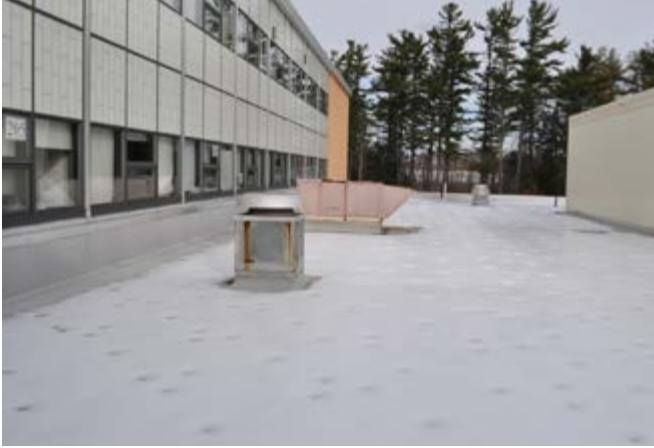
View of Roof with snow cover

In 2008, a new white Thermoplastic Polyolefin (TPO) roof was installed over the entire (DHS –CTC) addition. These roofs generally carry a 20 year prorated warranty, so the roof is 7 years old. When walking the site, the roof was covered in 3" to 4" of snow. When viewing the roof in this condition, the melting pattern of the snow on the roof indicated areas where heat was escaping due to the thermal breaks at the roof fasteners. This melting pattern might imply the installation of the mechanical fasteners was directly connected to the metal deck. Further investigation into this melting pattern is recommended should the building be renovated.

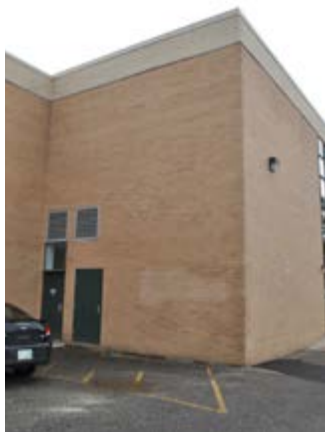
Visible Efflorescence

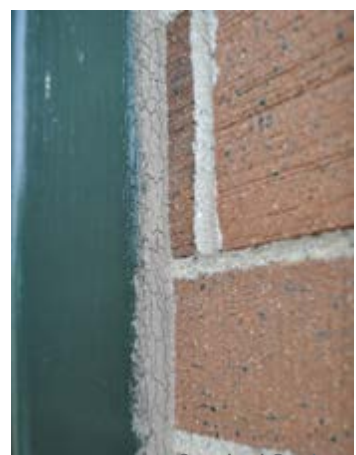
Cracked Sealant

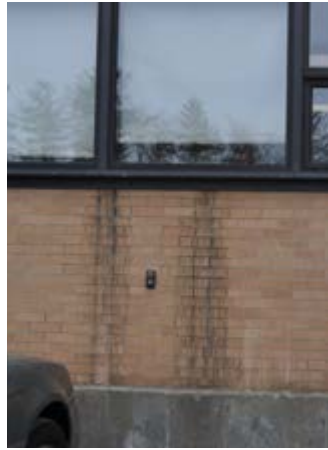
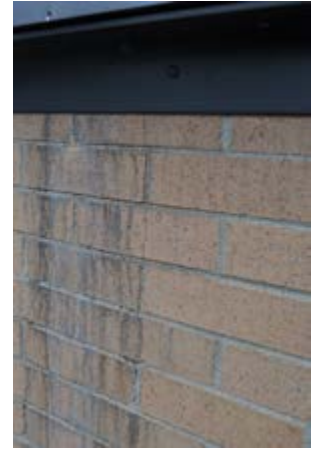
Stained Brick Under Curtain Wall System

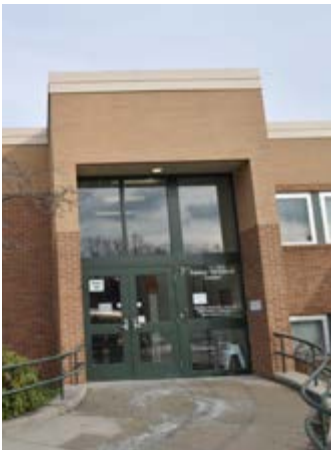
CTC Entrance & Brick in Disrepair

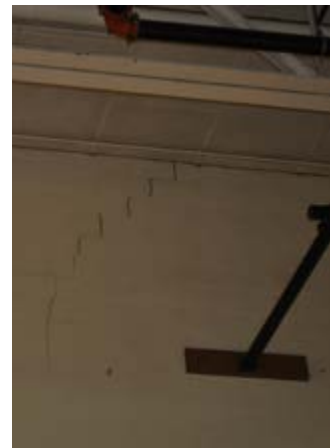
Drinking Fountain, Aged Base Board & Cracking CMU

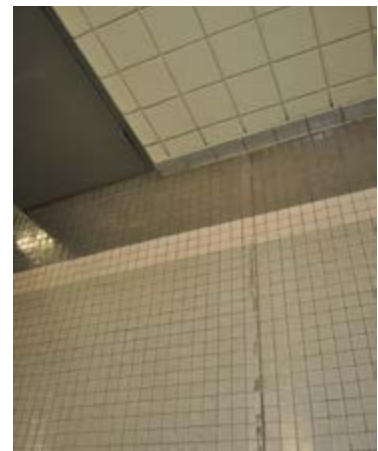
Cracked Tile Floor

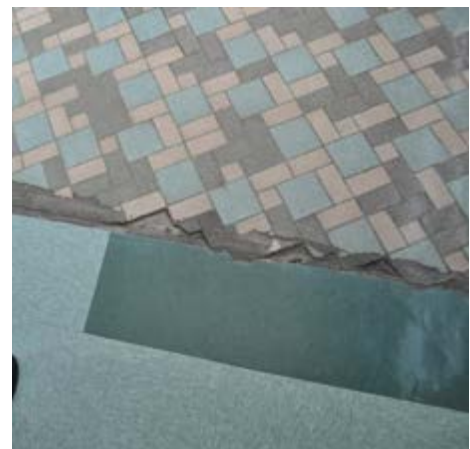
Missing Expansion Joint at 2002 Addition

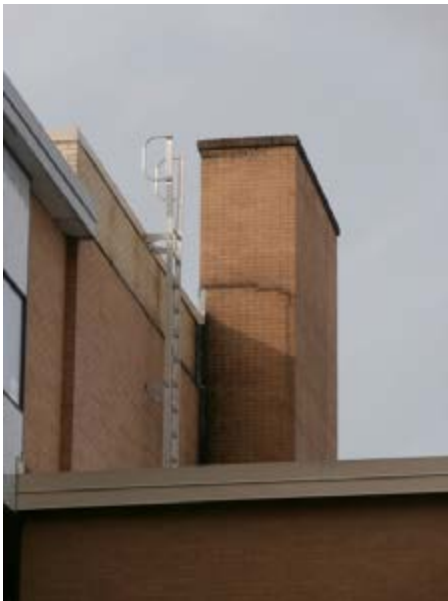
6. Masonry chimney – note step crack near upper roof line.

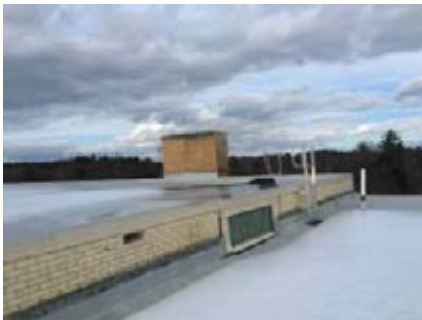
The boilers are vented by a common manifold double wall steel breeching system that terminates through a masonry chimney to the outdoors. There are some visible cracks at the top of the chimney. The condition of the interior liner was not inspected during the site visit.

*Boiler Chimney*

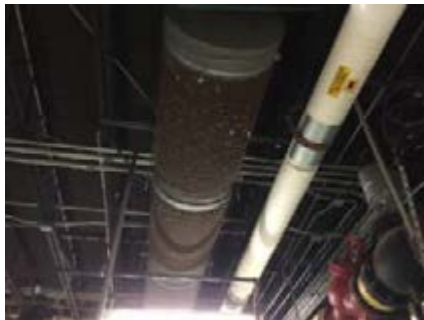
*Combustion Air Perforated Supply Diffuser*

Combustion air for the boilers is provided by two (2) inline combustion air fan systems. Combustion air is distributed to the boilers via galvanized sheetmetal ductwork and perforated supply diffusers that are located between the boilers. The perforated supply diffusers were observed to be dirty and clogged.

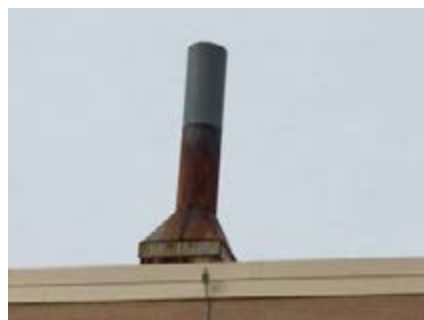
The boilers are vented by a common steel breeching system that terminates through the roof to the outdoors. The steel breeching is uninsulated, and the exterior breeching shows visible signs of rust and corrosion.

*Exterior Boiler Breeching Stack*

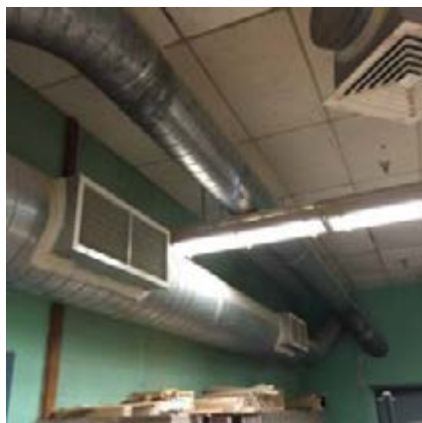
The Wood Shop is primarily heated and ventilated by a hot water unit ventilator, and supplemental ventilation air is provided by a central station air handling unit. There is an outdoor grade mounted dust collector installed that is ducted to wood-working saws and equipment via galvanized sheetmetal ductwork. The unit ventilator, dust collector and associated ductwork appears to be in poor condition.

*Wood Shop - Ventilation Ductwork*

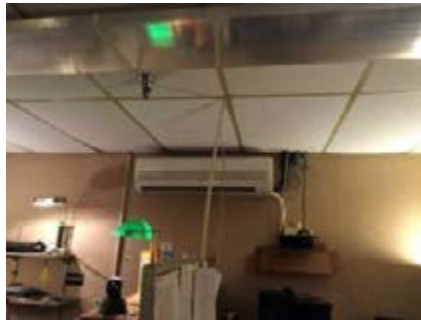
The IT Server and Office room is air conditioned by a ductless AC unit. It was reported that the room is consistently warm and experiences inadequate airflow and temperature control.

*IT Room - Ductless AC Unit*

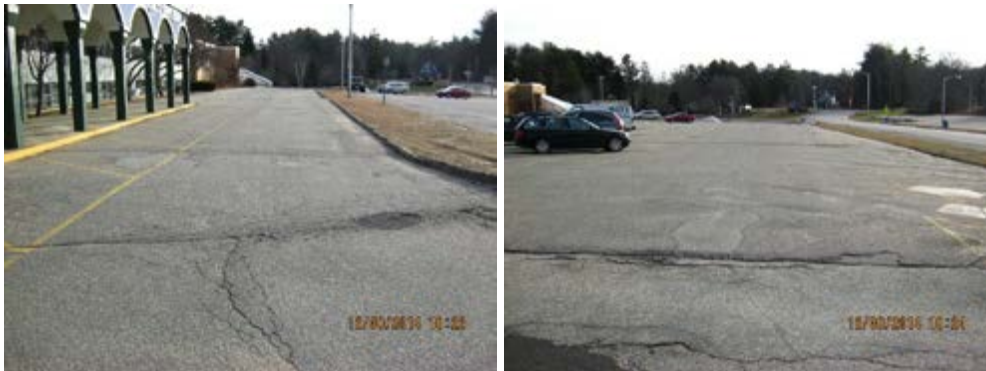
- Upon visual inspection the condition of the existing pavement is generally less than satisfactory. Numerous cracks (longitudinal, traverse, alligator) were observed in both the bus-drop off loop and the A Lot. Few of the cracks observed in the pavement have been sealed using asphalt crack sealant while the majority of the cracks have been left untreated.
- Some patch work and pavement overlays have been done over the years presumably to address the worst sections of pavement.
- Some raveling and aging (pavement surface deterioration/loss of aggregate) of the pavement is evident throughout but is the worst in the visitor parking spaces.
- The pavement overlays at the entrance and exit from Alumni Drive are in good condition.

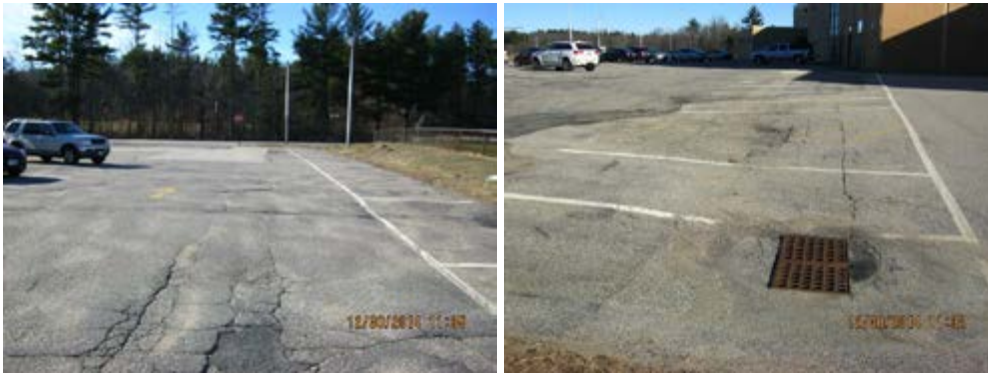
- Upon visual inspection the condition of the existing pavement is generally poor. Numerous cracks (longitudinal, traverse, alligator) were observed in both the B lot and the portion of the lot associated with the 2002 addition. Few of the cracks observed in the pavement have been sealed using asphalt crack sealant while the majority of the cracks have been left untreated.
- Some patch work and pavement overlays have been done over the years presumably to address the worst sections of pavement.
- Some raveling and aging (pavement surface deterioration/loss of aggregate) of the pavement is evident throughout.

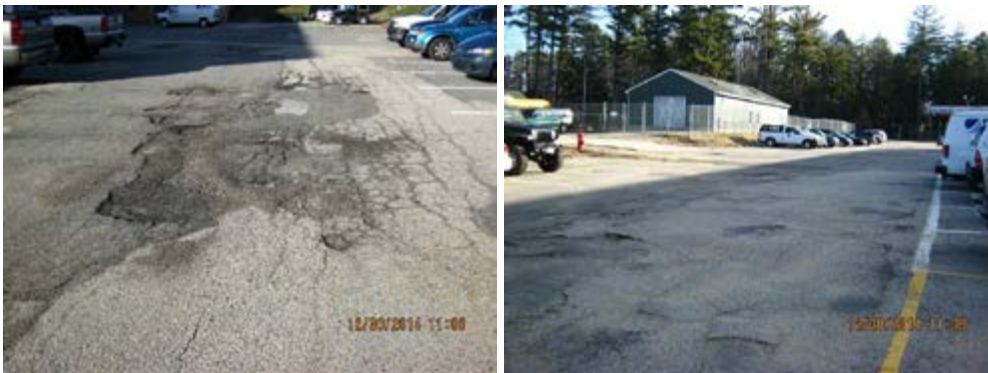
- Upon visual inspection the condition of the existing pavement is generally very poor. Numerous cracks (longitudinal, traverse, alligator) were observed in the C lot. Few of the cracks observed in the pavement have been sealed using asphalt crack sealant while the majority of the cracks have been left untreated.
- Some patch work and pavement overlays have been done over the years presumably to address the worst sections of pavement.
- Serious raveling and aging (pavement surface deterioration/loss of aggregate) of the pavement is evident throughout sections of the C lot. This likely results in surface ponding during/following rain events.
- The entrance and exit from Alumni Drive to the parking spaces associated with the 2002 addition is in less than satisfactory condition.
