Enclosed is the MFMA Flooring Inspection Report on the maple athletic floor system at the Dover High School in Dover, New Hampshire.

**MAPLE FLOORING MANUFACTURERS ASSOCIATION  
DOVER HIGH SCHOOL  
DOVER, NEW HAMPSHIRE  
INSPECTOR: DANIEL F. HENEY  
DATE OF INSPECTION: APRIL 4, 2019**

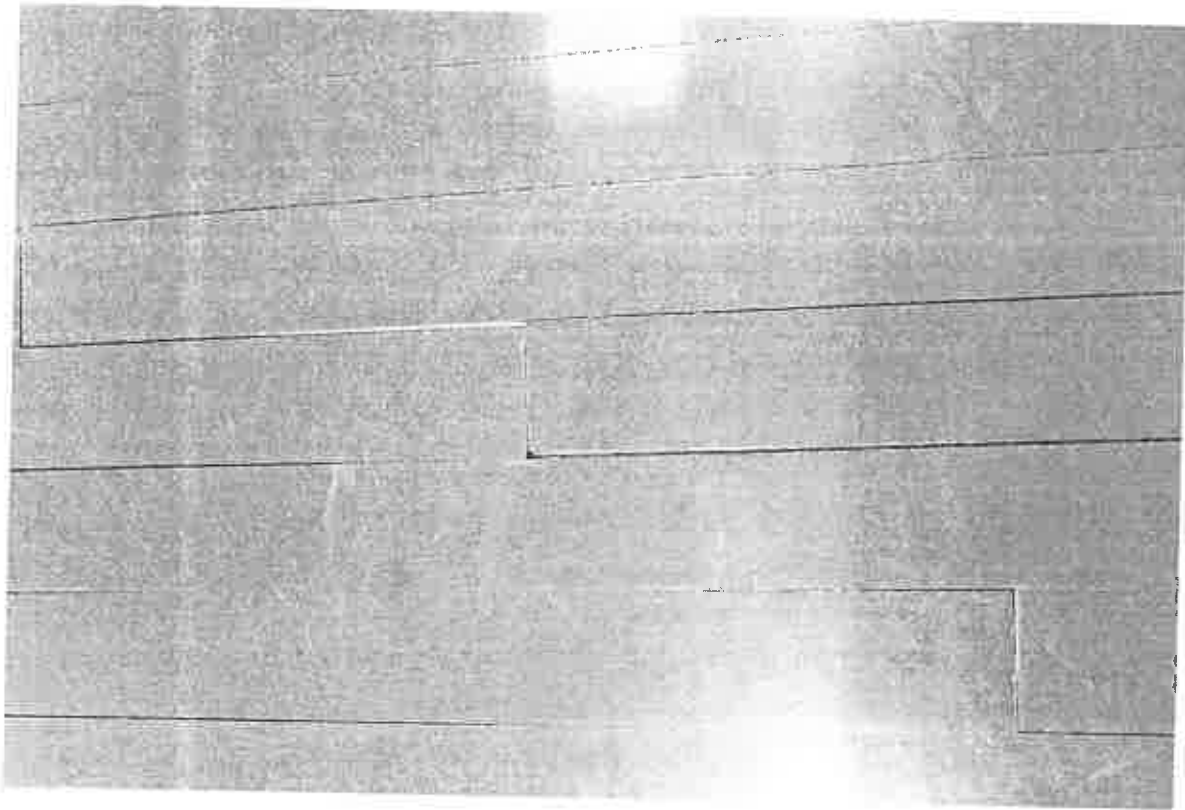
3. Facility officials indicated that they were concerned about loose flooring strips in the floor system. Officials reported loose flooring strips along the ends of the floor system and loose flooring strip within the interior portion of the floor system. Our inspector was unable to find any loose flooring strips at the perimeter but did locate several boards within the interior of the floor system where one end of a flooring strip could be kicked into the shrinkage gaps.

The floor system installed at Dover High School is a Connor Sports "Alliance" floor system which has a subfloor that provides nailing sleepers. Per Connor's installation specification the flooring should be nailed at each intersection with the subfloor nailers. The subfloor nailers are spaced 11" o.c. and the width of the plywood nailers is 4" which leaves a space between plywood nailers of 7". Therefore, end joints in flooring strips could fall between subfloor nailers resulting in one end of the flooring strip being unable to be anchored to the subfloor, especially with shorter flooring strips. In a floor suffering from extreme shrinkage like the floor at Dover High School those end joints are susceptible to side-to-side movement. Under normal condition the tightness of the floor system and the tongue and groove of the flooring strip are sufficient to hold that flooring strip in place. MFMA does not consider this condition a design defect or an installation error. This is a result of the extremely dry conditions in the gymnasium.

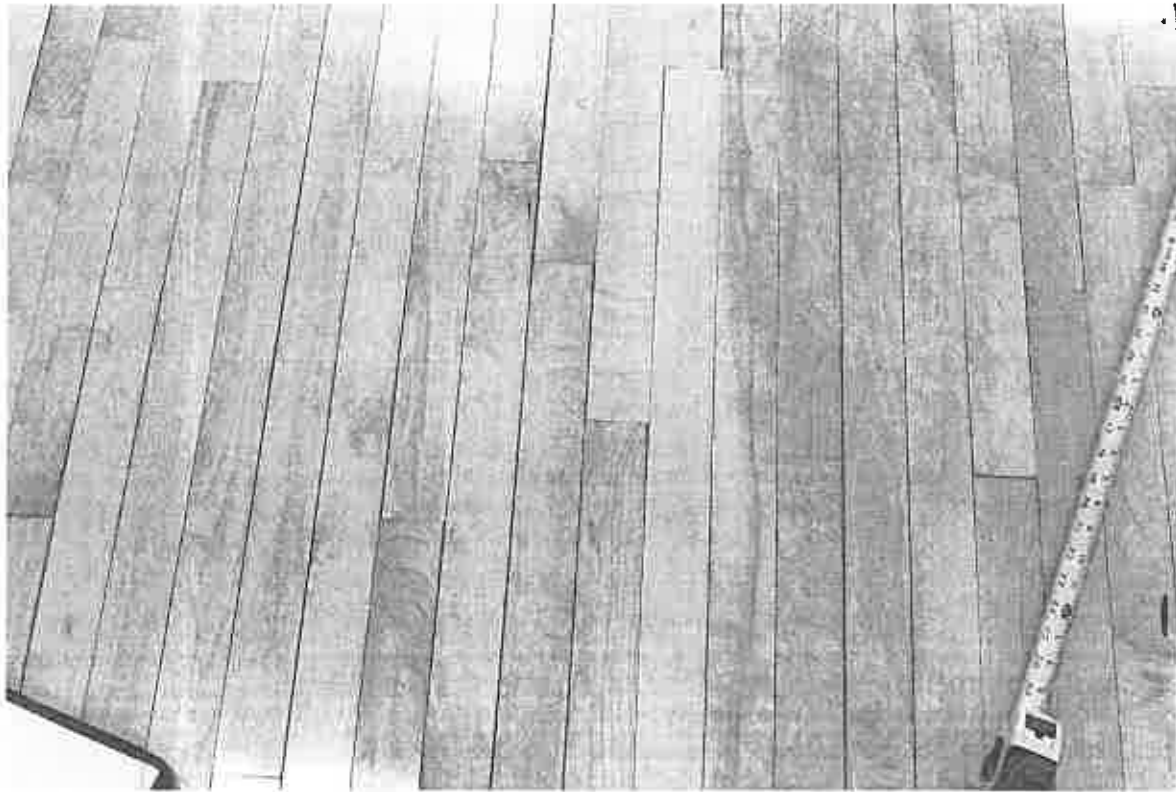
Our inspector checked the moisture content levels in the maple flooring and recorded the environmental conditions in the gymnasium. Our inspector recorded moisture contents readings from four locations throughout the floor system. Our inspector found no measurable amount of moisture in the floor. The Delmhorst moisture meter used by our inspector cannot read moisture contents below 6%. Our inspector also recorded the environmental conditions within the gymnasium on the day of the inspection. The average temperature was 70.5 degrees Fahrenheit with a relative humidity level of 15.5%. According to the USDA, based on the temperature and relative humidity levels recorded on the day of our inspection the maple flooring at Dover High School should have a moisture content of 3.5%. That means the maple floor system at Dover High School may have been exposed to extremely dry indoor relative humidity conditions if conditions like those observed on the day of our inspection are representative of typical environmental conditions in the space. The unmeasurable low moisture content conditions of the maple flooring at Dover High School seems to indicate that the floor has been exposed to extremely dry conditions. According to the USDA, maple flooring in New Hampshire should have a moisture content range of 6%-12%. The low end of that range can be expected in the winter months and the high end of that range in the summer months.

Our inspector was provided environmental data from a HOBO reader installed in the gymnasium to record environmental conditions in the space. The data covers a time period between September 18, 2018 thru October 15, 2018. According to that data the average temperature was 67.38 degrees Fahrenheit with a relative humidity level of 53.95%. According to the USDA, based on the average temperature and average relative humidity levels from the data provided the maple flooring at Dover High School would have a moisture content of 10.1% during this time period.

When you compare the environmental conditions from the day of our inspection and the average environmental conditions from the HOBO reader it shows that the temperature has risen slightly while the relative humidity levels in the gym have dropped almost 40 percentage points. This would result in a maple flooring moisture content loss of 6.5% which will result in 3/64" contraction per flooring strip.

**It is MFMA's opinion that there is reason to believe that humidity level differences have been in excess of 15% which has resulted in significant shrinkage. Wood is a hygroscopic material. When exposed to varying temperatures and humidities, it will release or absorb moisture until it is at equilibrium with the surrounding atmosphere.**

MFMA strongly recommends officials contact a HVAC expert to assess the HVAC equipment to help utilize the system to provide the best possible environment for the maple athletic floor. After the HVAC equipment is evaluated and recommendations to help utilize the system to provide the best possible environment for the maple athletic floor are achieved the shrinkage separations should be minimized.

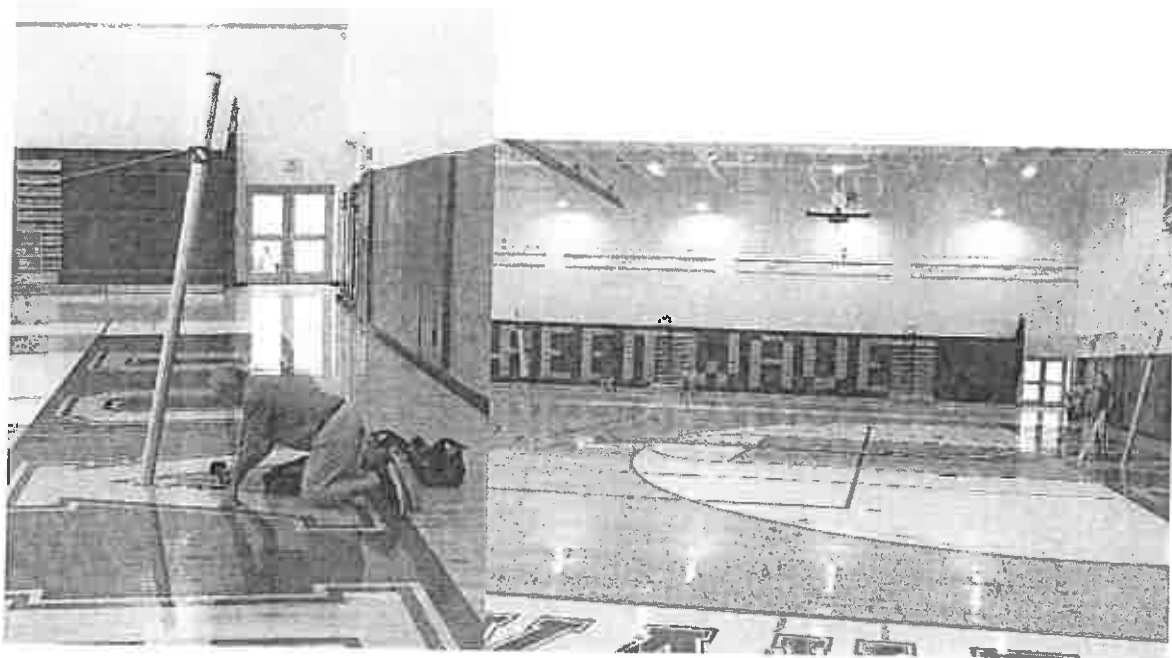
5. Our inspector was asked to comment on the volleyball sleeve installation. Our inspector was shown the pictures below of the volleyball stanchions installed in the volleyball sleeves.

The volleyball sleeves were not installed correctly. To correct this situation will involve removing sections of the floor system to provide access to the concrete slab to correct the sleeve. This will require providing adequate space for removal of the sleeves, typically involving jack hammering the concrete slab to remove the existing sleeves. Once old sleeves are removed and new sleeves installed, the subfloor system will have to be reinstalled and new maple flooring installed.

The new maple flooring will need to be sanded down to match the profile of the existing maple. This will require the rest of the floor to be lightly sanded, sealed, painted and finished to provide a smooth uniform surface. This type of light sanding typically does not remove more than 1/64" of wear layer.

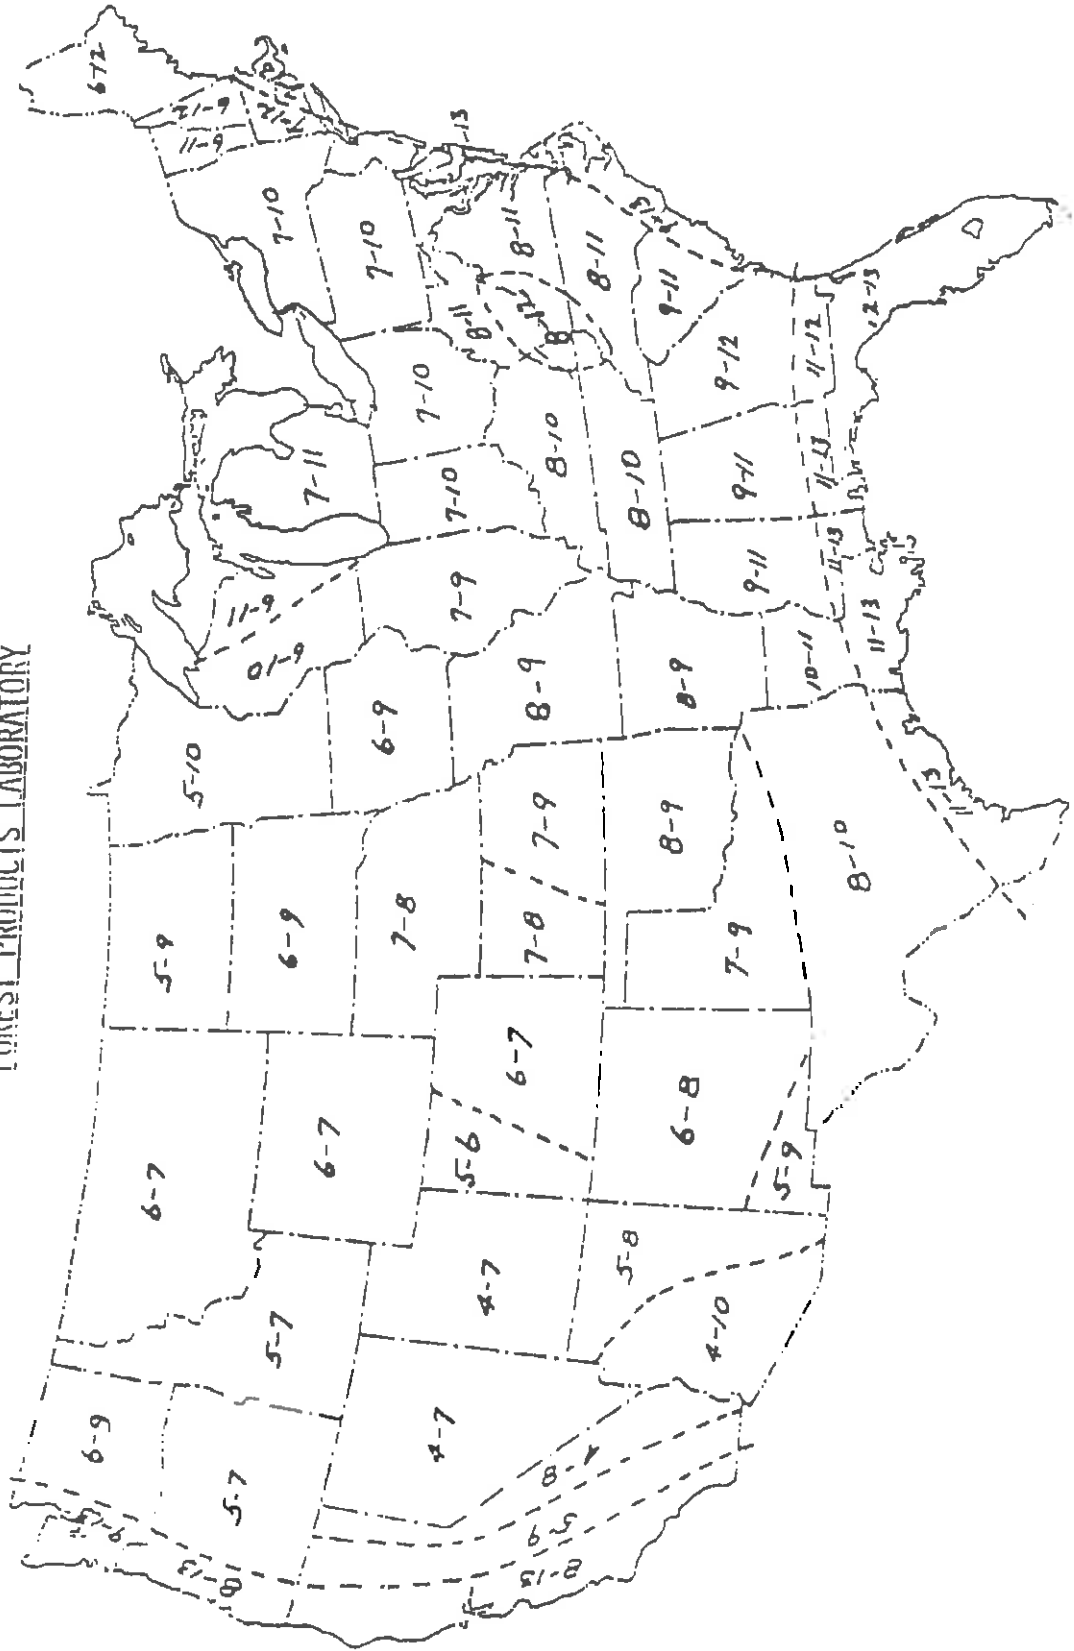
Variation of average moisture content. In each pair of figures, the first is average moisture content during January and the second is average moisture content during July for wood used indoors.
