**From:** Alan Pemstein <apemstein@hmfh.com>  
**Sent:** Wednesday, June 10, 2020 2:26 PM  
**To:** Robin Lafleur  
**Cc:** Cartabona, Stephanie; Tina Stanislaski; Laura Wernick  
**Subject:** FW: dover floor pictures

**From:** Dan Heney <DHeney@maplefloor.org>  
**Sent:** Wednesday, June 10, 2020 1:53 PM  
**To:** Kevin Radziwon <KRadziwon@pcconstruction.com>; Alan Pemstein <apemstein@hmfh.com>  
**Cc:** s.cartabona@dover.nh.gov  
**Subject:** RE: dover floor pictures

**Subject:** Re: dover

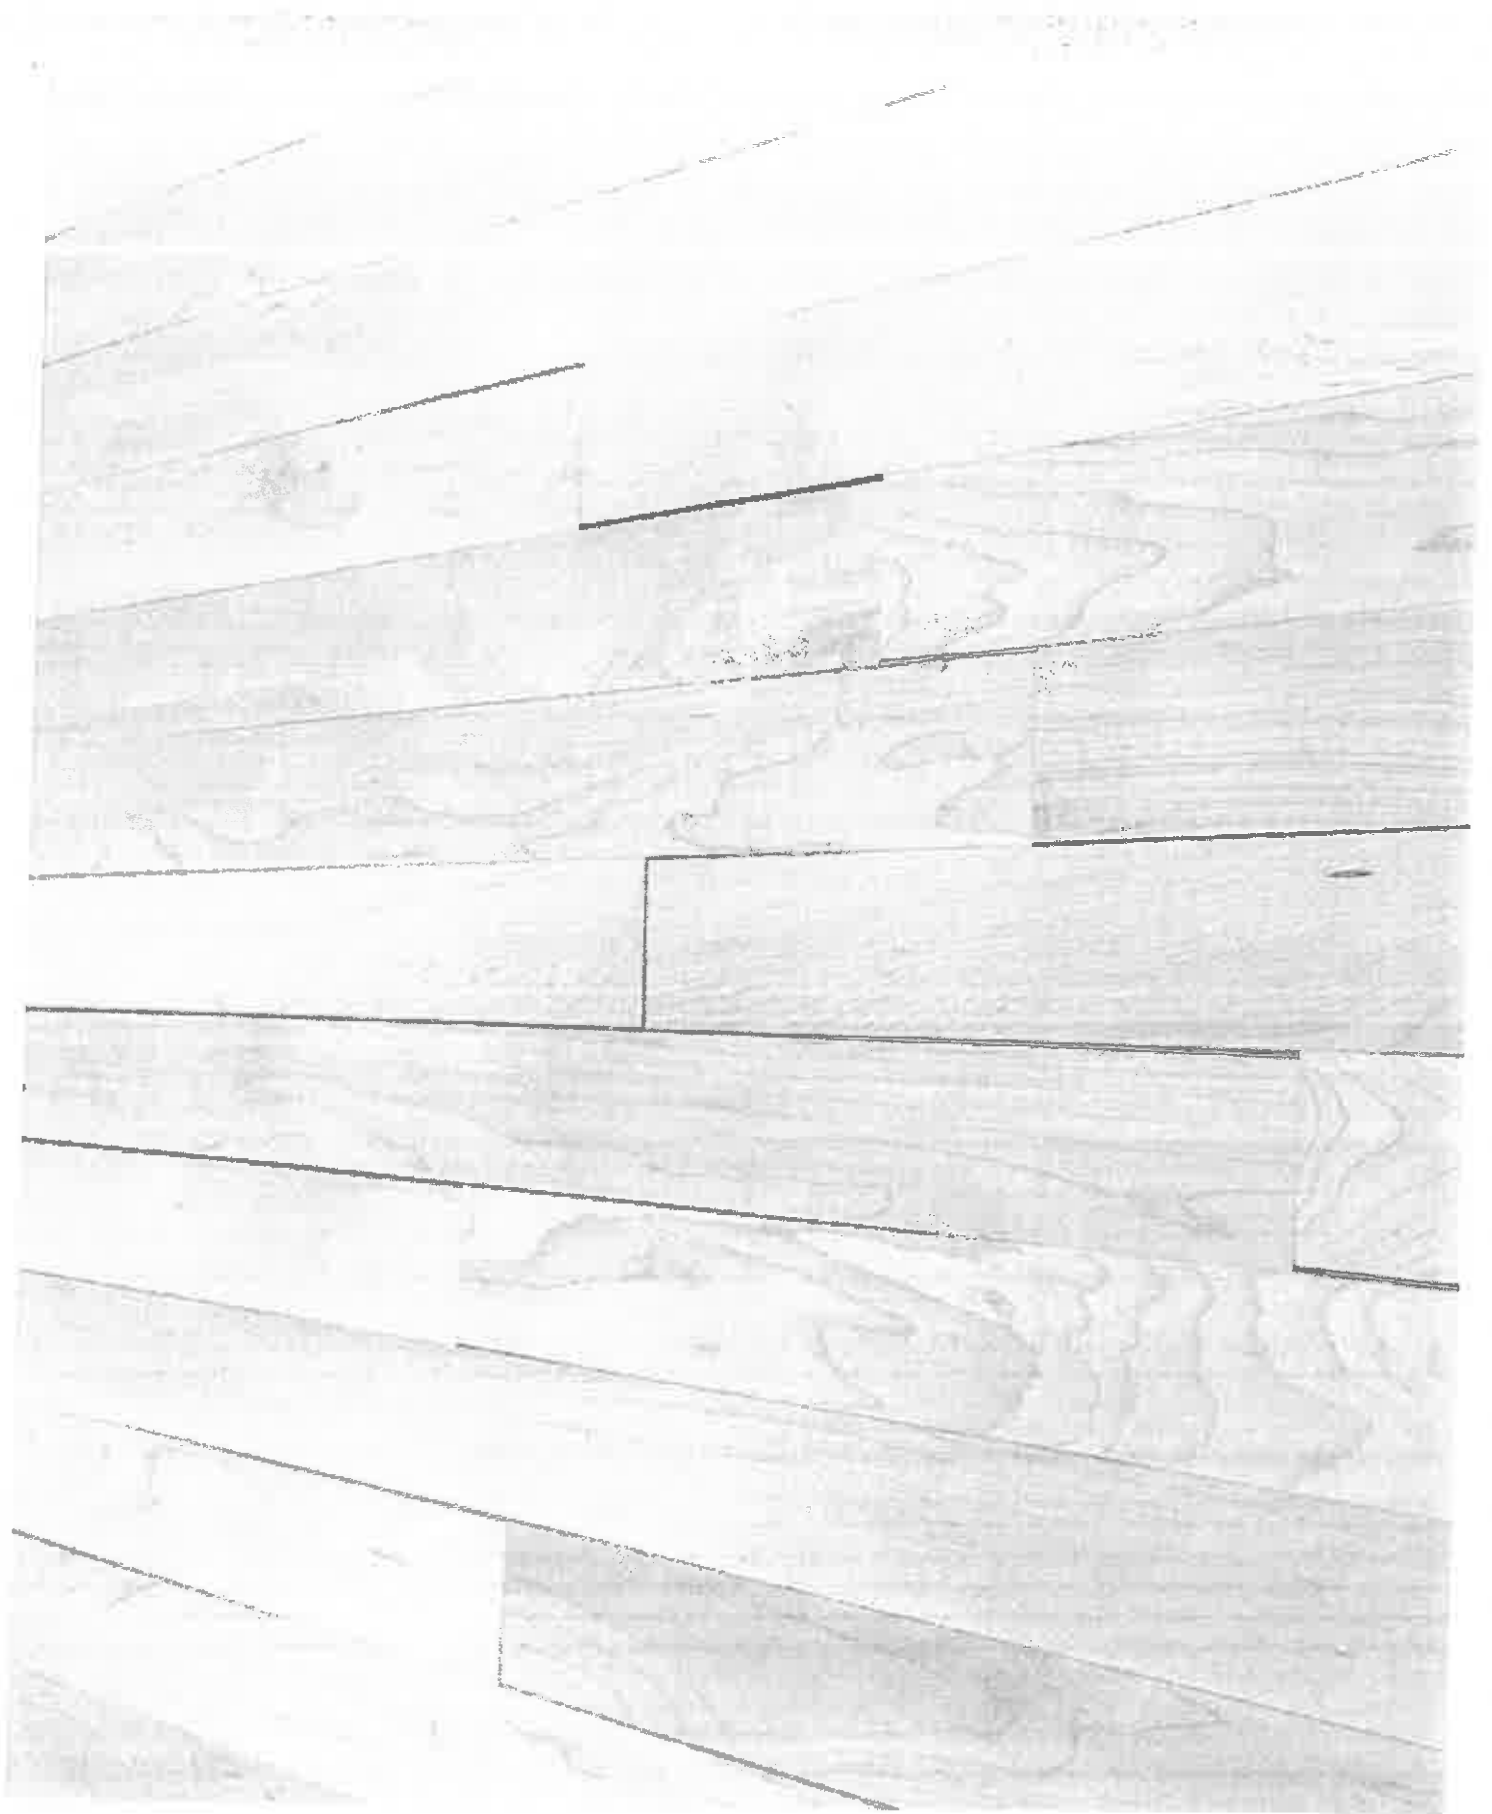
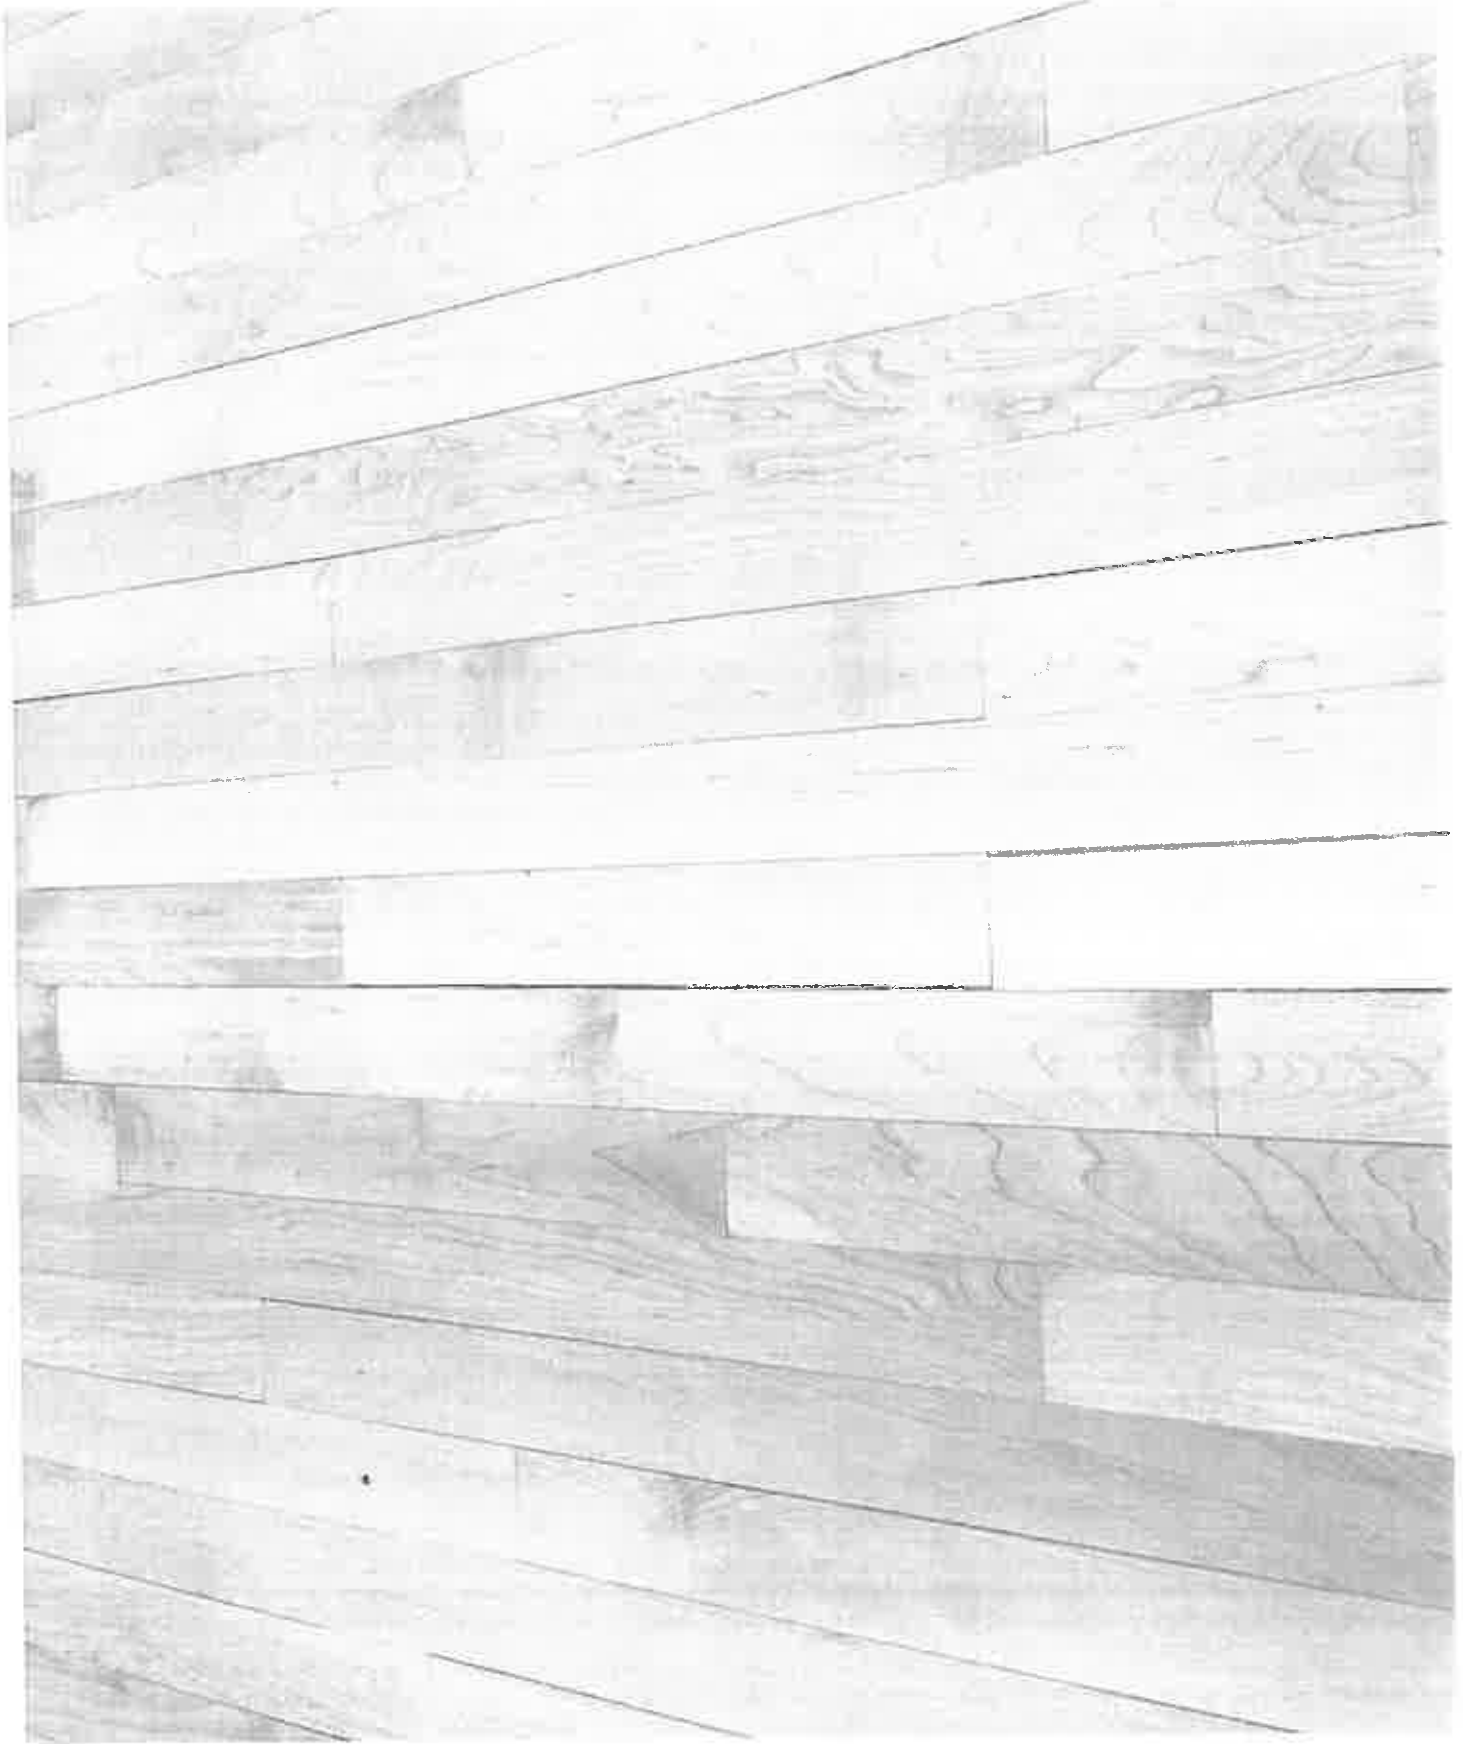
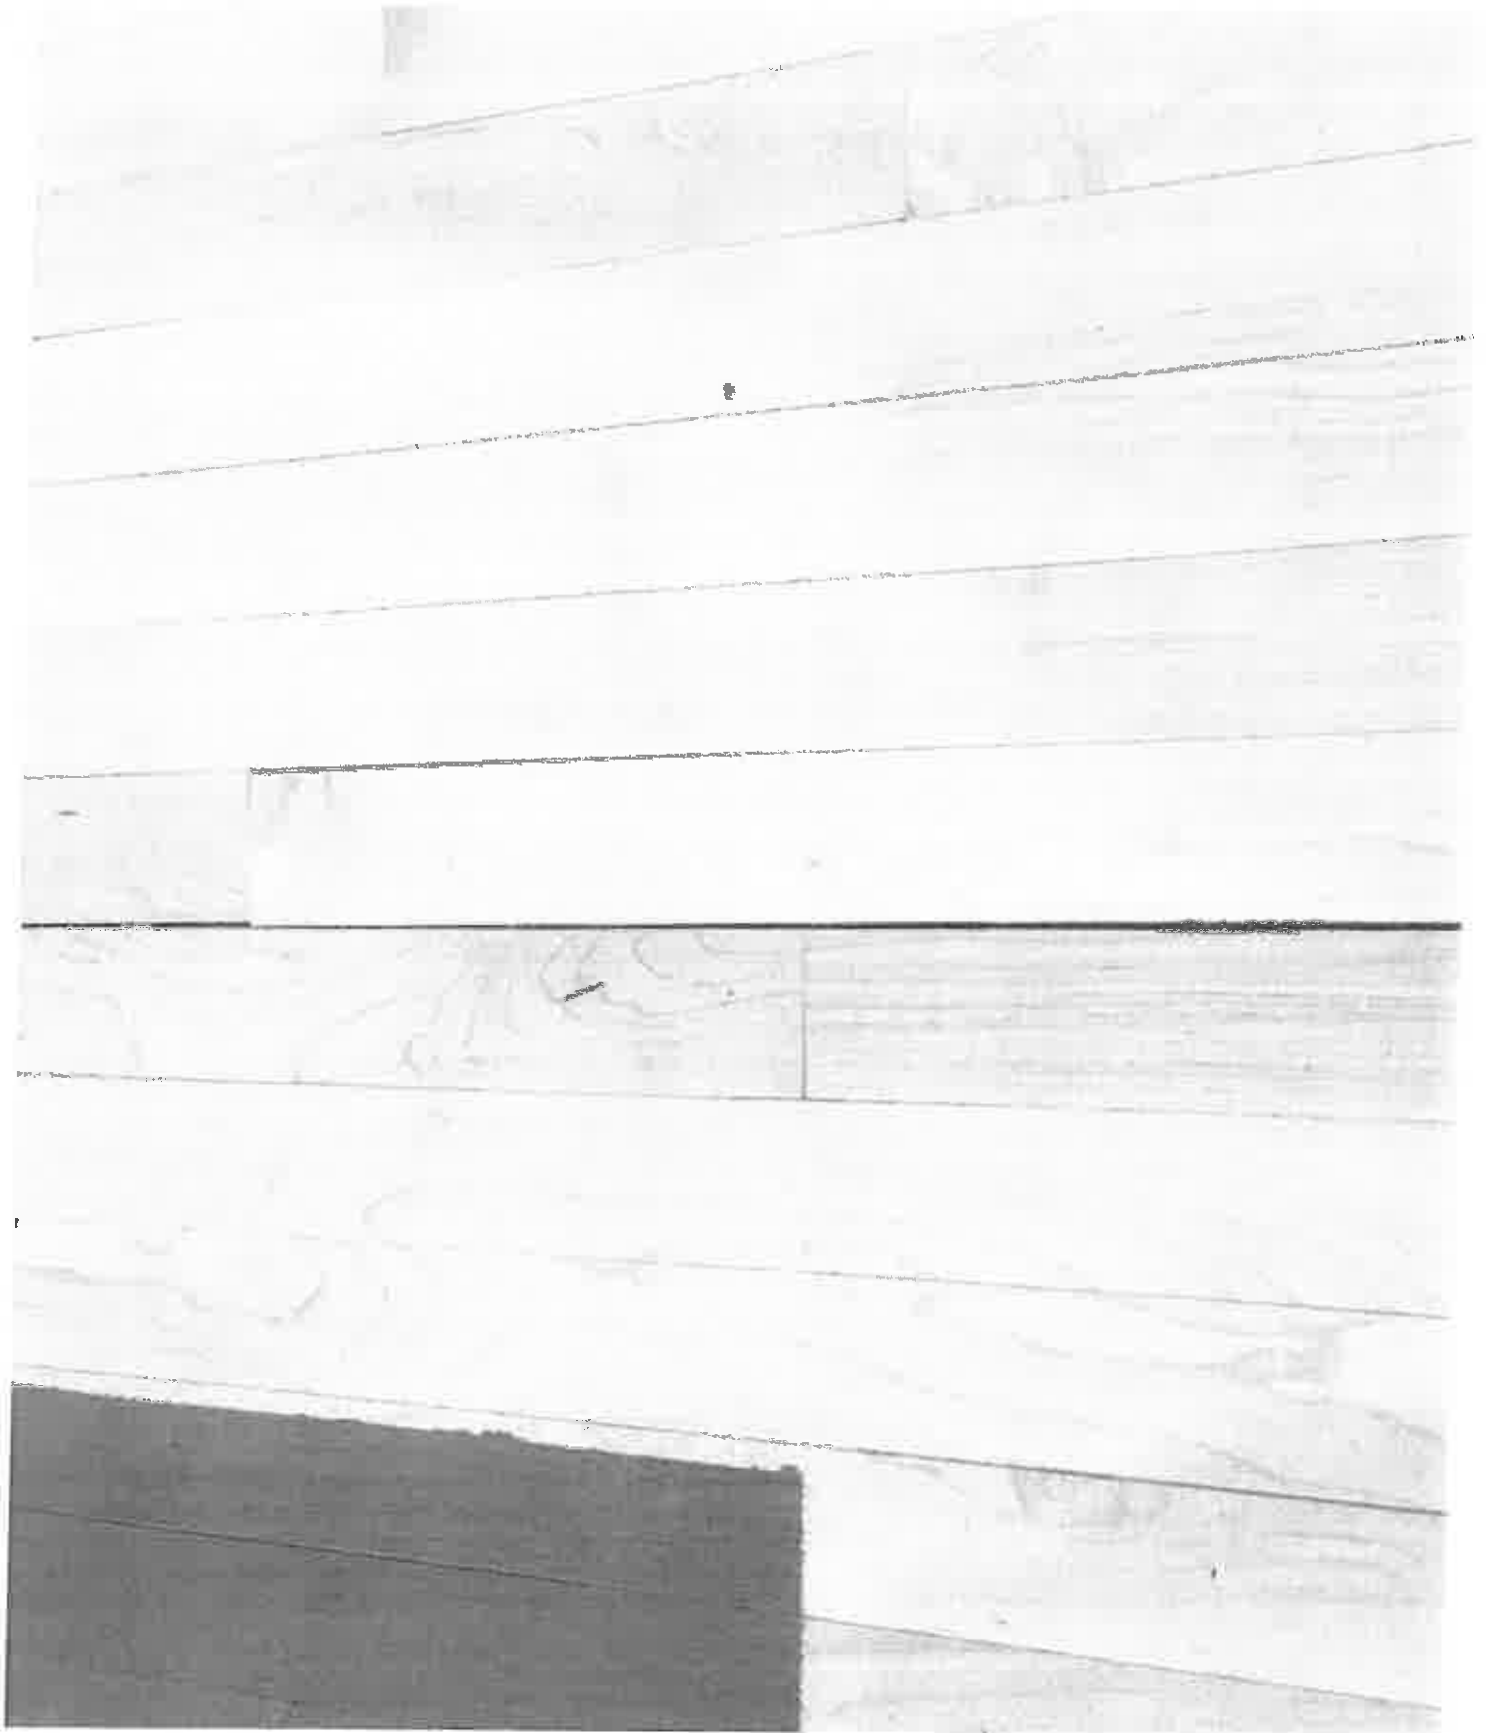
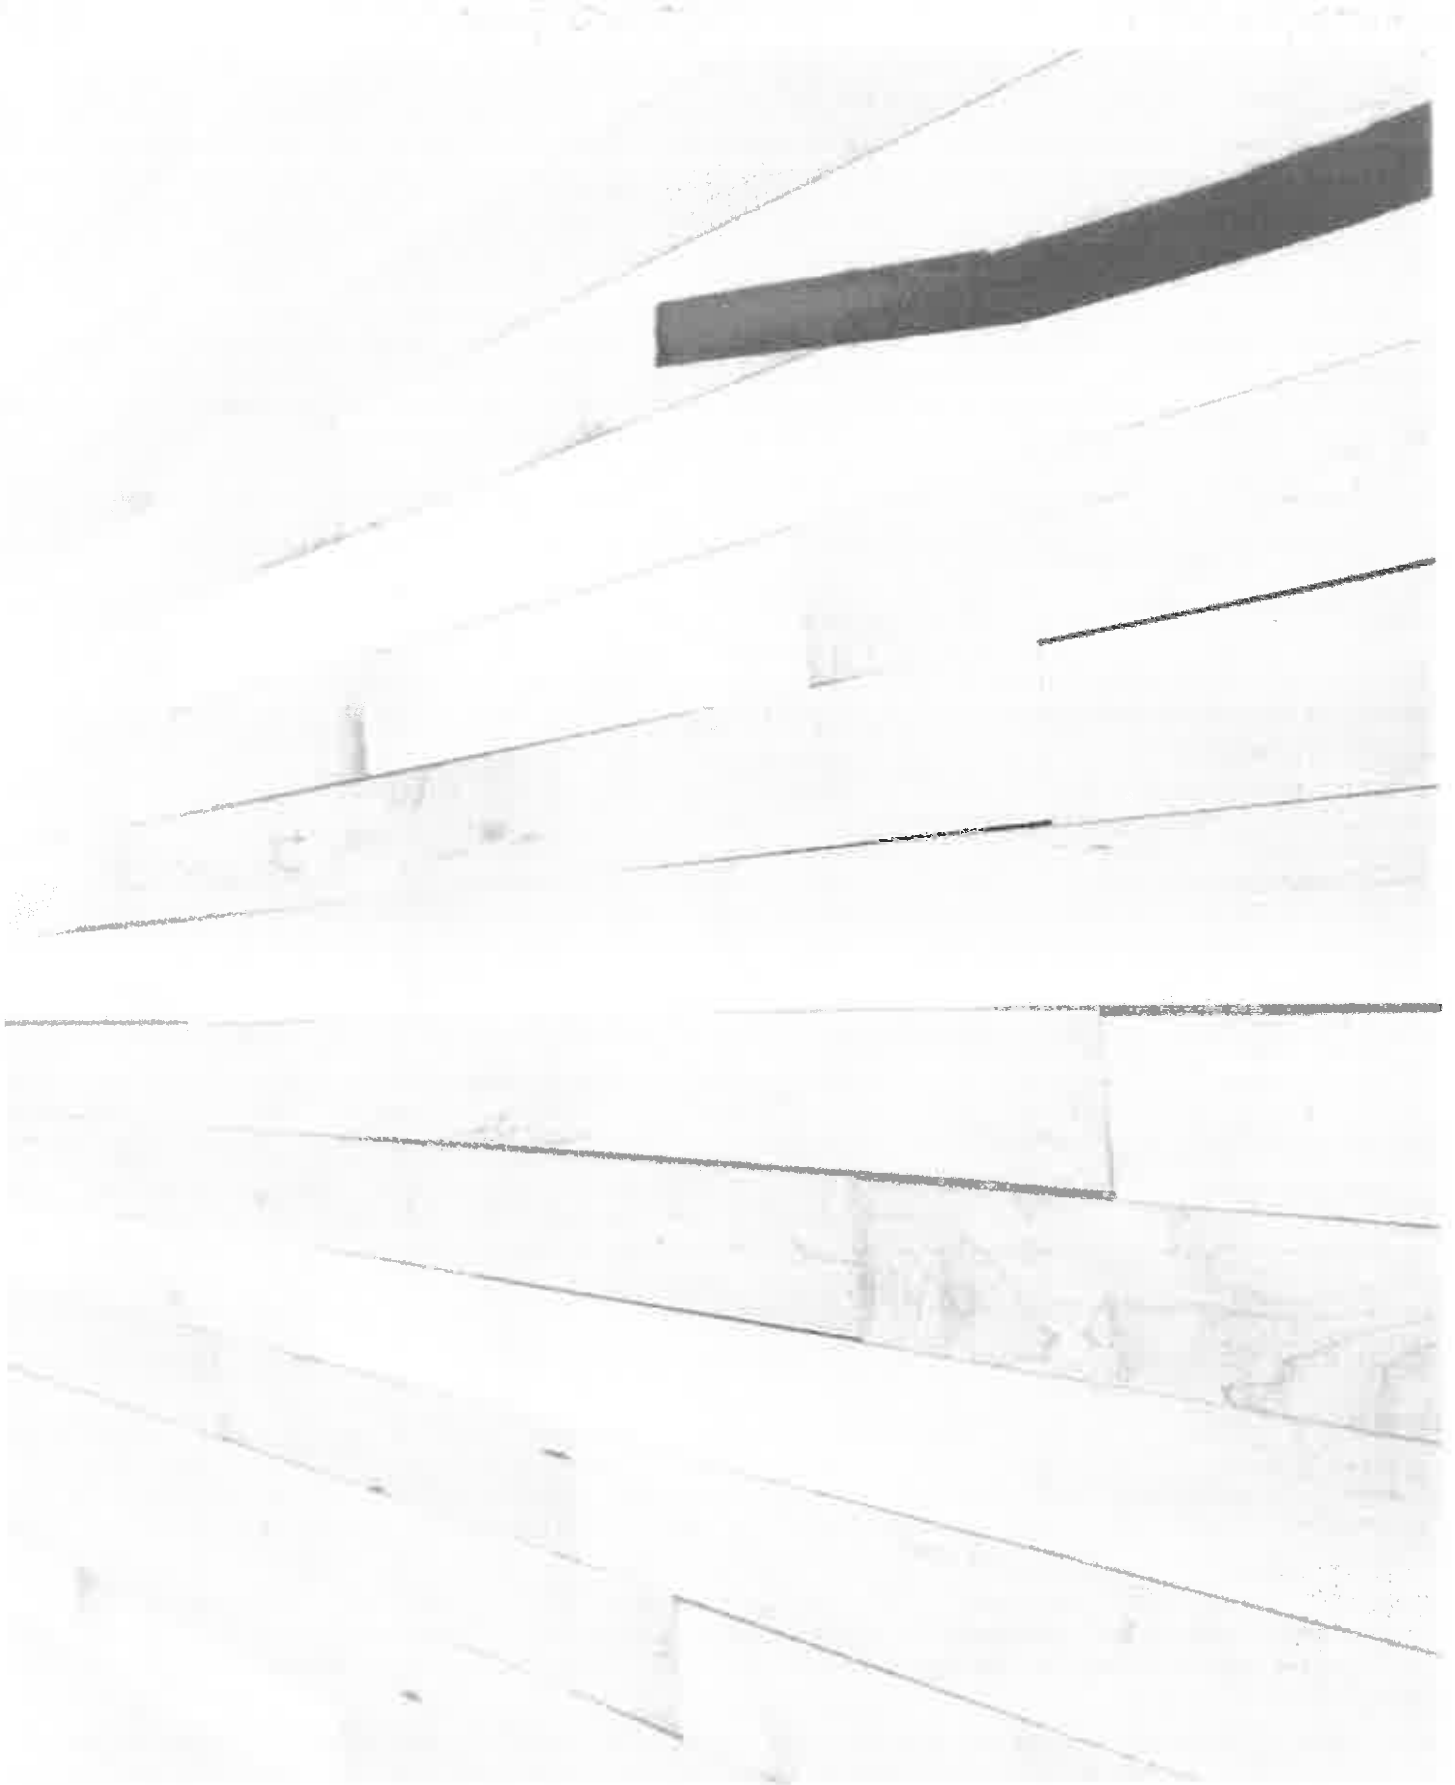
As long as the floor gets to a minimum moisture content range of at 9% the use of water based sealer/finishes or oil based sealers/finishes is acceptable to the MFMA. If the floor doesn't reach a minimum moisture content of 9% and large cracks still are present, MFMA would like to make the school officials aware of possible side effects of each product.

Thank you for the pictures. MFMA would advise waiting until the moisture content of the maple flooring reaches a minimum of 9% before sealing and finishing is started. It is important that school officials understand that proper environmental conditions must be maintained in the space year-round. High Levels of temperature/humidity in the summer/fall can result in excessive expansion and/or cupping of the floor systems and low levels of temperature/humidity in the winter/spring can result in excessive contraction of the floor system.

Kevin - could you send me a few pictures of the gaps? And advise dimension of opening?  
Thanks, Alan

Alan, the moisture readings are as follows –

7.4  
8.2  
6.5  
8.4  
6.5  
8.5  
7.6  
8.1  
6.5  
7.8

The Maple Flooring Manufacturers Association (MFMA) recommends maintaining indoor relative humidities between 35 percent and 50 percent, and air temperatures between 55 degrees and 75 degrees year-round.

To assist school officials, MFMA recommends using a HOB0 reader in the gymnasium space to monitor environmental conditions.
