# BUILDING ANALYSIS REPORT

**Property Location:** *53-55 Cataract Ave.  
Dover, NH 03820*

**Date of Inspection:** *1/30/2026*

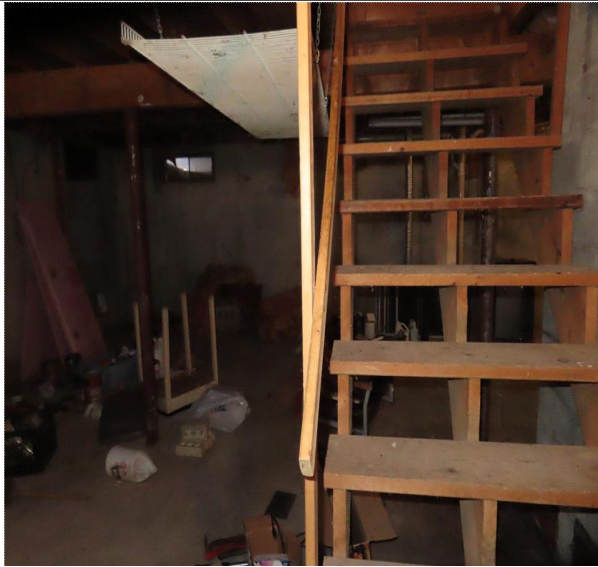
IMG\_2343.JPG

53 basement stairs need a stronger railing installed for safety.

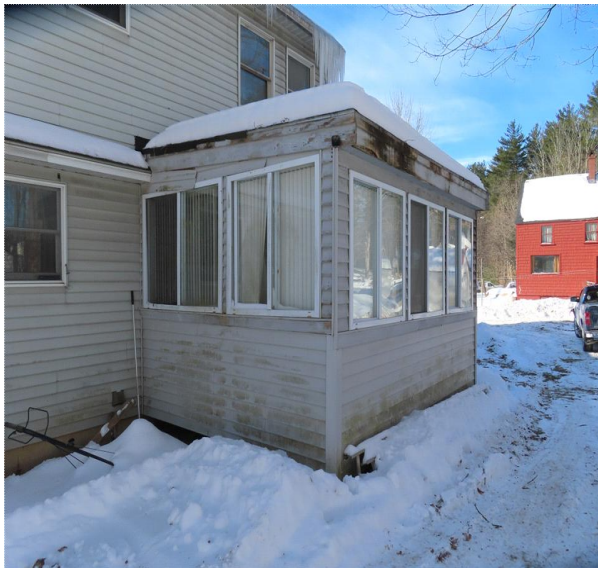
IMG\_2296.JPG

The crawl spaces under 53 rear porch and family room were not accessible because of the deep snow around them, they were not observed.

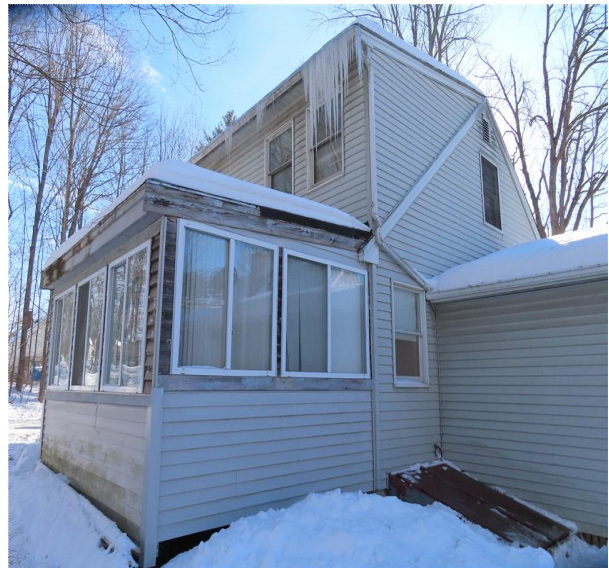
IMG\_2300.JPG

The crawl spaces under 53 rear porch and family room were not accessible because of the deep snow around them, they were not observed.

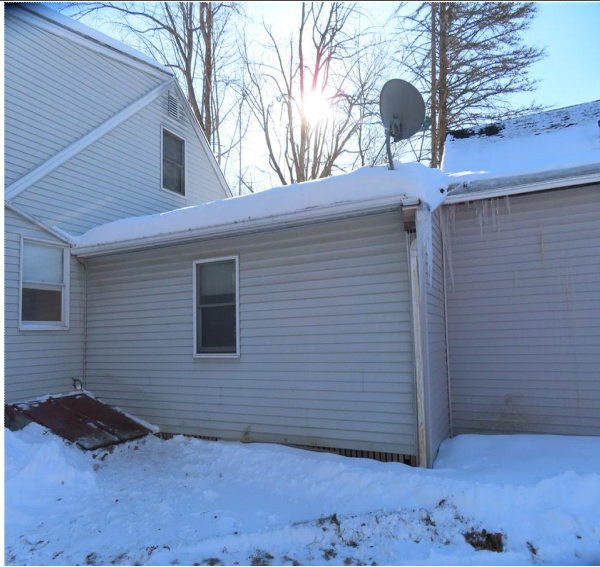
IMG\_2303.JPG

The crawl spaces under 53 rear porch and family room were not accessible because of the deep snow around them, they were not observed.

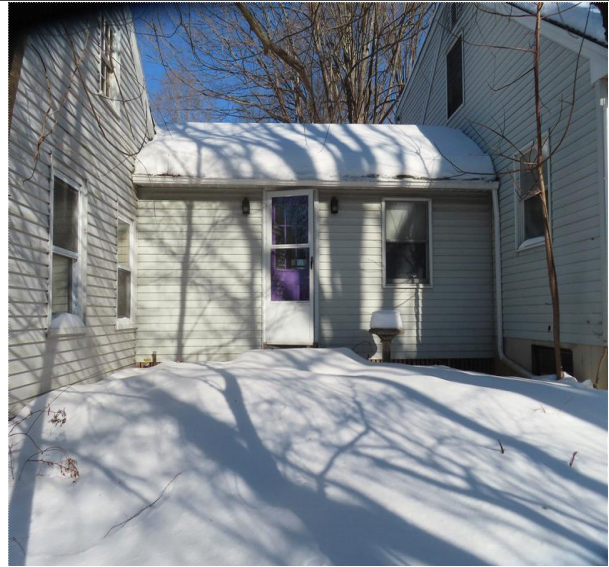
IMG\_2284.JPG

The crawl spaces under 53 rear porch and family room were not accessible because of the deep snow around them, they were not observed.

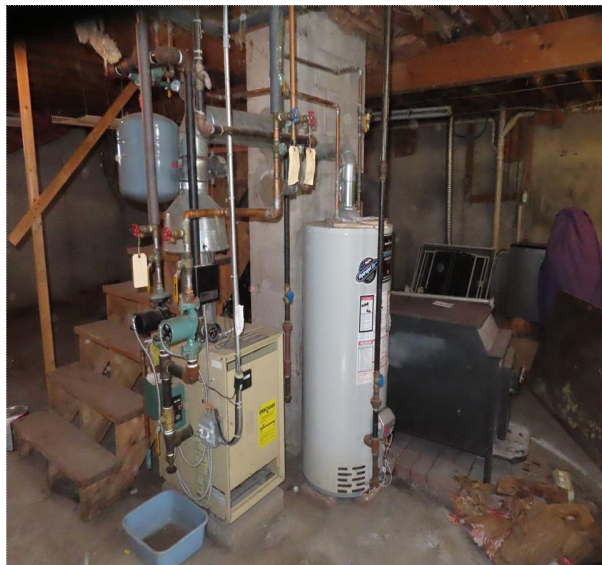
IMG\_2319.JPG

53 Forced hot water boiler is operating as designed but there are no service tags on the boiler.

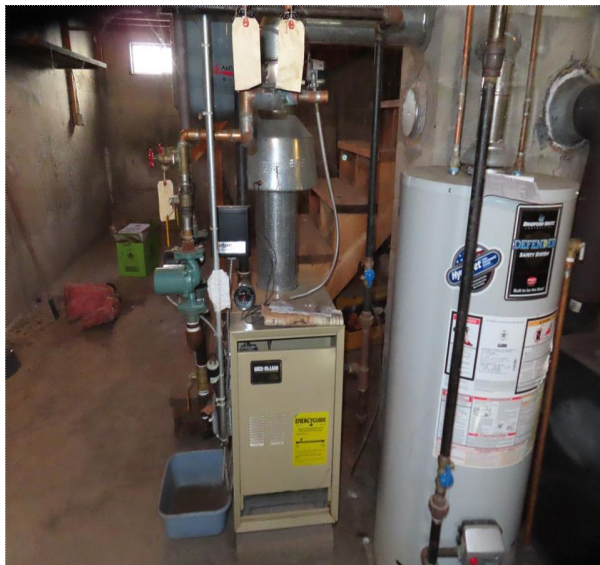
IMG\_2324.JPG

If the boiler has not been serviced within the last 12 months it should be inspected, cleaned and serviced as needed before closing on the property and annually after that.

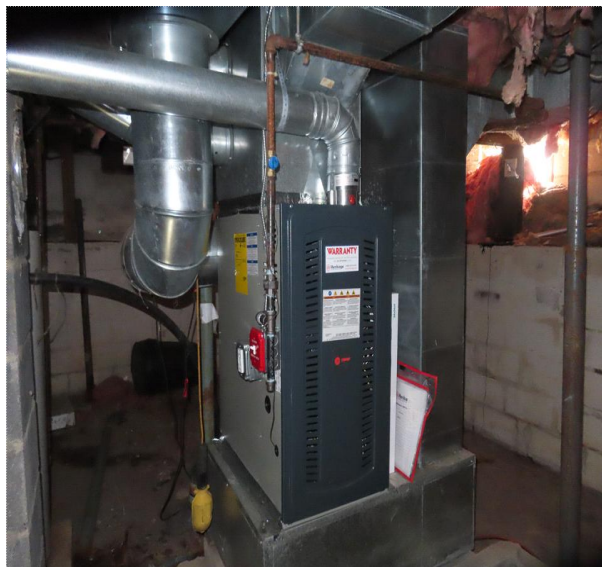
IMG\_2412.JPG

55 furnace is less than one year old and is due for service in September 2026.55 has no provision for an air filter in the return duct to the furnace.

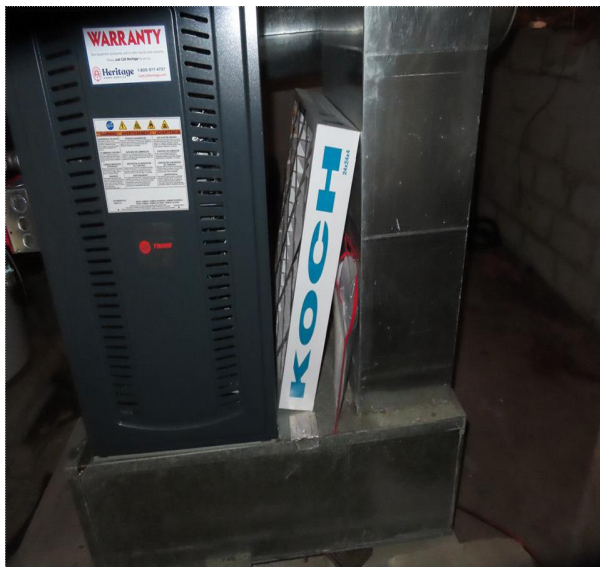
IMG\_2414.JPG

55 furnace is less than one year old and is due for service in September 2026.55 has no provision for an air filter in the return duct to the furnace.

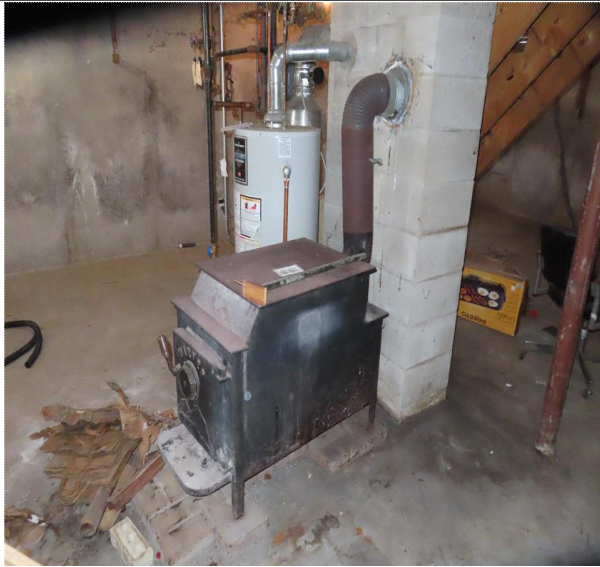
IMG\_2326.JPG

The wood stove in 55 basement is installed properly and has its own chimney flue, the wood stove flue should be inspected and cleaned annually.

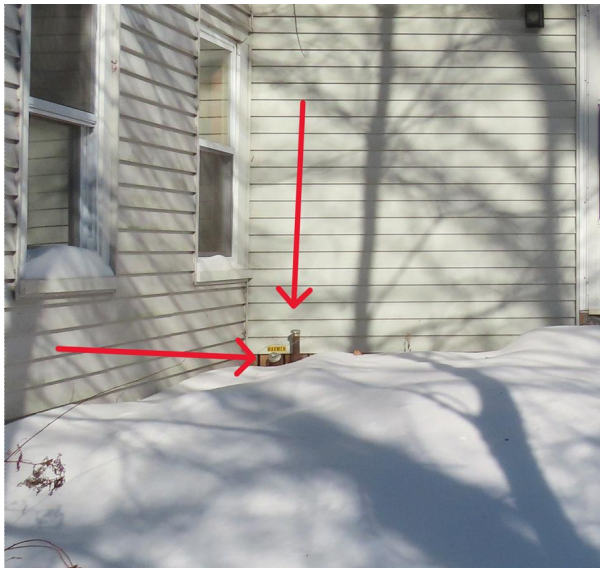
IMG\_2284x.JPG

55 has an abandoned oil tank and filler pipes that need to be removed to prevent accidental oil fill.

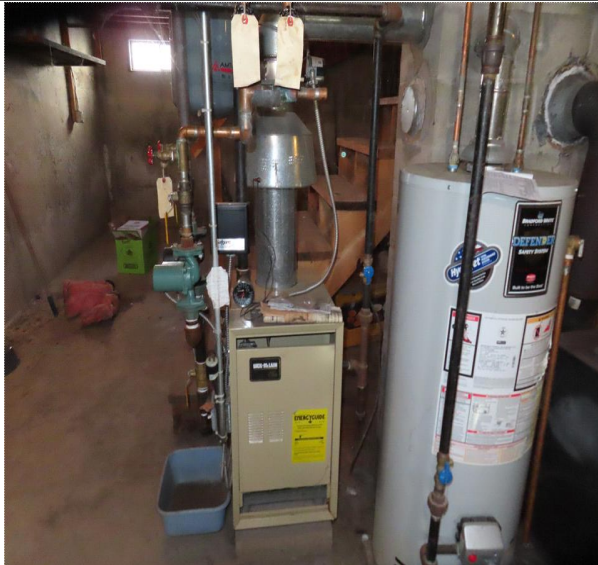
IMG\_2324.JPG

53 boiler had no serial number on it, age could not be verified.

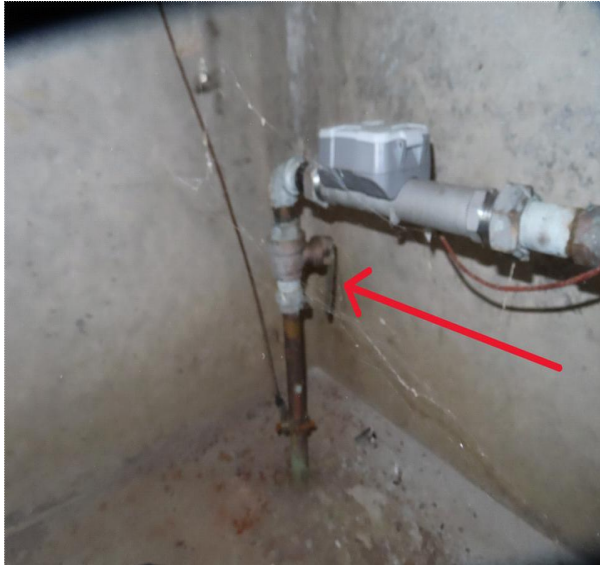
IMG\_2318.JPG

53 Water shutoff is in the right front basement corner.

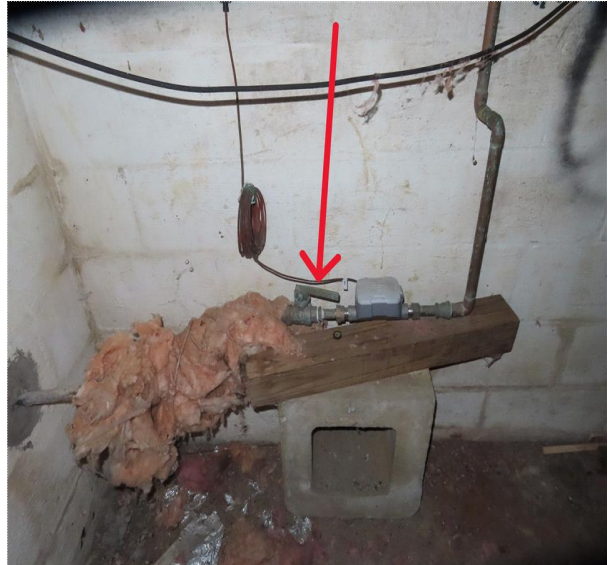
IMG\_2392.JPG

55 Water shutoff is in the right front basement corner

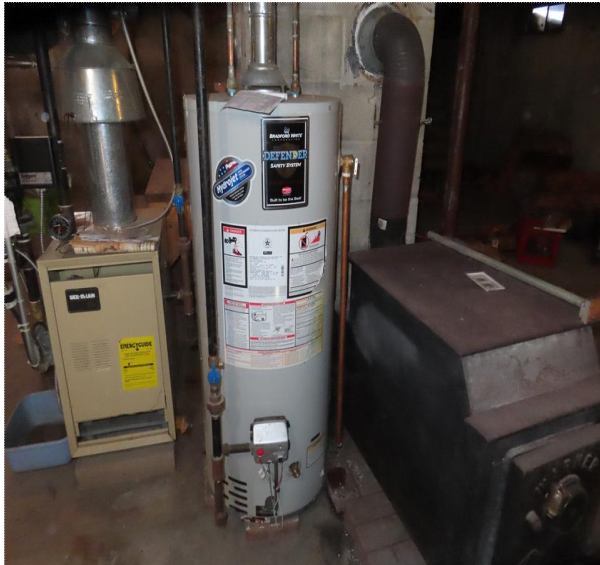
IMG\_2323.JPG

53 water heater is 11 years old and is operating as designed.

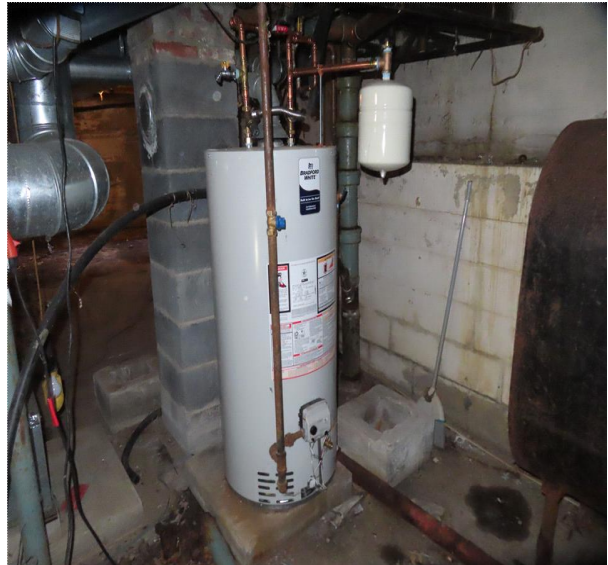
IMG\_2408.JPG

55 water heater is 2 years old and is operating as designed.

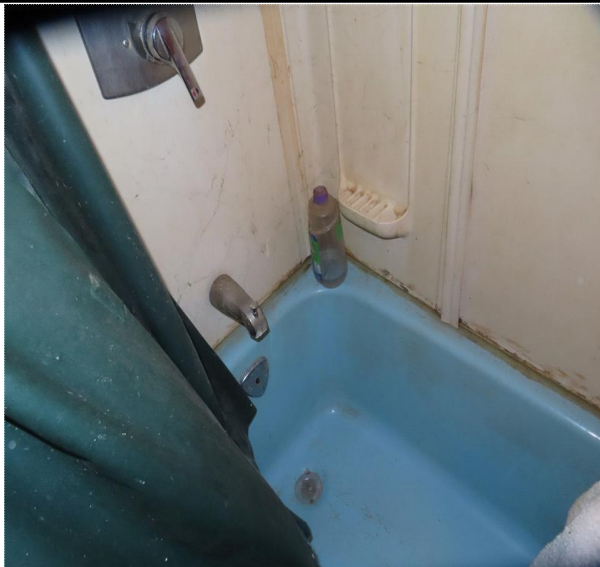
IMG\_2442.JPG

55 bath needs a total renovation.

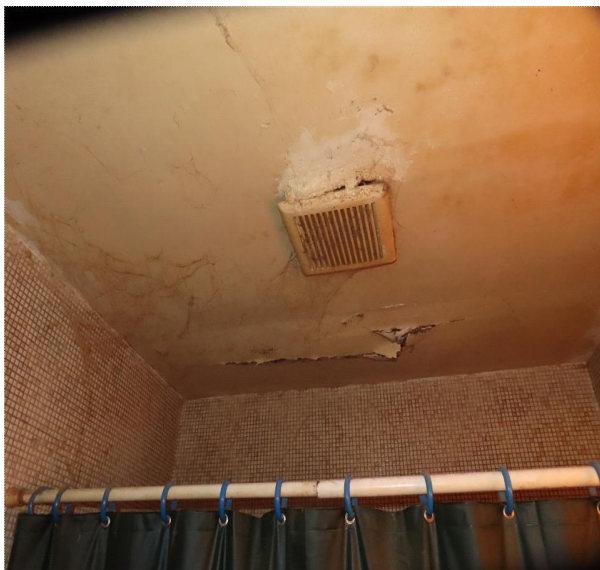
IMG\_2440.JPG

55 bath needs a total renovation.

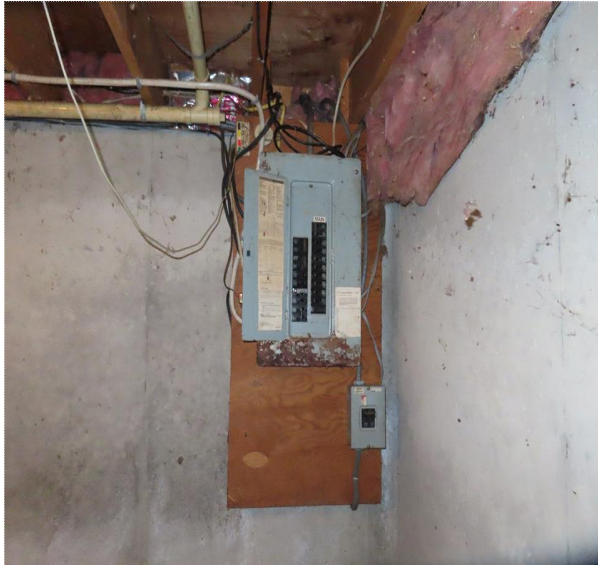
IMG\_2337.JPG

53 100 amp main electrical panel and 55 60 amp main electrical shutoff breaker are located in 55 right rear basement corner.

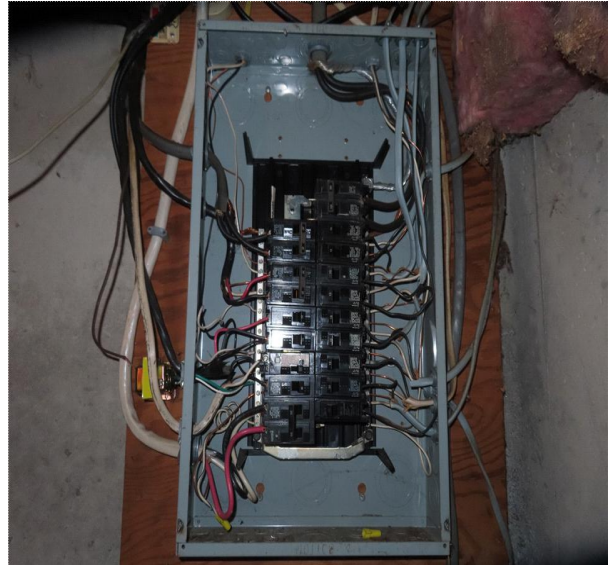
IMG\_2340.JPG

No issues were observed in 53 main electrical panel.

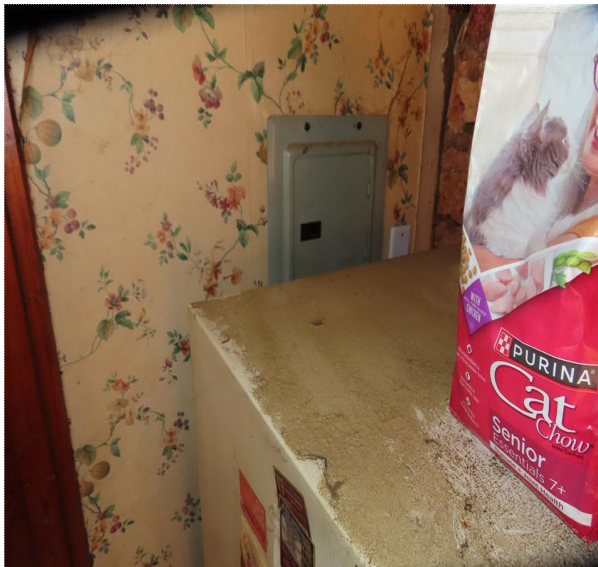
IMG\_2445.JPG

55 Main sub panel is in the kitchen behind the refrigerator, it was not accessed during the inspection. This panel feeds the sub panel in 55 basement

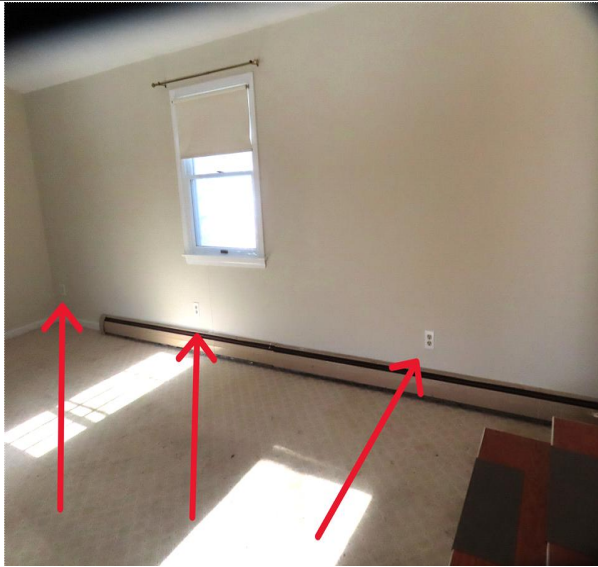
IMG\_2356.JPG

53 family room rear wall electrical outlets and both outlets in the left rear corner of the dining room have the hot and neutral wires reversed.

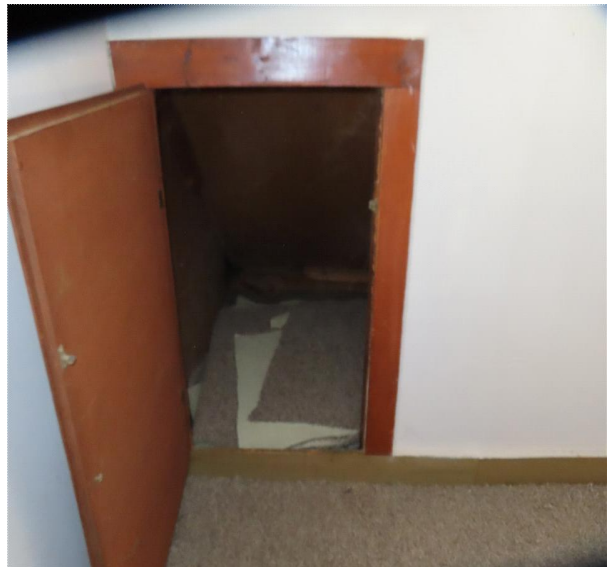
IMG\_2425.JPG

Attic access was limited with no overhead access and the only accessible kneewall access was in 55 2nd floor.

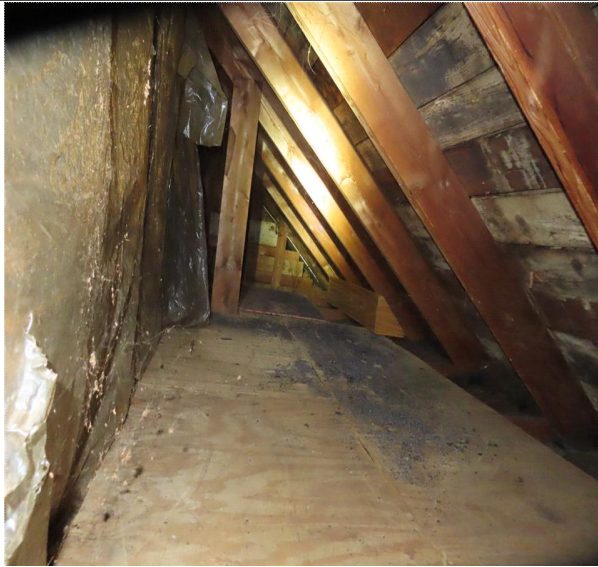
IMG\_2428.JPG

Attic access was limited with no overhead access and the only accessible kneewall access was in 55 2nd floor.

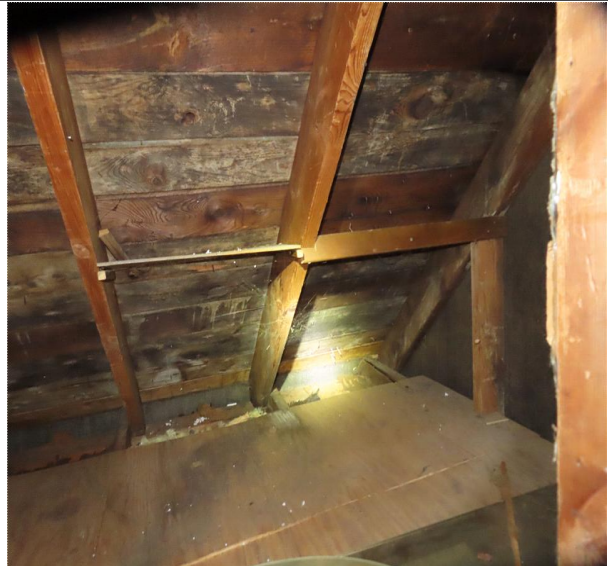
IMG\_2429.JPG

Attic access was limited with no overhead access and the only accessible kneewall access was in 55 2nd floor.

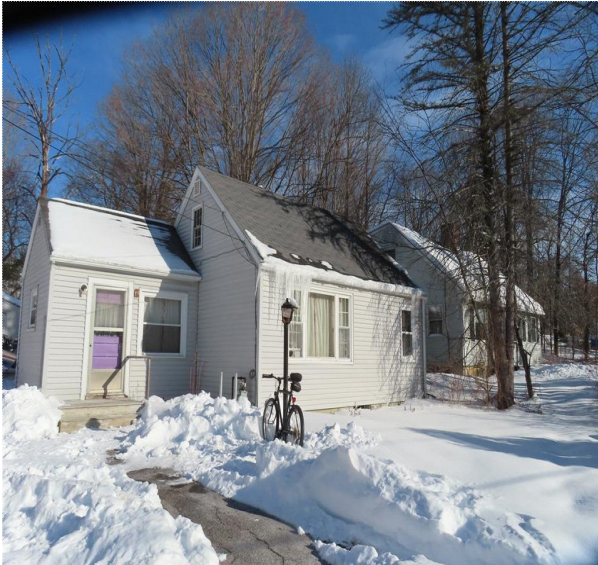
IMG\_2275.JPG

Most of the roofs were snow covered and not fully observable. The exterior of the home is in normal condition for its age with some issues observed.

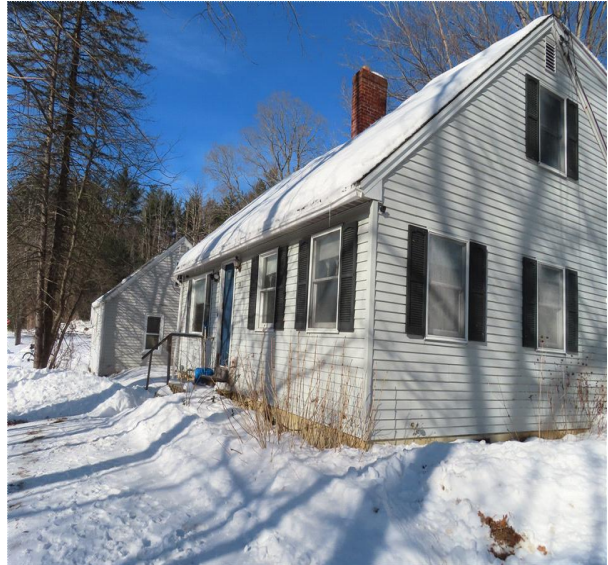
IMG\_2293.JPG

Most of the roofs were snow covered and not fully observable. The exterior of the home is in normal condition for its age with some issues observed.

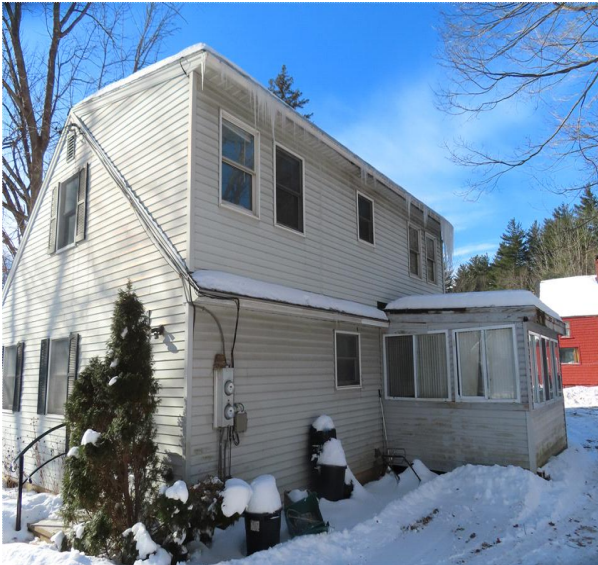
IMG\_2295.JPG

Most of the roofs were snow covered and not fully observable. The exterior of the home is in normal condition for its age with some issues observed.

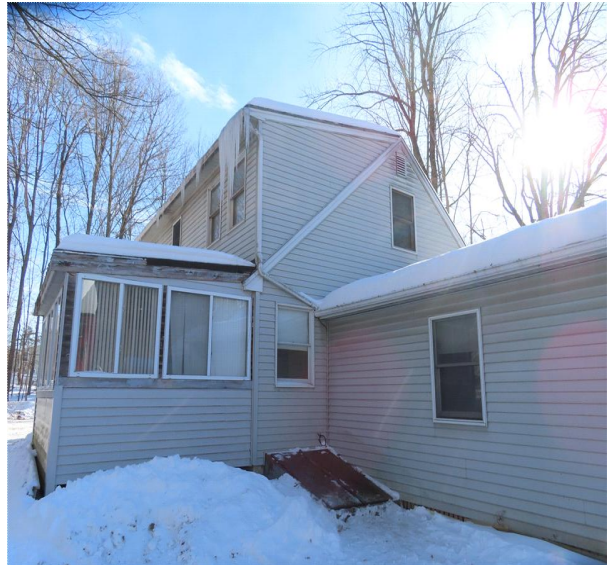
IMG\_2302.JPG

Most of the roofs were snow covered and not fully observable. The exterior of the home is in normal condition for its age with some issues observed.

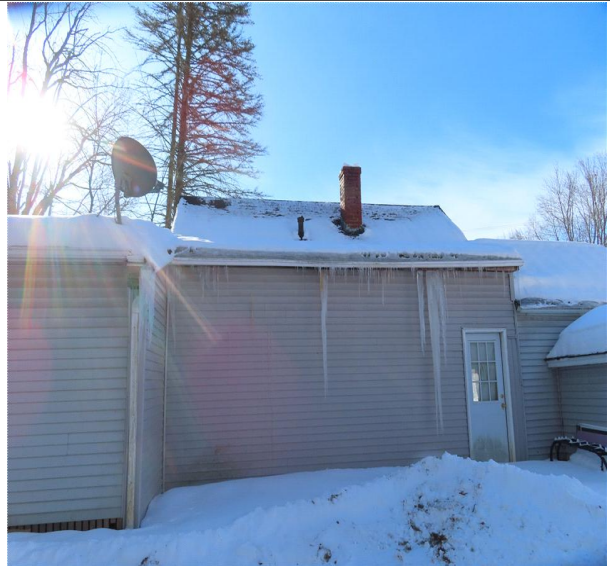
IMG\_2304.JPG

Most of the roofs were snow covered and not fully observable. The exterior of the home is in normal condition for its age with some issues observed.

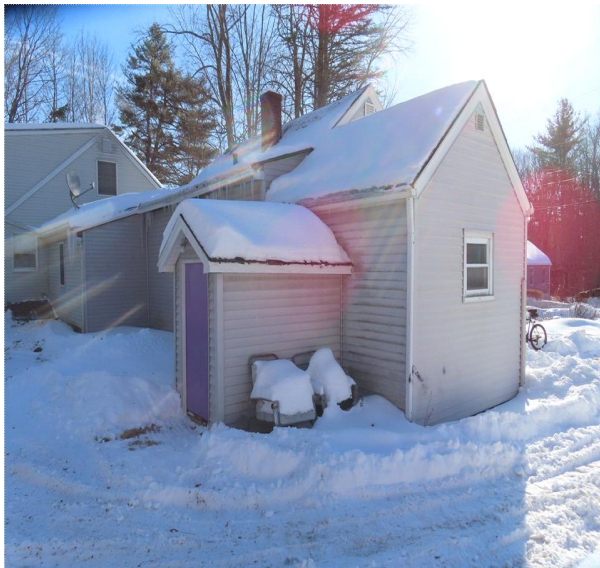
IMG\_2307.JPG

Most of the roofs were snow covered and not fully observable. The exterior of the home is in normal condition for its age with some issues observed.

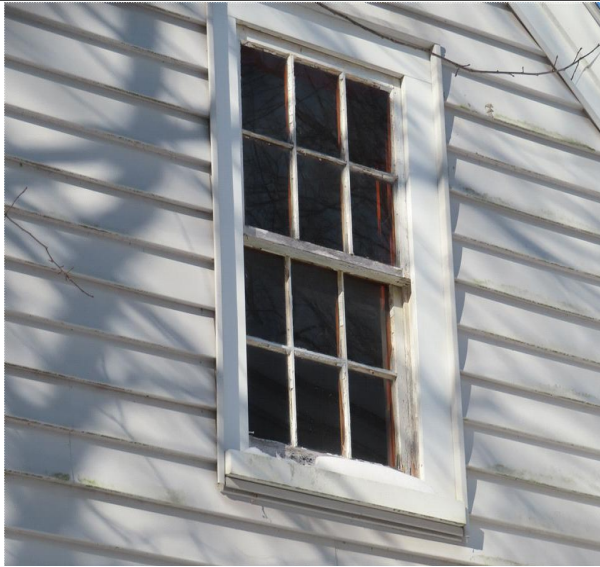
IMG\_2286.JPG

55 gable attic windows need to be scraped and painted.
