## **DOVER HIGH SCHOOL AND CAREER TECHNICAL CENTER** Site & Building Assessment Report

Dover, New Hampshire

January 2015

**Volume I of II**

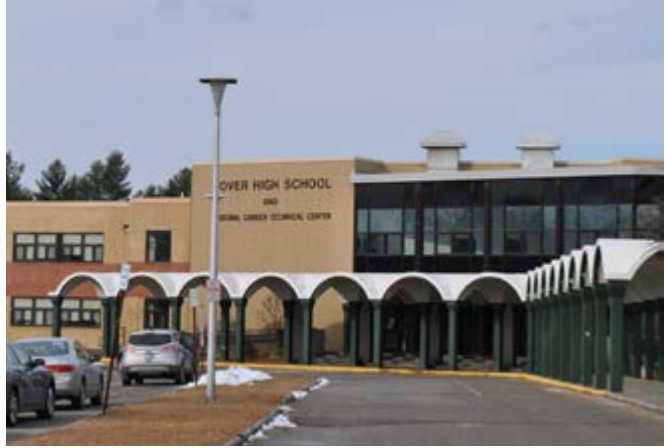
View of Entrance Canopy

At the main entrance a large double barrel vaulted canopy covers the walk-way as you approach the school from two directions. The canopy is held up by painted concrete columns, and the roof structure is concrete with painted plaster. The structure itself is sound, however the plaster is continuously flaking, requiring yearly maintenance repairs.

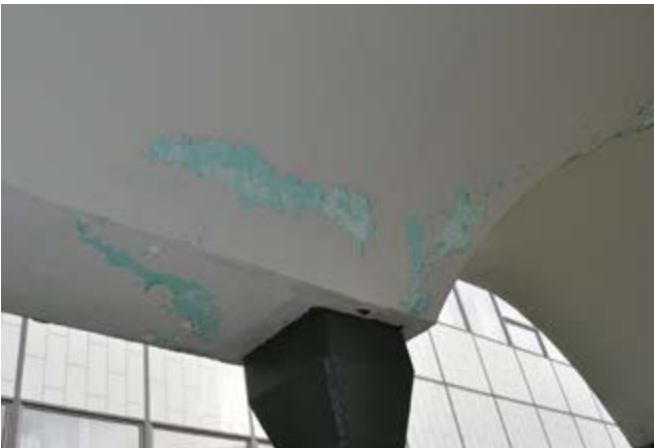
Flaking Plaster at Entrance Canopy

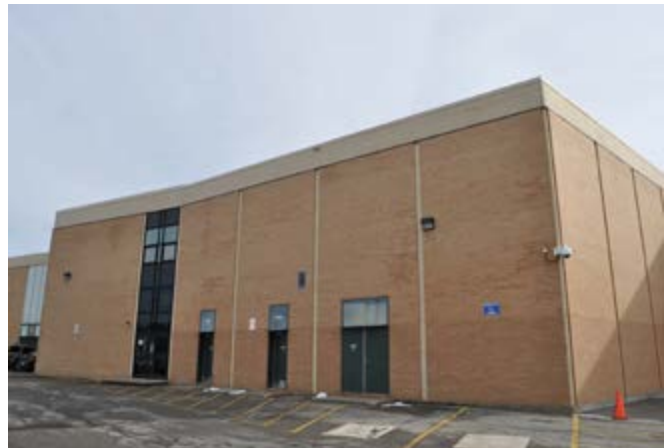
Exterior Wall System 1 - Brick Veneer

Both the addition added in 1989 & 2002 utilize a similar brick veneer wall system with a CMU back up wall and 2" of rigid poly-urethane insulation. This wall construction would meet today's IECC 2009, using an alternate compliance method. Over all the brick veneer is in good shape, with small areas of visible staining at window sills, and the 2002 addition has visible efflorescence stains. Further investigation regarding the efflorescent stains is recommended, to ensure there is not a larger problem with the drainage cavity and weeps of the wall system, that can lead to larger failures of the wall system over time.

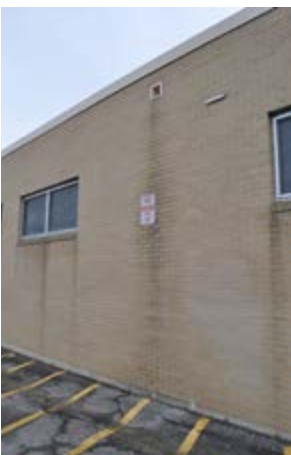
Stained Brick

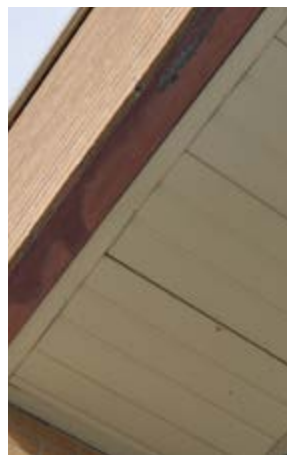
Rusted Lintels

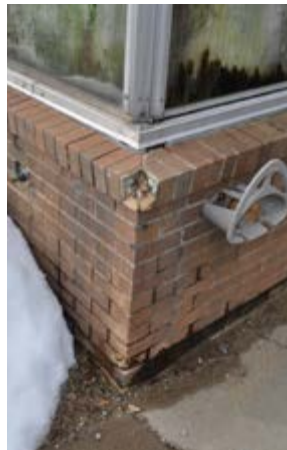
CTC Entrance & Brick in Disrepair

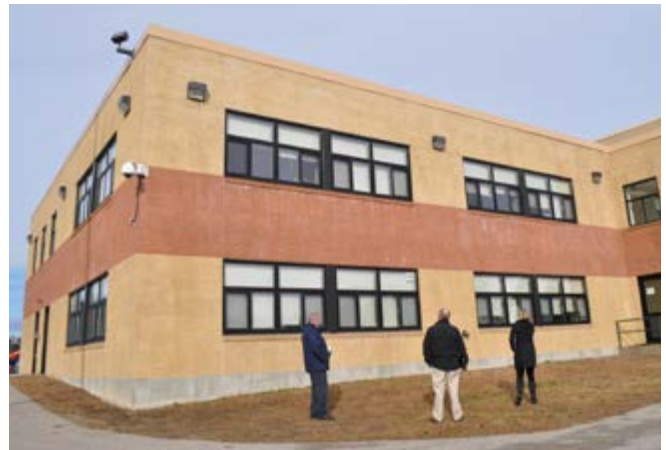
2002 Addition with Visible Efflorescence

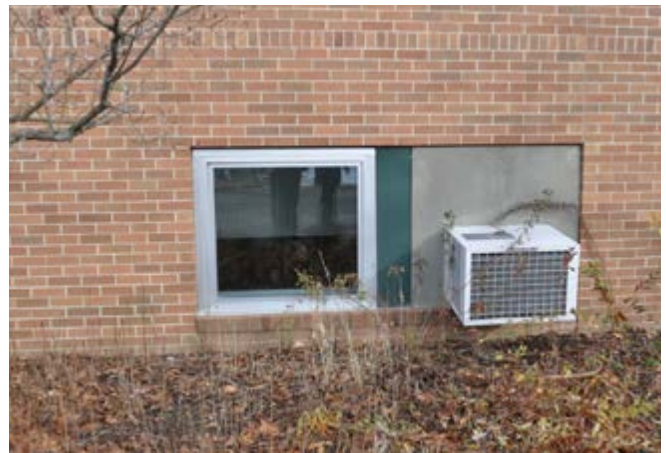
Windows Located at Grade

The windows at the 1967 building are original to the building. They are aluminum with a single pane 1/4" tempered glass. There are a variety of fixed and operating windows. The windows are still functioning, but have exceeded their useful life and complete replacement is recommended if a renovation option is selected. As noted in the summary, many of the interior spaces do not have any windows; in fact 21 out of 52 classrooms are interior with no views to the exterior. The current configurations of windows would not qualify for the prerequisite access to views or the day lighting credits for LEED, which is one rating system for high performance buildings. The 2002 addition have aluminum frame windows with double glazing. These windows are near their life expectancy, but appear to be functioning. The exterior doors are constructed of aluminum with aluminum frames and have 1/4" tempered glass similar to the windows. There are just under 10 roll up garage doors, all functioning but beyond their useful life. The windows on the lower level of the north side are located almost at grade, and have to be shoveled out when it snows, creating a maintenance nightmare, and increase risk for leaking.

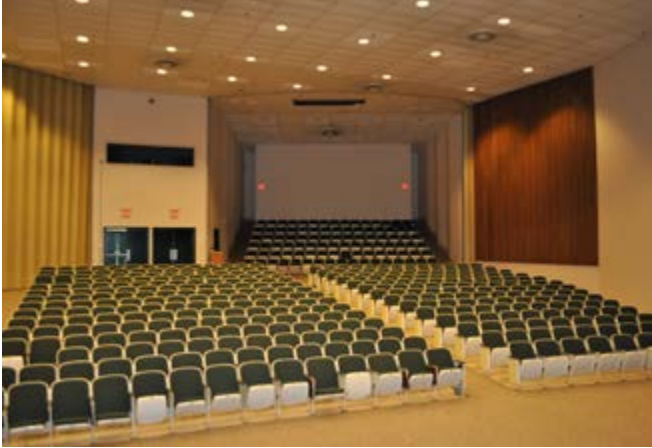
The Auditorium is a double height space with original fixed metal seating. The slope of the Auditorium floor is too steep to meet ADA and no wheelchair locations with companion seat are currently provided. There is no accessible access to the seating that rises up at the back to the second floor. These areas of seating that rise up to the second floor were also originally designed to be separated from the main auditorium space with large movable partitions which no longer work. The operable partitions are beyond their useful life, and the school has found that parts are no longer made for these partitions. The seating throughout the auditorium is damaged uncomfortable and well beyond its useful life. Also, the auditorium stage is not accessible from the seating area. A wheelchair lift or ramp system would need to be installed to correct this problem. There are no assisted listening devices currently provided. One would need to be installed. Given the large size of the Auditorium it may be cost effective to renovate this portion of the existing school.

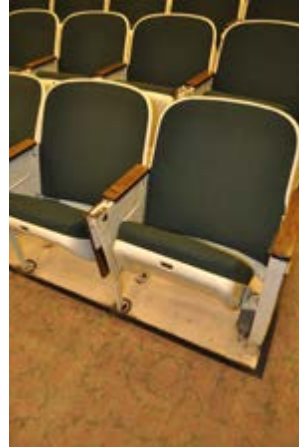
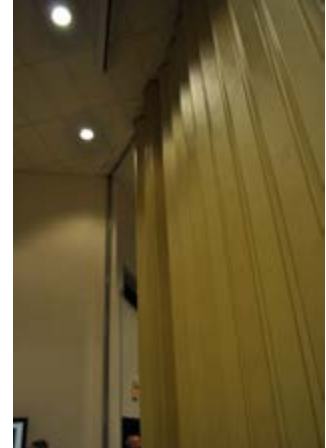
Fixed Seating and Operable Partition

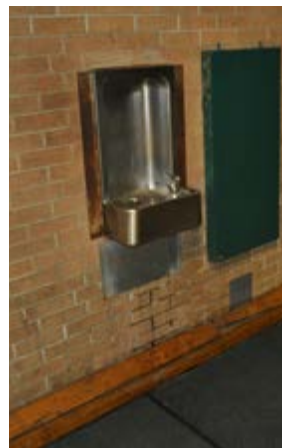
Drinking Fountain, Aged Base Board & Cracking CMU

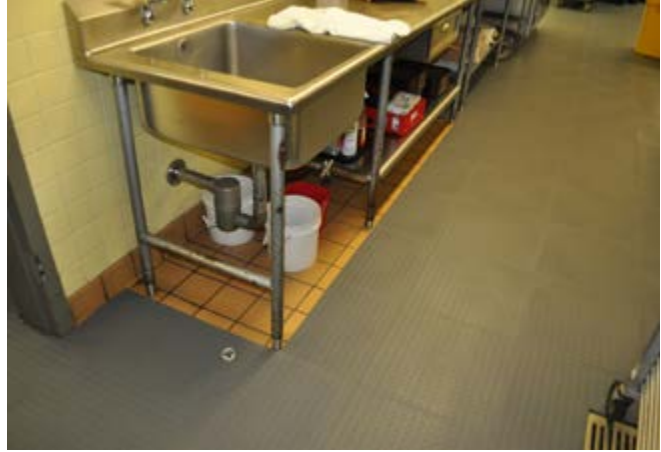
Kitchen Rubber Floor

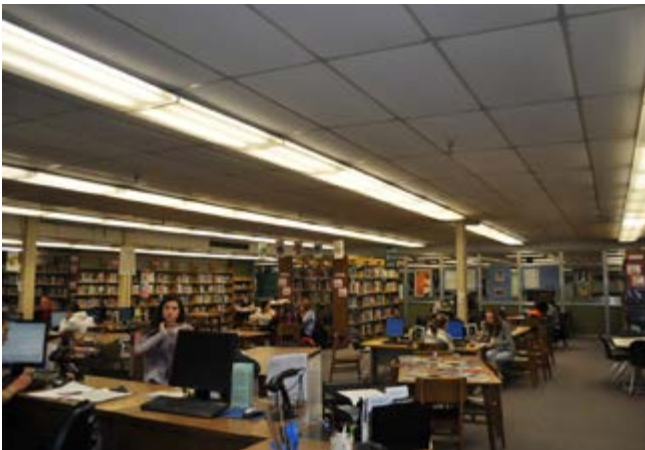
Library, No Natural Daylight

The Library is located central to the school on the main level. There are no exterior windows or natural light, and the interior lighting is poor. This interior space is furnished with aged tables, chairs and book shelves. The wall paper is original to the school, and well beyond its useful life with visible tears and repairs with duct tape. The space requires a complete renovation, and would benefit greatly from natural light.

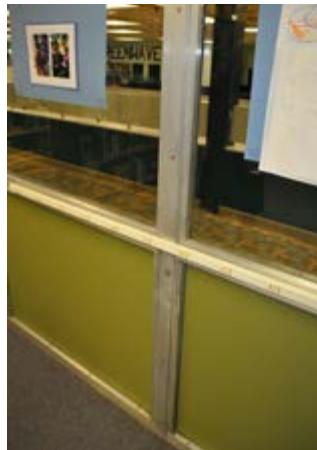
Interior Aluminum Wall System & Aged Bookshelves

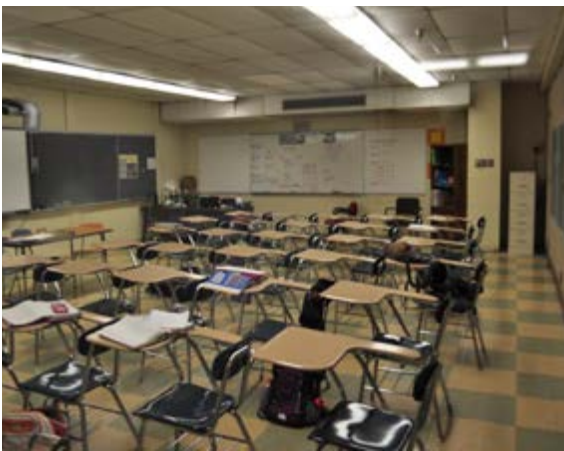
Typical Classroom - Asbestos Tile Floor

The 1966 portion of DHS has a variety of floor types throughout the school. The corridors, kitchen, bathrooms, and lockers rooms are ceramic tile, the classrooms and cafeteria are Vinyl Coated Tile (VCT), the auditorium, library, computer room, administration areas and select other spaces have carpet, the gymnasium is athletic wood flooring. All of the flooring in the 1966 portion of the school is beyond its useful life and would require full replacement. The 2012 AHERA report as attached in the appendix, indicates that all of the flooring listed above with the exception of the gym floor is assumed to have asbestos containing material, and would need full remediation prior with any renovation , demolition or addition.

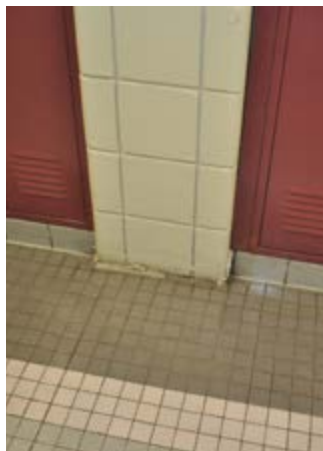
Base in Disrepair

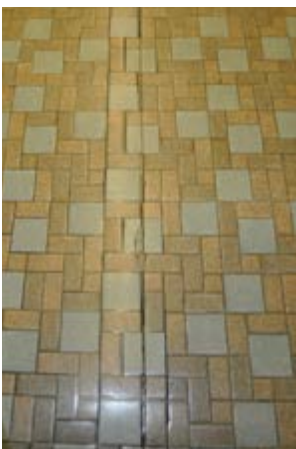
Cracked Tile Floor

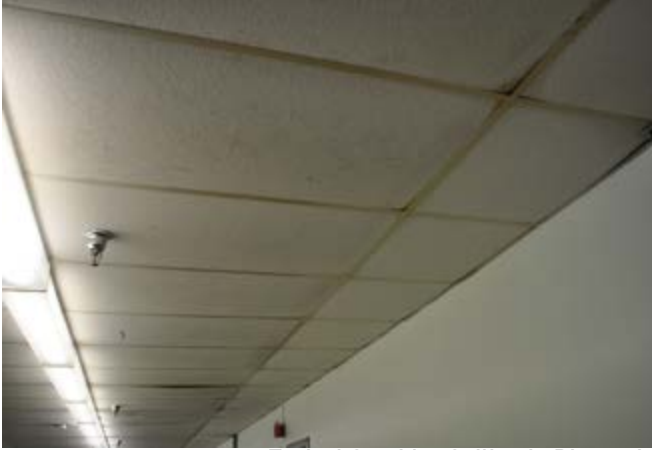
Typical Corridor Ceiling in Disrepair

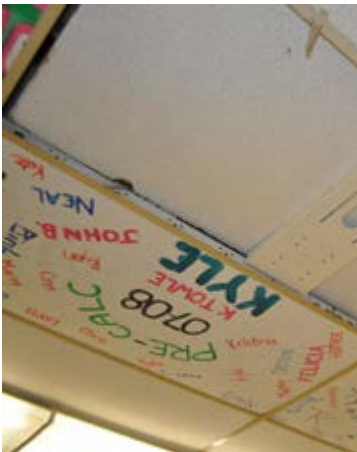
Typical, Painted Ceiling Tiles

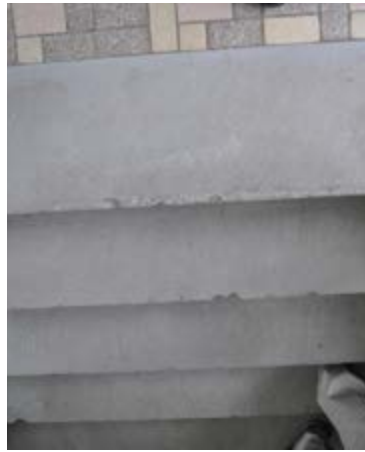
Chipped Blue Stone Treads

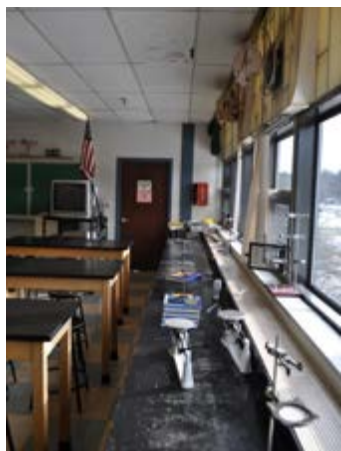
Counter Tops in Disrepair

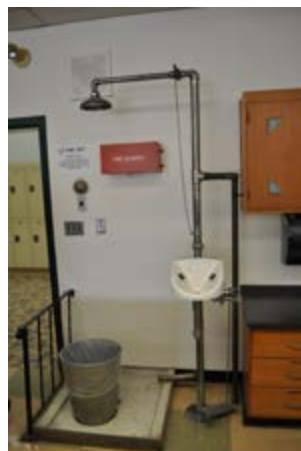
Original Chemical Shower

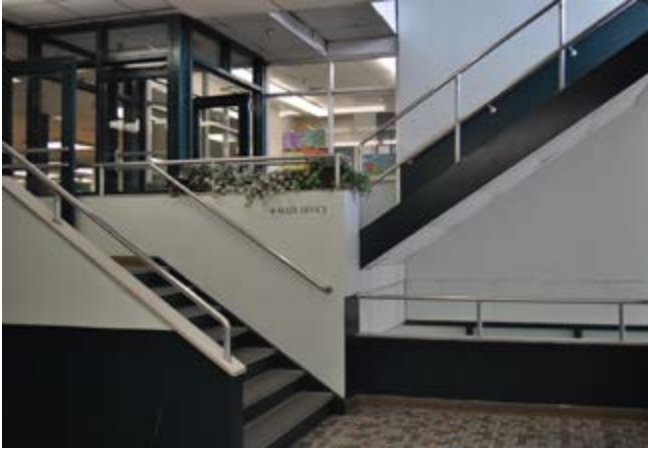
Multiple Levels

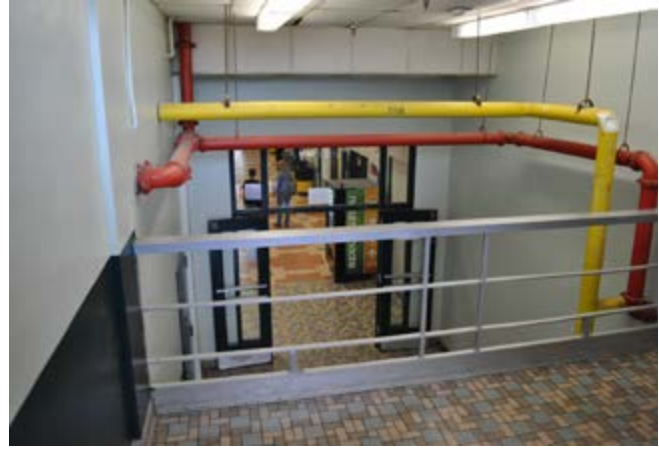
Rails and Guards

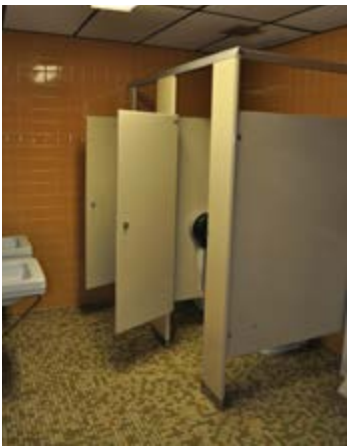
Inaccessible Toilet Stalls

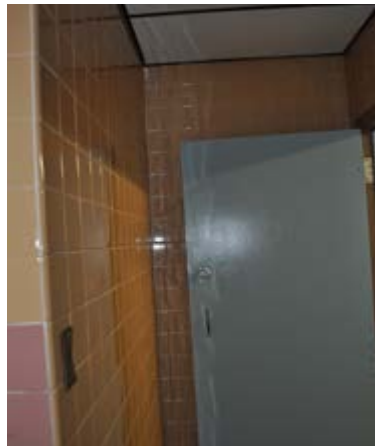
Hardware Issues

- Door hardware must be upgraded or replaced to meet ADA regulations including, but not limited to, door handles, closers and panic devices, as previously noted

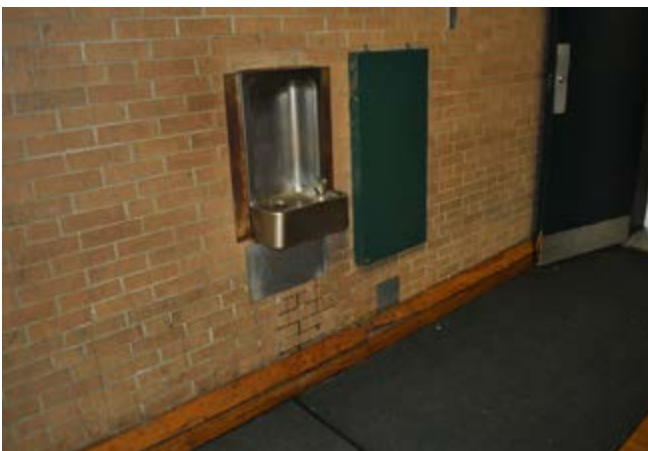
Inaccessible Water Fountain

- Currently the drinking fountains lack appropriate clear floor space and height requirements ADA.
- Many of the doors do not provide the required push/ pull clearances and must be replaced or relocated to meet the ADA requirements. This condition occurs throughout the building including several of the classroom entrances, and secondary egress doors.

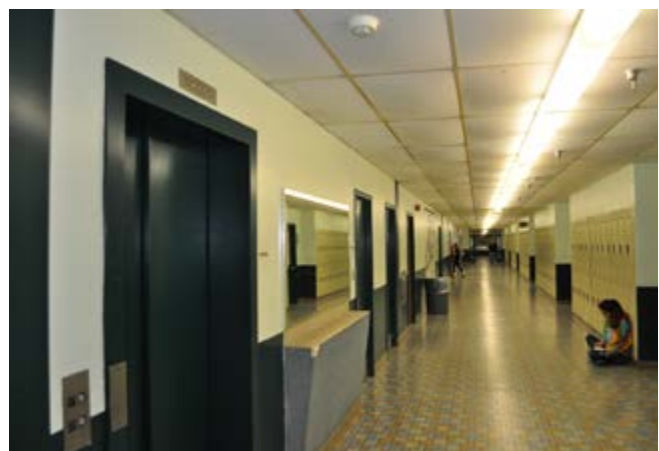
Remotely Located Elevator

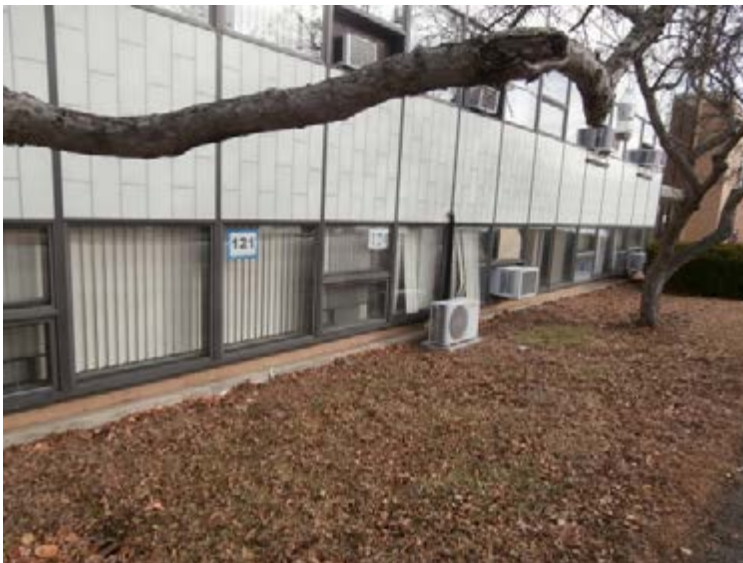
2. 1966 Classroom wing: South side window sill elevation near grade.

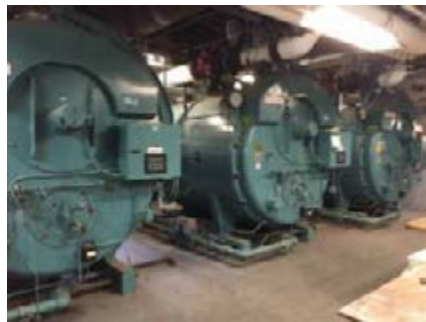
The building is primarily heated by gas fired hot water boiler plant. There are three (3) gas-fired hot water boilers located in the lower level boiler room. The boilers were manufactured by Cleaver Brooks (Model CBLE-700 240 125, Serial Nos. 0L102065, 0L102066, 0L102067) with 9,900 MBH gas input. The boilers are equipped with CB Hawk boiler controls. The boilers were installed circa 2002 and are approximately 12 years old. The boilers appear to be in good physical condition.

*Existing Boilers*

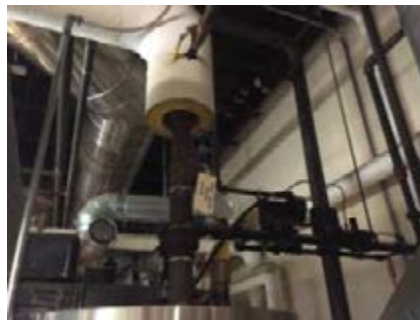
The boilers are vented by a common manifold double wall steel breeching system that terminates through a masonry chimney to the outdoors. There are some visible cracks at the top of the chimney. The condition of the interior liner was not inspected during the site visit.

*Steel Breeching (top left)*

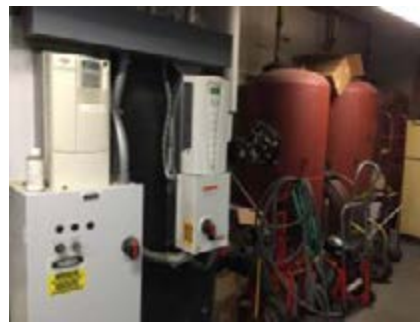
*Existing HW Pump VFDs (left)  
and Expansion Tanks (right)*

There are three (3) hot water expansion tanks that appear to be in good condition.

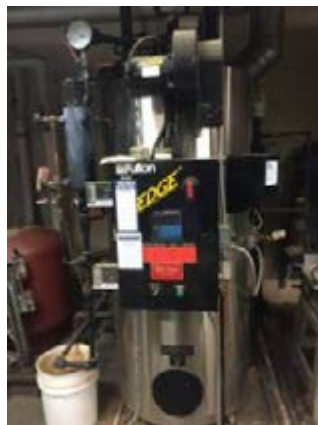
There is a steam boiler system installed in the mechanical room. The steam boiler is a Fulton Edge boiler. The steam boiler provides steam for the Kitchen dishwasher and steam cooking kettles. The steam boiler appears to be in good condition.

*Steam Boiler*

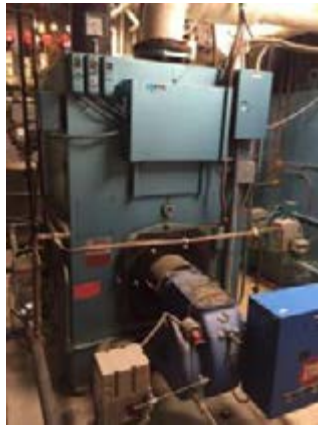
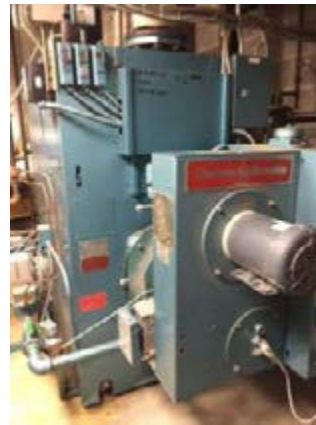
The CTC building is primarily heated by a gas fired hot water boiler plant. There are two gas-fired cast iron sectional hot water boilers located in the boiler room. The boilers were manufactured by Cleaver Brooks. One boiler is equipped with a S.T. Johnson Co, burner and the other boiler has a Cleaver Brooks burner. The boiler equipped with Johnson burner has an input capacity of 2,520 MBH. The boiler equipped with a Cleaver Brooks Burner (Model I-506 Series 200, Serial No. CI-1296) has a capacity of 2,237 MBH gas input and 1,786 MBH output (I=B=R). The boilers were installed circa 1988 and are approximately 26 years old and nearing the end of their useful service life. The boilers appear to be in fair physical condition. One boiler has recently had a damaged control board replaced.

*Existing Boiler (Johnson Burner)*

*Existing Boiler (CB Burner)*

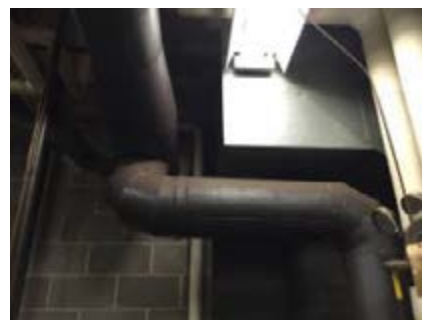
The boilers are vented by a common steel breeching system that terminates through the roof to the outdoors. The steel breeching is uninsulated, and the exterior breeching shows visible signs of rust and corrosion.

*Interior Boiler Breeching*

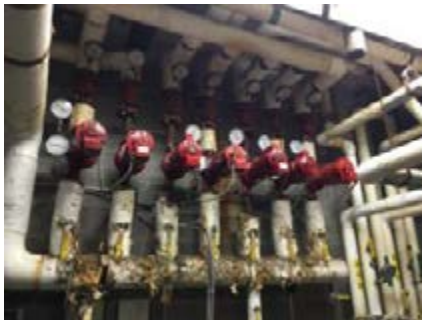
Hot water is distributed from the Boilers to terminal heating equipment located throughout the building by six (6) inline zone circulator pumps. The pumps appear to have been installed in 1988. In general, the pumps appear to range from fair to poor physical condition. Much of the adjacent piping insulation is damaged. There is a hot water expansion tank which appears to be in good condition.

*Existing Hot Water Pumps*

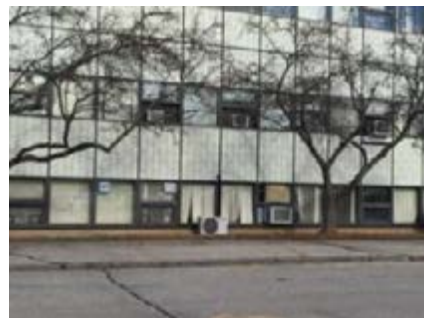
The majority of the building is not air conditioned. Some areas of the building are air conditioned by window AC units, split-system and ductless cooling type air conditioning systems. There are several roof mounted and grade mounted air-cooled condensing (ACC) units that are connected to ductless split system AC units located throughout the building. The Administration area, Copy room, Computer Classroom and Main Server room are air conditioned by split system AC units. The teacher Dining Room, Custodian's office and various Classrooms are air conditioned by Window AC units. In general the majority of these units appear to have been installed within the past 5-10 years and in fair to good physical condition. There was one older condensing unit observed that appeared to be of an older vintage and in need of replacement.

*Window AC Units*

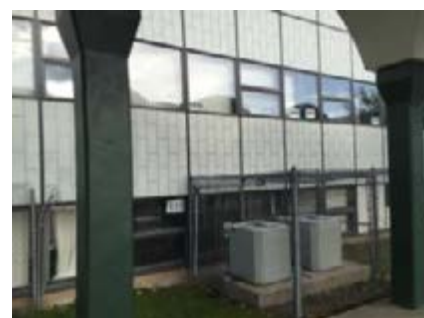
*Grade Mounted Air cooled Condensing Units*

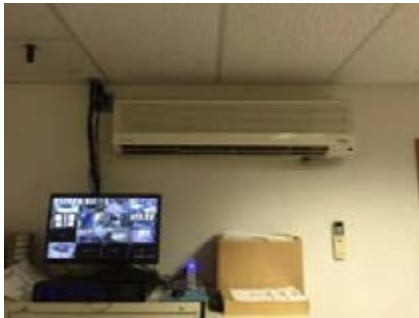
*Ductless Cooling Unit – Operations Office*

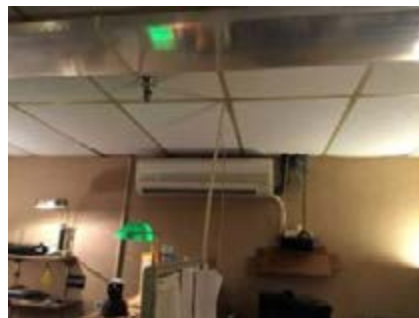
*Ductless Cooling Unit – IT Server and Office*

The IT Server and Office room is air conditioned by a ductless AC unit. It was reported that the room is consistently warm and experiences inadequate airflow and temperature control.

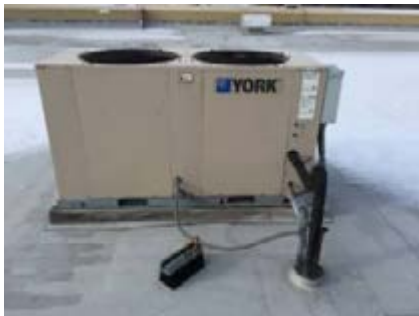
*Administration Area ACC Unit*

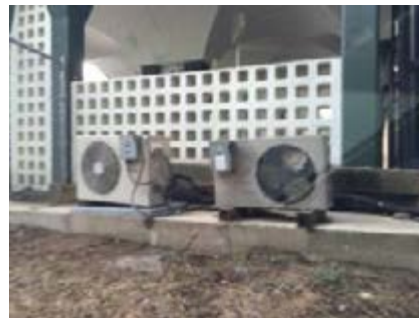
*Ductless AC Unit ACC Units*

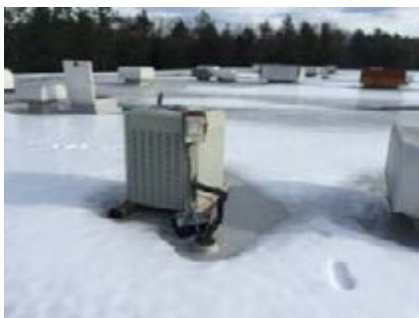
*Roof ACC Unit*

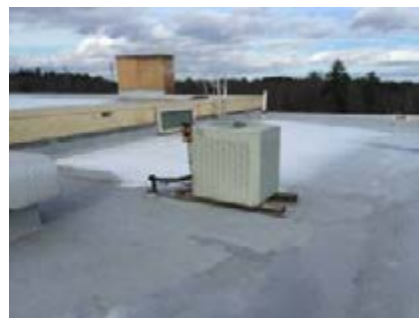
*Roof ACC Unit*

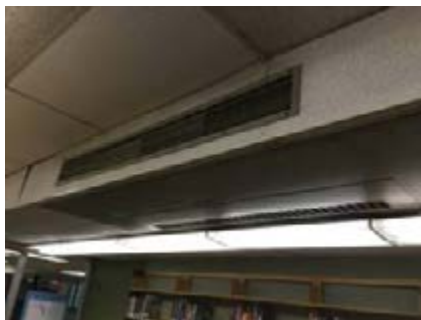
The Library/Media Center is heated and ventilated by indoor ceiling suspended heating and ventilation unit ventilators. The units were installed circa 1966, and are approximately 48 years old and past their expected service life. The Library/Media Center is also heated by supplemental fin tube radiation that is located along the perimeter exterior walls.

*Library Heating & Ventilation Unit*

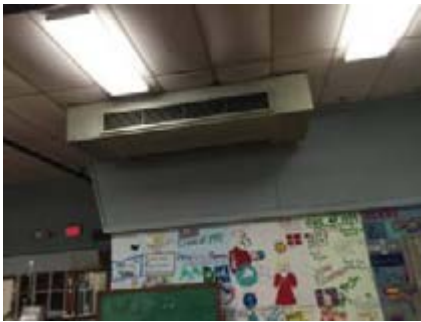
The Music classrooms are heated and ventilated by horizontal type classroom unit ventilators, and are exhausted by exhaust air fan systems. The unit ventilators and ductwork distribution systems appear to be originally installed equipment, installed circa 1966, and past their expected service life. Some Music classrooms also have supplemental hot water fin tube radiation installed; the fin tube radiation also appear to be originally installed equipment.

*Music Classroom – Unit Ventilator*

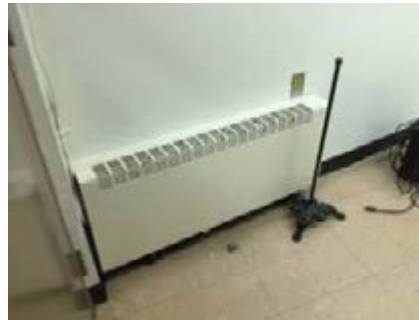
*Music Classroom – Fin tube Radiation*

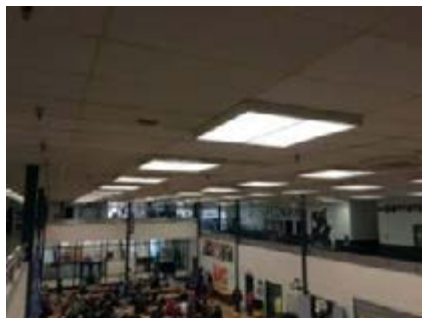
The Cafeteria is heated and ventilated by an indoor hot water air-handling unit (AHU-6) that delivers supply air to the space via a galvanized sheetmetal distribution system and ceiling mounted diffusers. Return air is primarily removed from the space by low wall return registers. The air handling unit and ductwork distribution system was installed circa 1966, and is approximately 48 years old and past its expected service life.

*Cafeteria – Ceiling Diffusers*

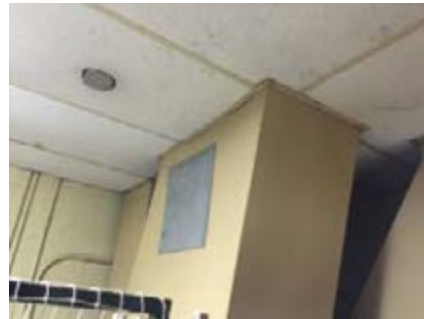
The Kitchen has a stainless steel exhaust hood that is exhausted by a centrifugal utility set exhaust fan located in the Penthouse Mechanical room. The kitchen exhaust ductwork riser does not appear to meet all current NFPA 96 code requirements as the riser is not located in a 2-hr fire rated enclosure. The Kitchen is heated by supplemental hot water unit heaters and supply air registers that are connected to a make-up heating and ventilation air-handling unit (AHU-7). There is a wall mounted propeller fan that is utilized to provide airflow movement within the space. The dishwasher is exhausted by stainless steel ductwork that is connected to an exhaust air fan. The Kitchen service corridor is heated by a unit heater.

*Kitchen Exhaust Duct Riser in Storage Closet*

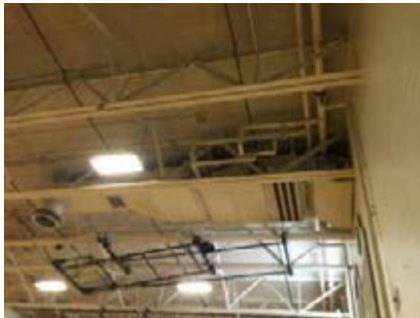
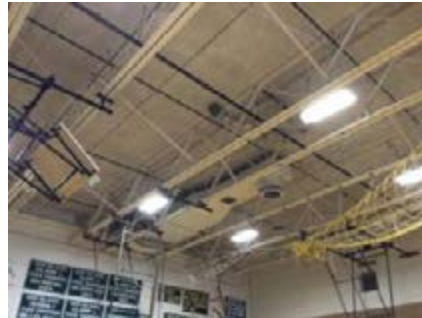
The Gymnasium is heated and ventilated by four (4) indoor, ceiling suspended, hot water heating and ventilation units (AHU-1, 2, 3 & 4). The units appear to have been installed circa 1966 and are in poor physical condition and have exceeded their expected service life. Exhaust air is removed from the gymnasium via ceiling exhaust grilles that are connected to roof exhaust fans. There are (4) four roof exhaust fans.

*Gym Heating & Ventilation Units*

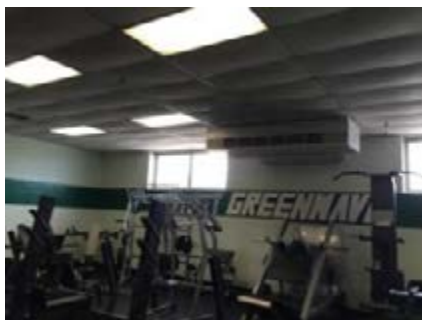
The Fitness Room is heated by a ceiling suspended hot water unit ventilator. It appears that the unit ventilator is originally installed equipment circa 1966. The heating and ventilation system appears to be in poor condition and past its expected service life.

*Fitness Room Unit Ventilator*

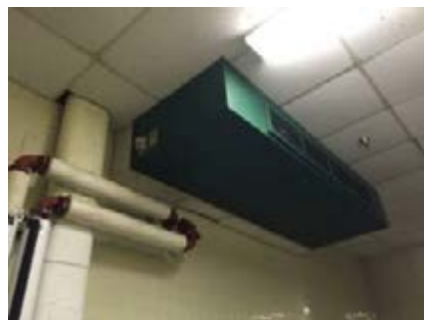
The Locker Rooms are heated by a combination of suspended hot water unit ventilators and hot water fin tube radiation heating equipment. The Girls locker room has a ducted exhaust air system that is served by two (2) inline exhaust air fans. The Boy's Locker room is exhaust by rooftop exhaust air fans. It appears that the heating and ventilation system appears to be originally installed equipment, in poor physical condition and past its expected service life. Sections of the fin tube radiation and several of the air distribution devices appear to be rusted and soiled.

*Locker Room Unit Ventilator*

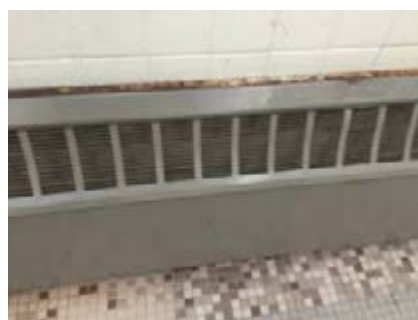
*Locker Room Fin tube Radiation*

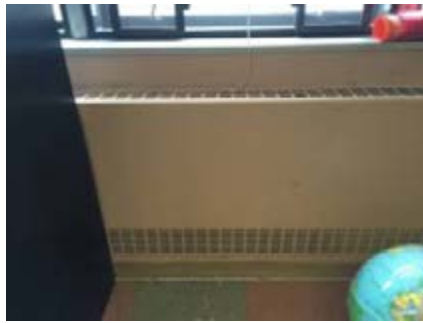
The majority of interior classrooms are heated and ventilated by horizontal type classroom unit ventilators. The exterior classrooms are typically heated by hot water fin tube radiation and ventilated through the use of operable windows. Roof mounted exhaust air fans and associated exhaust ductwork distribution systems provide exhaust air for the majority of classrooms. The unit ventilators, exhaust fans and ductwork distribution systems appear to be originally installed equipment, installed circa 1966, and past their expected service life.

*Classroom – Fin tube Radiation*

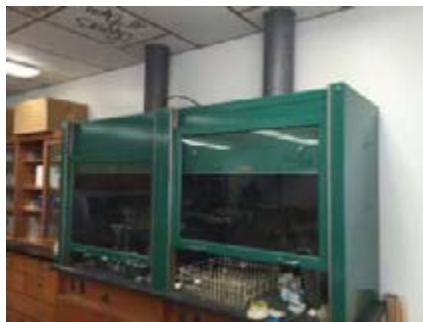
*Science Classroom Fume Hoods*

Some of the Science Classrooms have fume hoods and associated exhaust air fan systems. Some of the Science classrooms also have a sidewall exhaust air fan. It has been reported that the fume hood operation interferes with the heating and ventilations system's ability to properly heat the space, as warm air is exhausted through the fume hood and sidewall exhaust air fan while they are in operation. Tempered mechanical make-up air ventilation should be provided in these Classrooms.

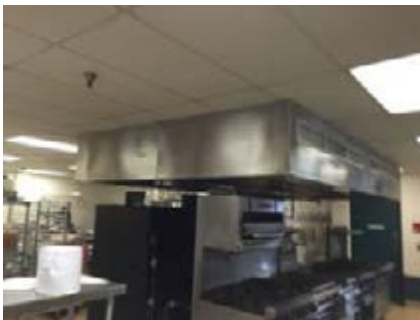
The CTC Kitchen has a main stainless steel kitchen exhaust hood and associated roof mounted exhaust air fan. There is also a stainless steel canopy dishwasher hood. There are hot water ceiling suspended unit heaters that provide heating to the kitchen. Make up air ventilation is provided by a roof top make-up air unit. The exhaust, make-up air and heating systems appears to have been installed circa 1989 and appear to be in fair to poor condition.

*Kitchen Exhaust Hood*

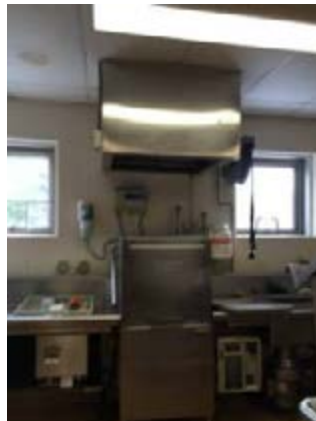
*Dishwasher Exhaust Hood*

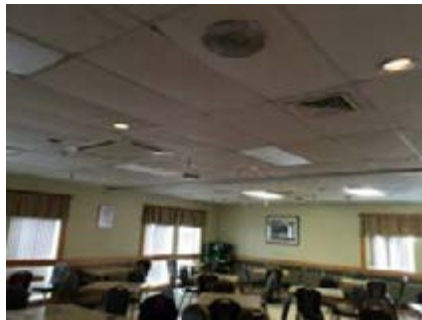
The CTC Dining room is heated and air conditioned by a ductless AC split system heat pump system. There is also perimeter hot water fin tube radiation heating. It has been reported that the heat pump AC system and hot water fin tube radiation heating operate simultaneously at certain times of the year, resulting in both excess energy usage and temperature control complaints. The ductless cassette type AC heat pump system has its own stand-alone thermostat controls which are not fully integrated into the building control system.

*CTC Dining Room - Cassette Type AC Unit (left)*

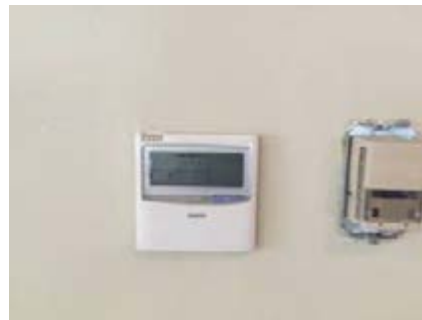
*CTC Dining - Thermostats*

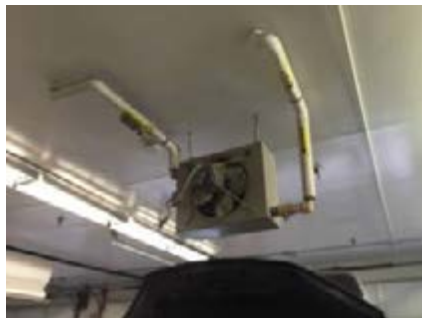
The Auto Shop is primarily heated and ventilated by a central indoor air handling unit and duct mounted hot water heating coils. Supplemental heating is provided by hot water unit heaters. There are general exhaust air, welding booth and under-slab exhaust air systems installed. The air handling unit, unit heaters, general exhaust and under slab exhaust were installed circa 1989 and are generally in poor physical condition. The welding booth exhaust and ventilation ductwork appear to be in fair condition.

*Auto Shop Unit Heater*

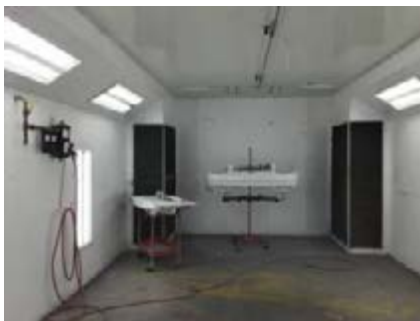
The Auto Body Shop is primarily heated and ventilated by a central indoor air handling unit and duct mounted hot water heating coils. Supplemental heating is provided by hot water unit heaters. There are general exhaust air, and paint booth exhaust welding booth systems installed. The air handling unit, unit heaters and general exhaust systems were installed circa 1989 and are generally in poor physical condition. The paint booth make-up ventilation air is provided from a rooftop unit and exhaust air is provided by an associated exhaust fan. The paint booth appears to be in fair condition.

*Paint Booth*

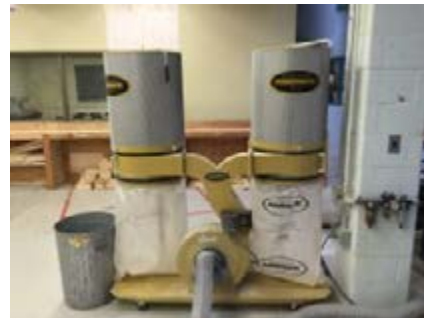
The Trades Shop is primarily heated and ventilated by a central indoor air-handling unit and duct mounted hot water heating coils, and supplemental heating is provided by ceiling suspended propeller type unit heaters. The unit heaters appear to be in good condition. There is a re-circulating filtered type dust collector installed. The dust collector appears to be in good condition.

*Dust Collector*

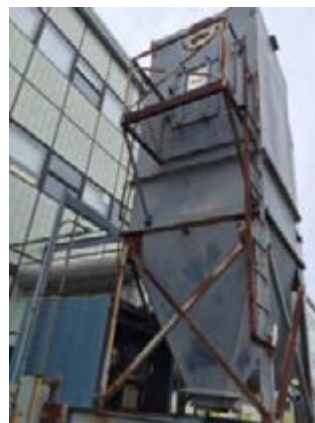
The Wood Shop is primarily heated and ventilated by a hot water unit ventilator, and supplemental ventilation air is provided by a central station air handling unit. There is an outdoor grade mounted dust collector installed that is ducted to wood-working saws and equipment via galvanized sheetmetal ductwork. The unit ventilator, dust collector and associated ductwork appears to be in poor condition.

*Wood Shop - Dust Collector*

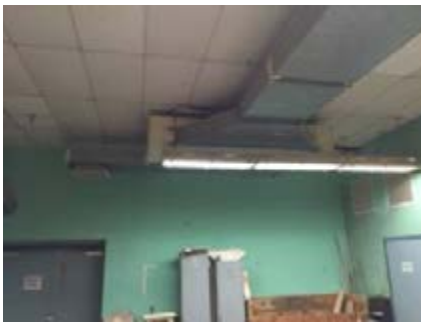
*Wood Shop Unit Ventilator*

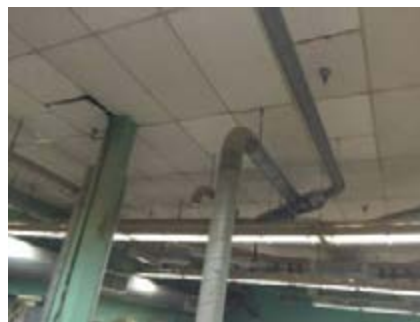
*Wood Shop Dust Collector Exhaust Ductwork*

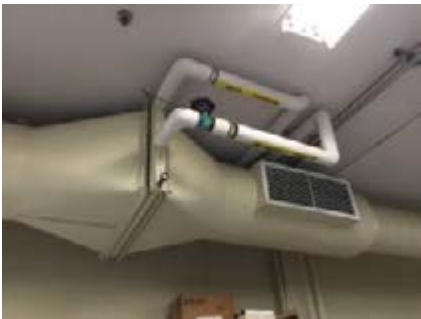
The CADD Classroom and Shop is primarily heated and ventilated by a central indoor air handling unit and duct mounted hot water heating coils. There are general exhaust air and hose-reel exhaust air systems installed. The air handling unit, general exhaust fan and hose-reel exhaust systems were installed circa 1989 and are generally in poor physical condition. The exhaust and ventilation ductwork appear to be in fair condition.

*CADD Shop Heating Coil and Ventilation Ductwork*

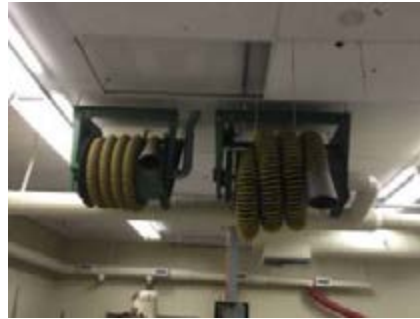
*Hose-Reel Exhaust*

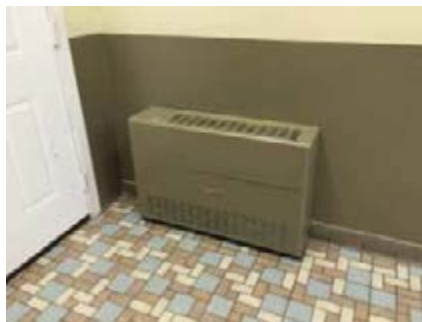
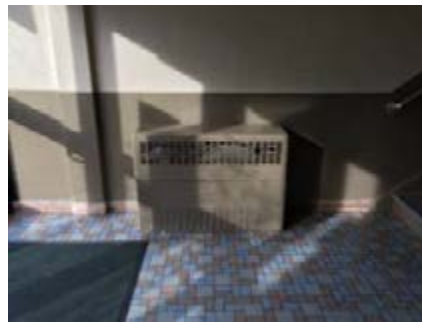
Entryways, stairwells, and corridors are typically heated by cabinet unit heaters. There are also locations where hot water fin tube radiation is installed. In general, the heating equipment is originally installed equipment, approximately 25 to 48 years old dependent upon its location and date of installation.

*Existing Cabinet Unit Heater*

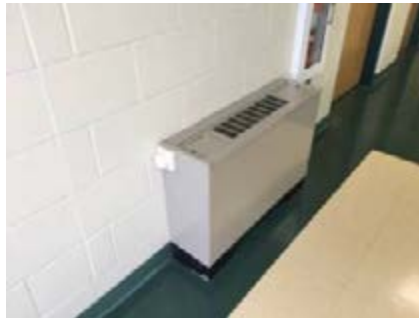
*Existing Cabinet Unit Heater – World Arts Wing*

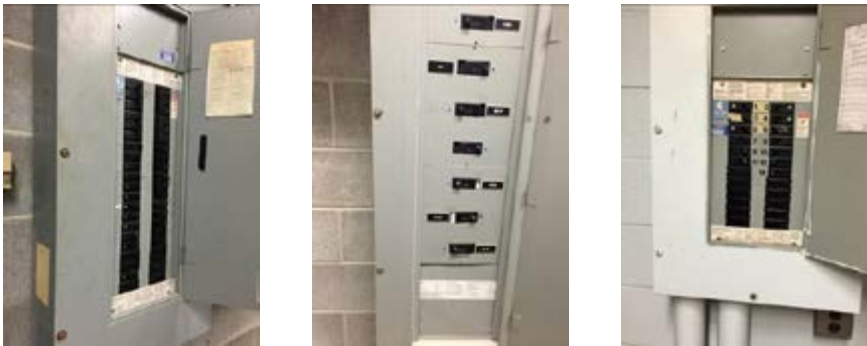
The service voltage is 120/208V rated at 2000 amps. The switch is in fair condition and within its 40 year useful life. The main switchboard does not have space for future expansion. The main switchboard is manufactured by Square D.

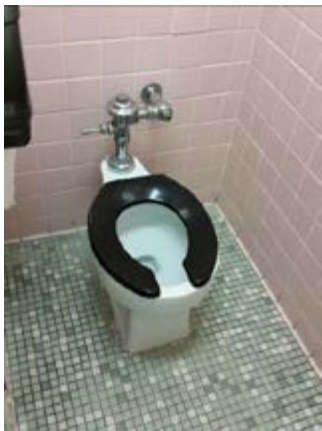
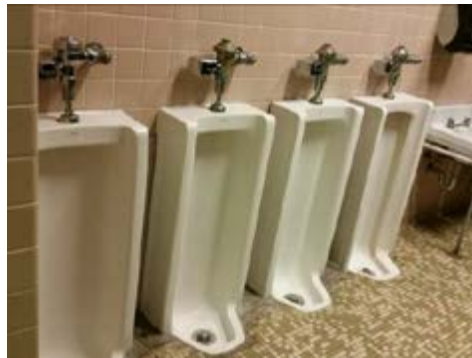
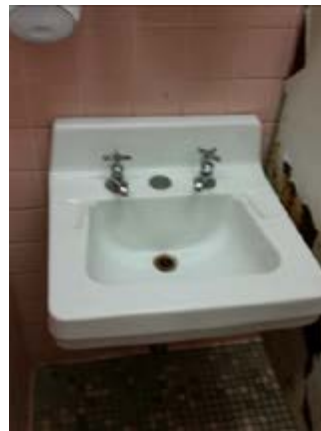
The plumbing fixtures are generally in fair condition. The plumbing fixtures in the 2003 building are in good condition. In general, the fixtures in the original and 1987 building appear to have served their useful life. Current Access Code requires accessible fixtures wherever plumbing is provided. In terms of the water conservation fixtures, their use is governed by the provisions of the Plumbing and Building Code. Essentially, the code does not require these fixtures to be upgraded, but where new fixtures are installed, as may be required by other codes or concerns, the new fixtures need to be water conserving type fixtures. All new fixtures are recommended in the original and 1987 building.

*Typical bathroom fixtures*

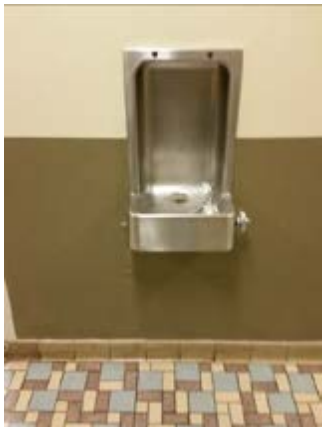
*Stainless steel drinking fountain*

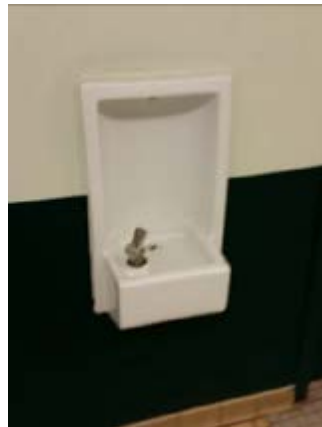
*China drinking fountain*

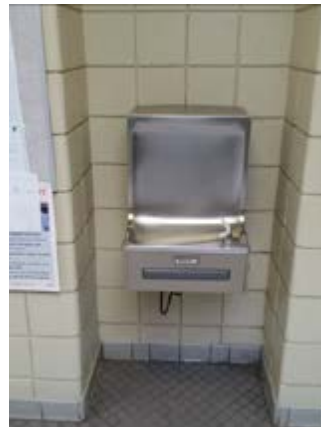
*Electric water cooler*

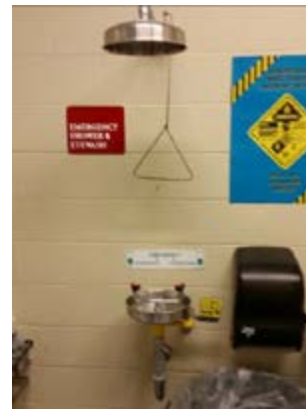
Shop/Tech labs contain either a combination emergency shower/eye wash or just an eyewash fixture. The emergency fixtures are fed by cold water system only; water is not tepid.

*Emergency fixture*

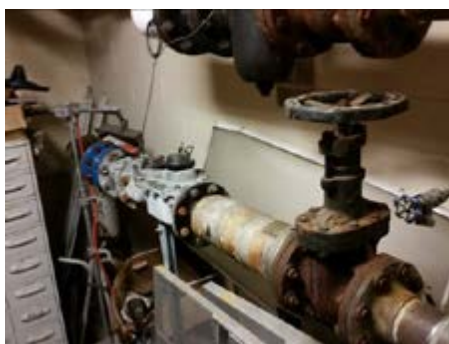
In the original building there is a dedicated 4" domestic water service which enters the mechanical room. There is a 4" domestic water meter and two 2" reduced pressure backflow preventers with pressure reducing valves located in parallel. There is also two 1-1/2" pressure reducing valves piped in parallel configuration. The distribution main is 4" in size.

*Original building water service & meter*

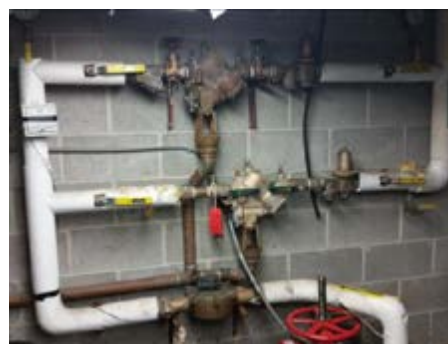
In the 1987 building there is a combined 8" water service which enters the lower level mechanical room. Off of this service there is a 2-1/2" domestic water supply with 2" water meter and two 1-1/2" reduced pressure backflow preventers with 1-1/2" pressure reducing valves located in parallel. The outlet water pressure is 70 PSI.

*1987 Building water meter*

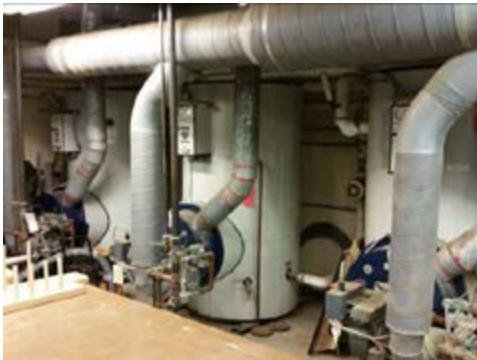
Domestic hot water in original building is generated through three natural gas fired storage type water heaters. Water heaters are PVI model 750N-400A, with a natural gas input of 600,000 BTUH and 400 gallon storage capacity. The water heaters are in fair condition. The hot water systems are recirculated. There are two thermostatic mixing valves on the systems to prevent scalding, Lawler model 805 and Lawler model 802.

*Original building water heaters*

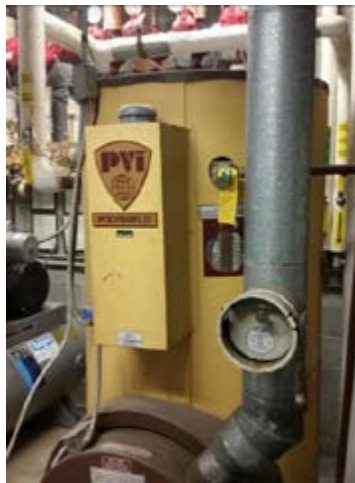
Domestic hot water in 1987 building is generated through a gas fired storage type water heater. Water heater are PVI model 375P-225, with a natural gas input of 300,000 BTUH and 225 gallon storage capacity. The water heater is in fair condition. The hot water system is recirculated. There are two thermostatic mixing valves on the systems to prevent scalding, both are Symmons model 5-900.

*1987 water heater*

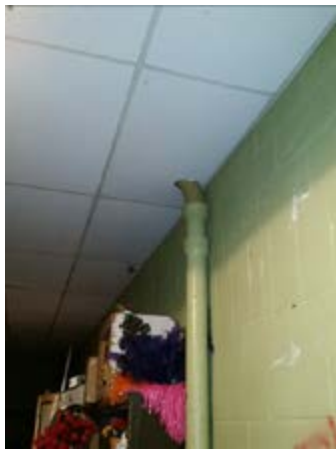
Cast iron is used for sanitary and storm drainage. Where visible, the cast iron pipe appears to be in fair condition. Smaller pipe sizes appear to be copper or PVC.

*Cast iron drainage piping*

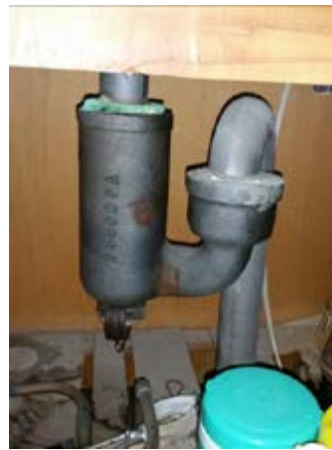
Acid waste and vent piping is hub and spigot dur-iron. The systems is not piped to an acid neutralization system

*Science waste piping*

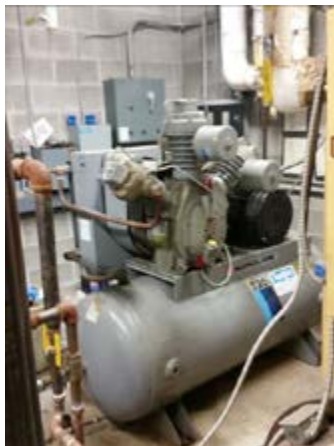
The compressed air is provided by a single 15 h.p. motor located on a horizontal receiver. Compressor is located in the 1987 Building mechanical room. The air compressor is in good condition.

*Air compressor*

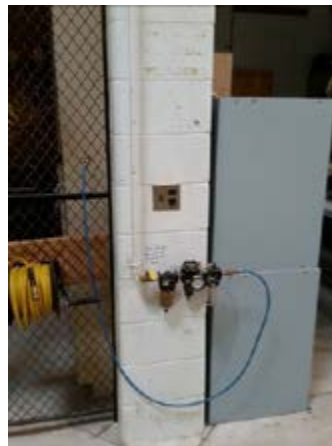
The technical shops are provided with compressed air. There are various pipe drops in each shop supplied from the piping distribution system. Typical outlets include a filter and pressure regulator.

*Typical air outlet station*

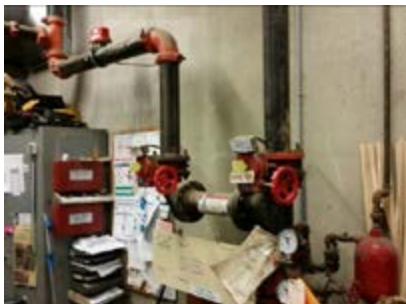
*Fire service riser*

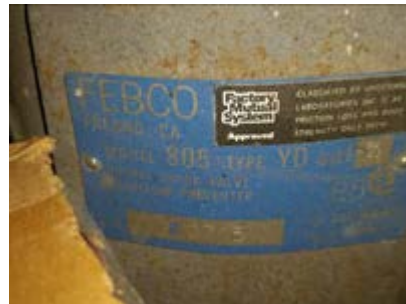
*Double check valve assembly*

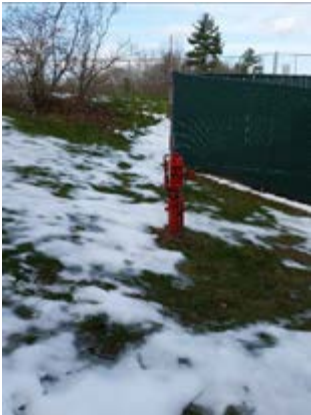
*Post Indicating valve*

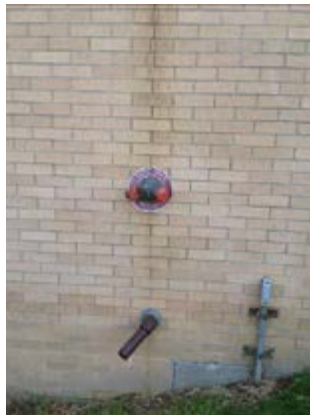
*Siamese Fire Department connection*

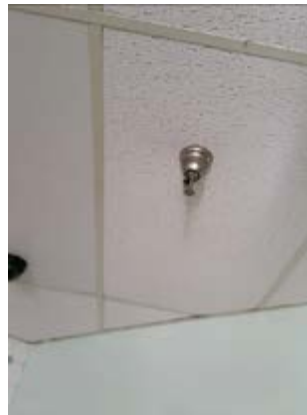
*Typical pendent sprinkler*

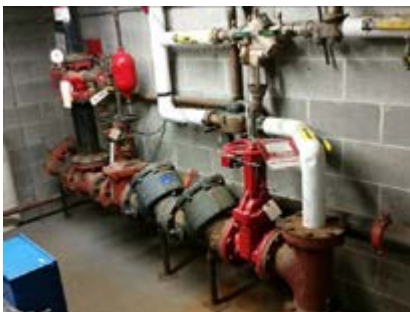
*Combined water service - FP riser*

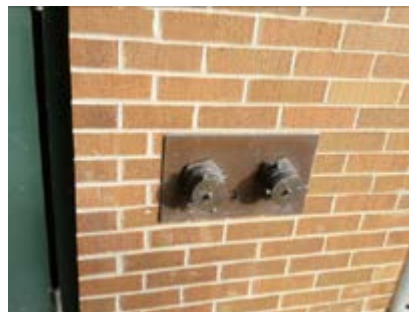
*Siamese Fire Department connection*

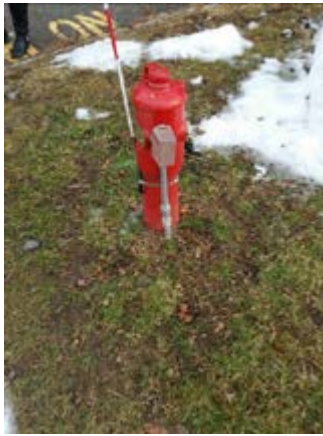
*Post indicating valve*

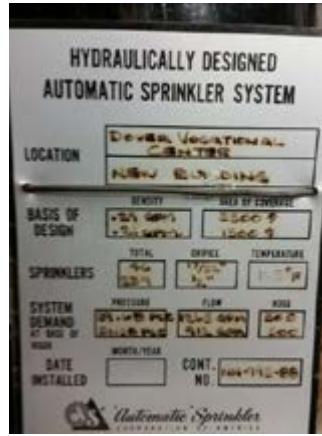
*Hydraulic data card*
