## **DOVER HIGH SCHOOL AND CAREER TECHNICAL CENTER** Site & Building Assessment Report

Dover, New Hampshire

January 2015

**Volume I of II**

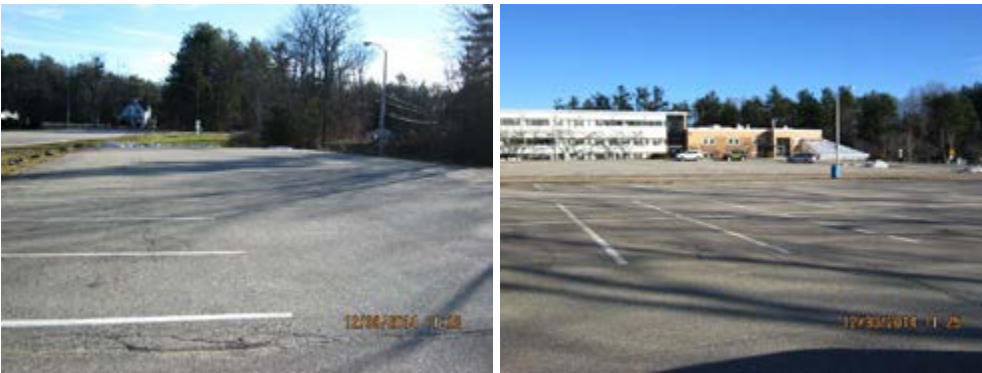
## Senior Lot

- Upon visual inspection the condition of the existing pavement is generally in satisfactory to less than satisfactory condition. Longitudinal and traverse cracking is low to medium in severity while alligator cracking is minimal. None of the cracks observed in the pavement have been sealed using asphalt crack sealant.
- Raveling and aging (pavement surface deterioration/loss of aggregate) of the pavement is not evident.

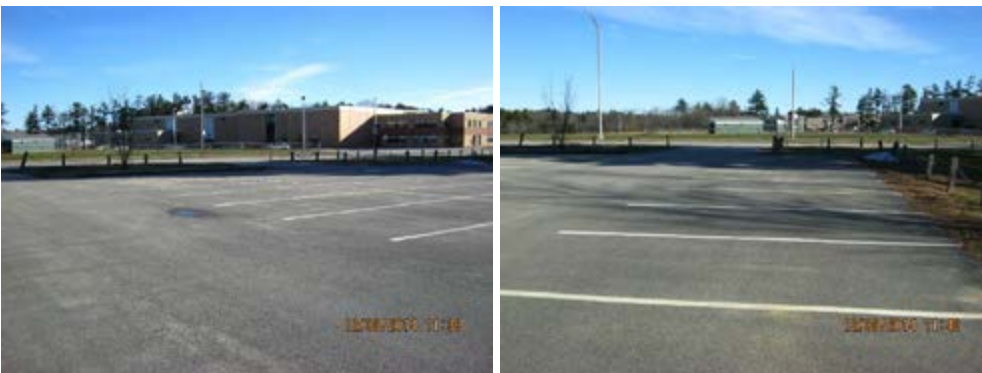
## Dover Alternate Program Parking Lot (50 Alumni Drive)

- Upon visual inspection the condition of the existing pavement is generally in good condition.
- No cracking, raveling and aging (pavement surface deterioration/loss of aggregate) of the pavement is evident.
- A couple of minor puddles were observed in the parking lot.

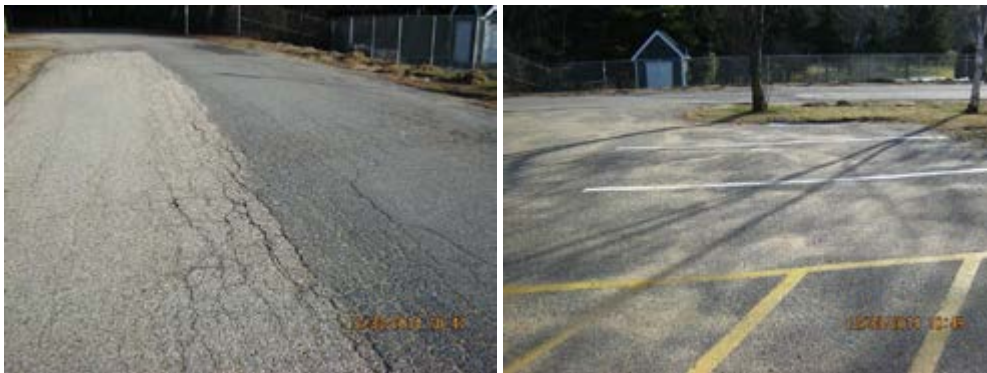
## Pavement East of 1989 CTC Addition (Including the access road from Alumni Drive)

- Upon visual inspection the condition of the existing pavement is generally satisfactory to less than satisfactory. Numerous cracks (longitudinal, traverse, alligator) were observed

in the pavement. None of the cracks observed in the pavement have been sealed using asphalt crack sealant.

- There is minor raveling and aging (pavement surface deterioration/loss of aggregate) of the pavement evident throughout the area.
- The pavement overlay at the entrance and exit from Alumni Drive is in good condition.

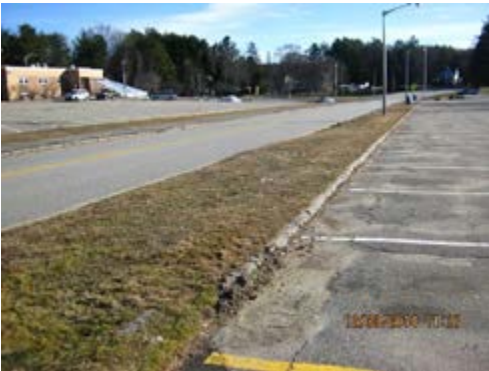
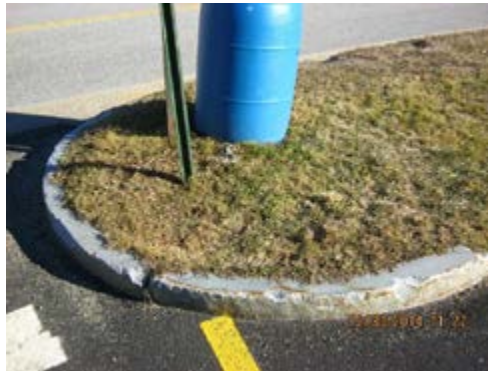
## Senior Lot

- No curb except around the landscape island abutting Alumni Drive. The landscape island has BCC along both sides of the island and VGC around the radial ends.
- The condition of the VGC is satisfactory while the condition of the BCC is nearing the end of its useful life. The BCC is cracked into several small 1 to 2 foot sections but has not begun to lose its alignment.

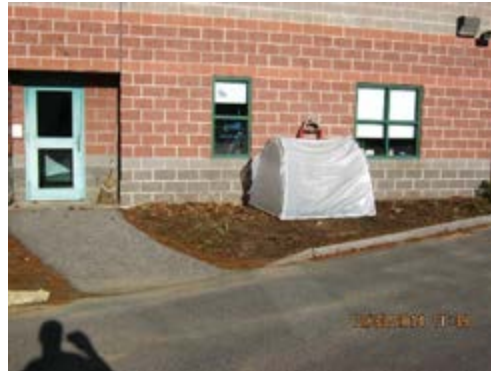
#### **Dover Alternate Program Parking Lot (50 Alumni Drive)**

- No curb except around the southeast corner of the building. The curb around the edge of the parking lot surrounding the southeast corner of the building is sloped granite curb (SGC). The SGC is in satisfactory condition.

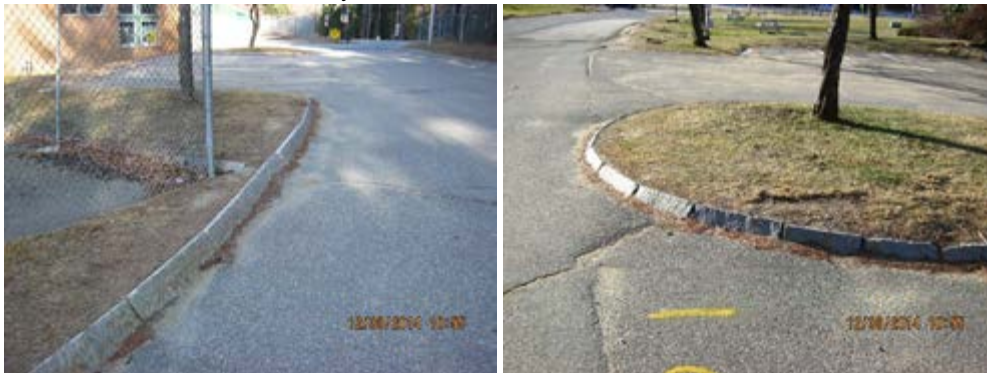
#### **Pavement East of 1989 CTC Addition (East Side of DHS)**

- SGC around portions of the asphalt perimeter along the east side of the CTC building. The SGC is in satisfactory condition.

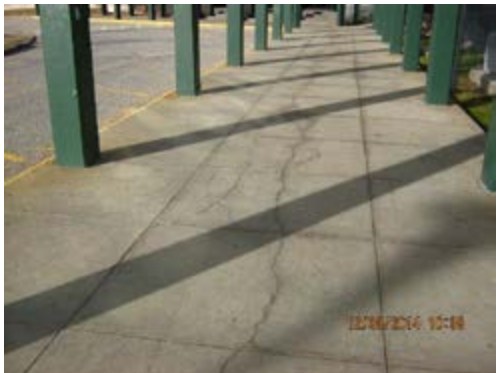
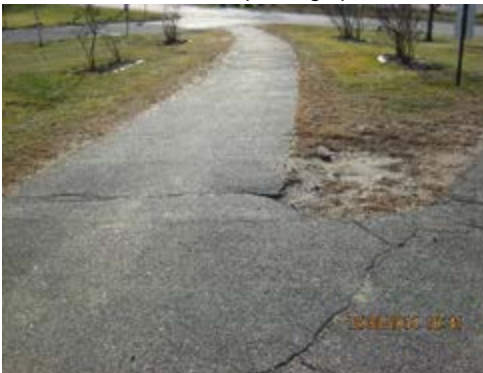
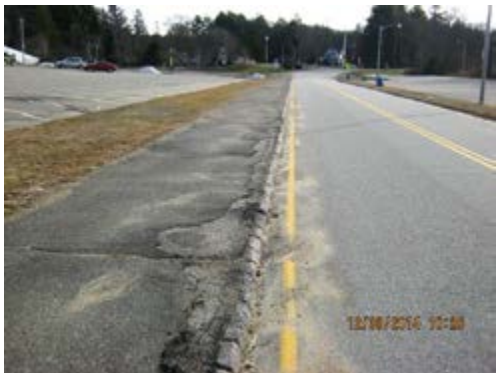
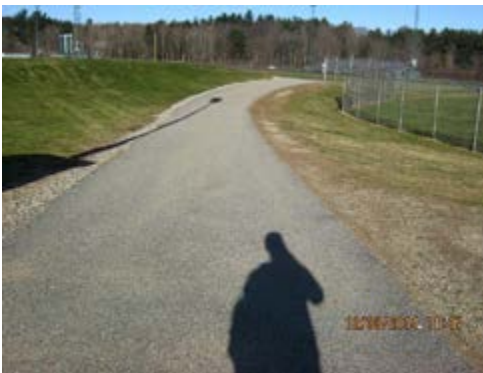
- The concrete sidewalk along the main entrance at the front of the school is in satisfactory condition. There is some cracking along the sidewalk and minimal chipping. The concrete steps to the main entrance have some chipped concrete at the edges.
- The asphalt sidewalk that loops from Alumni Drive along the front of the school is in less than satisfactory condition. Numerous cracks (longitudinal, traverse) were observed along the sidewalk. Some of the cracks have been treated with asphalt crack sealant

but the majority of the cracks have been left untreated. Appeared that the sidewalk has been overlain in the past.

- The sidewalk along the edge of Alumni Drive is in poor condition. Numerous cracks (longitudinal, traverse, alligator) were observed in the asphalt. Raveling and aging (pavement surface deterioration/loss of aggregate) of the asphalt was also observed, most notably at the sidewalk edges. Appeared that the sidewalk has been overlain in the past.
- The walkways to the building at 50 Alumni Drive are in good condition.
- The walkway from the B Lot to the ball fields was in good condition.
- The walkway from the B Lot to the doors at the front of the 2002 addition (Door #3 & Door #4) are in good condition.
- The concrete sidewalk leading to Door 28 at the east side of the CTC building is in poor condition. The concrete has deteriorated next to the accessible parking space.

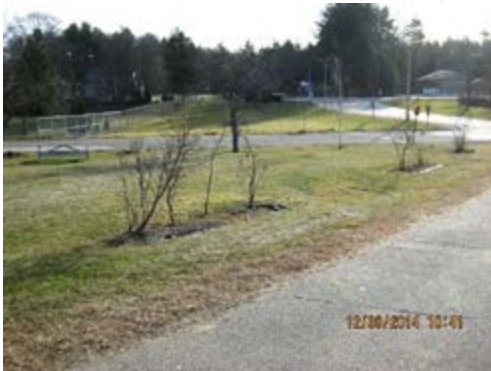
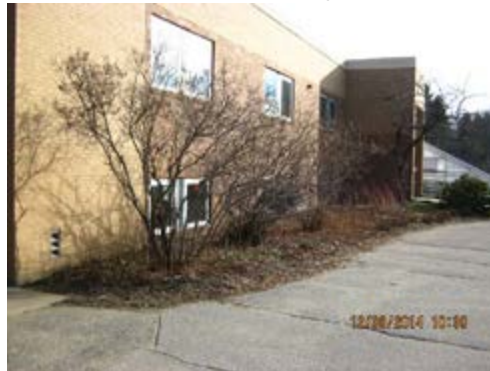
- Landscape inspection included the inspection of the trees and shrubs around the perimeter of the buildings and parking lots. The inspection did not include the landscaping and vegetation of the ball fields.
- The trees and shrubs planted around the buildings and parking lots appeared to be well established and healthy.
- The majority of the planted tree and shrubs are along the front face of the buildings and along the western edge of the driveway from Alumni Drive heading towards the C lot and middle school.
- Visible inspection of the grass appeared to be well established throughout the campus.
- The existence of an irrigation system could not be determined during the inspection.

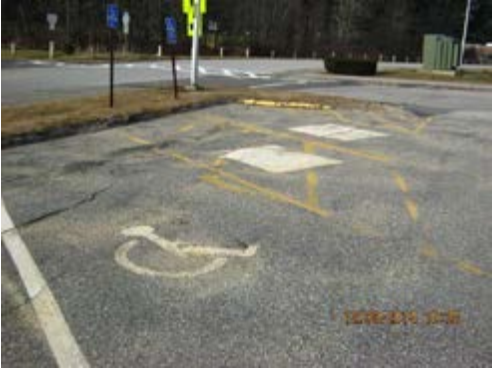
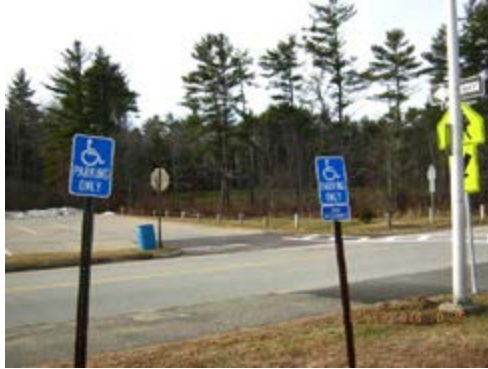
- Upon visual inspection there are two accessible parking spaces in the A lot and one accessible ramp into the main entrance of the building. There are approximately 87 parking spaces in the A Lot. According to state and federal ADA design standards there should be a minimum of 4 accessible parking spaces. In addition to having less than the minimum number of accessible spaces required, the access aisle striping and parking space signage are out of compliance. Also the head of the accessible aisles does not lead to an accessible path of travel as required by ADA.

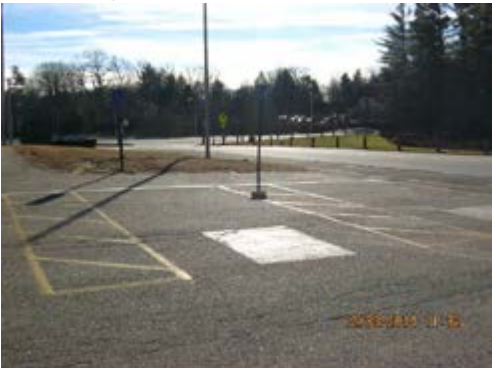
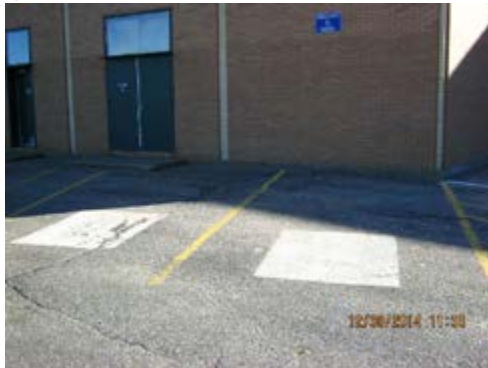
## B Lot

- Upon visual inspection of the building exterior it appears that Door 3, 4, 5, and 12 are accessible building entrances. There are approximately 90 parking spaces in the B Lot. According to ADA design standards there should be a minimum of 4 accessible parking spaces for which 4 accessible parking spaces are provided in the B Lot.

- There are two accessible parking spaces designated in the shortest accessible route to Door 5. Although the number of spaces is adequate one of the spaces should be designated as van accessible and the accessible spaces are not properly striped with an access aisle.

- There is a long concrete ramp leading to the Door 5 entrance. This ramp should have a handrail and a level landing per the ADA standards.
- No accessible parking spaces are provided to access Door 12. If this is an accessible building entrance a minimum of one van designated accessible space should be provided.

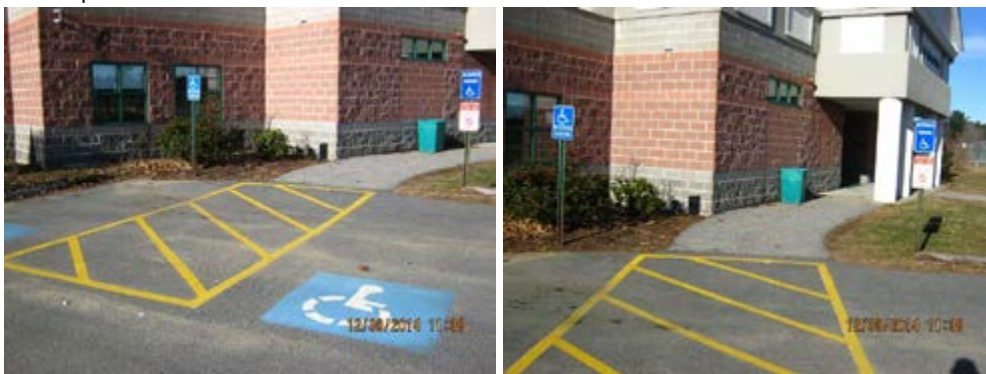
#### Dover Alternate Program Parking Lot (50 Alumni Drive)

- Upon visual inspection there are three accessible parking spaces in the parking lot and there appears to be one accessible entrance at the front of the building. There are approximately 76 parking spaces in the parking lot.
- Two accessible parking spaces are properly located closest to the accessible entrance although one of the spaces should be designated as van accessible. The other accessible space is located closest to the walkway to one of the ball fields. To be in accordance with ADA design standards this accessible space should be designated as van accessible and have an 8 foot wide access aisle to the right of the space.
- Based on the 76 parking spaces in the parking lot per ADA design standards 4 accessible parking spaces are required and only 3 accessible parking spaces are provided.

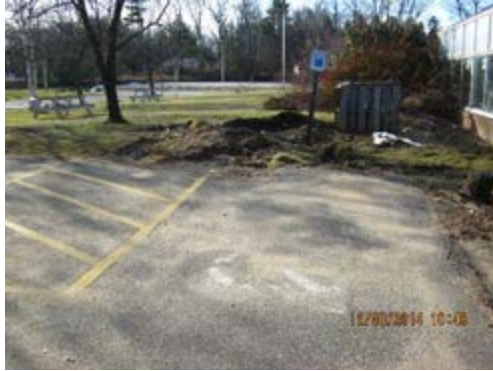
#### Career Technical Center Building

- Upon visual inspection there is one accessible entrance (Door 28) to the CTC building. There is a small 4 parking space lot accessible to this entrance. One of the four parking spaces is accessible which meets ADA design standards. However, this accessible parking space should be designated as van accessible and have an 8 foot wide access aisle to the right of the space.
